**STABLES MARKET
HORSE HOSPITAL**

**DESIGN AND ACCESS
STATEMENT AND
HERITAGE STATEMENT**

**For proposed works to
Units 87 and 93/94**

August 2016

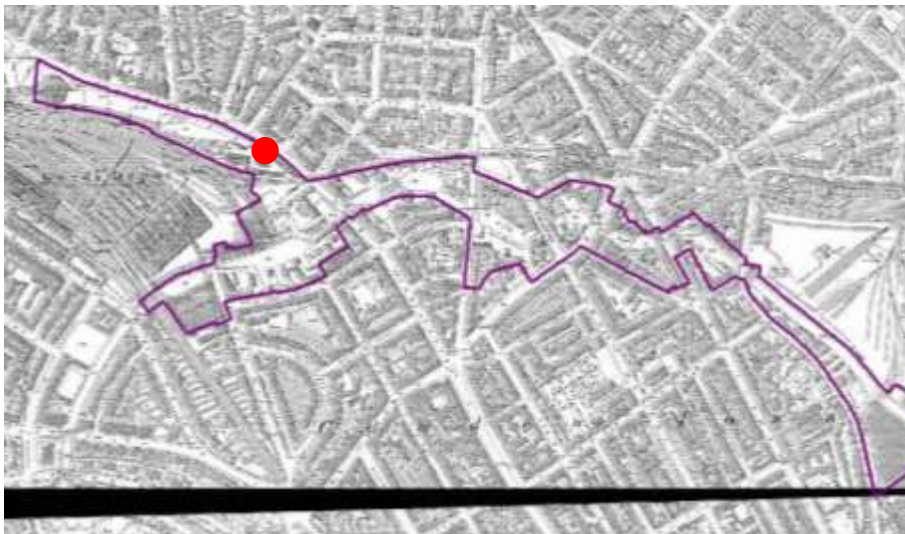
Figure 1: Regent's Canal Conservation Area map 1875 (subject site highlighted in red)

The Horse Hospital building is part of the internationally recognised Stables Market, in the northwest corner of the Regent's Canal Conservation Area, in the Sub-area 1 (Fig. 1).

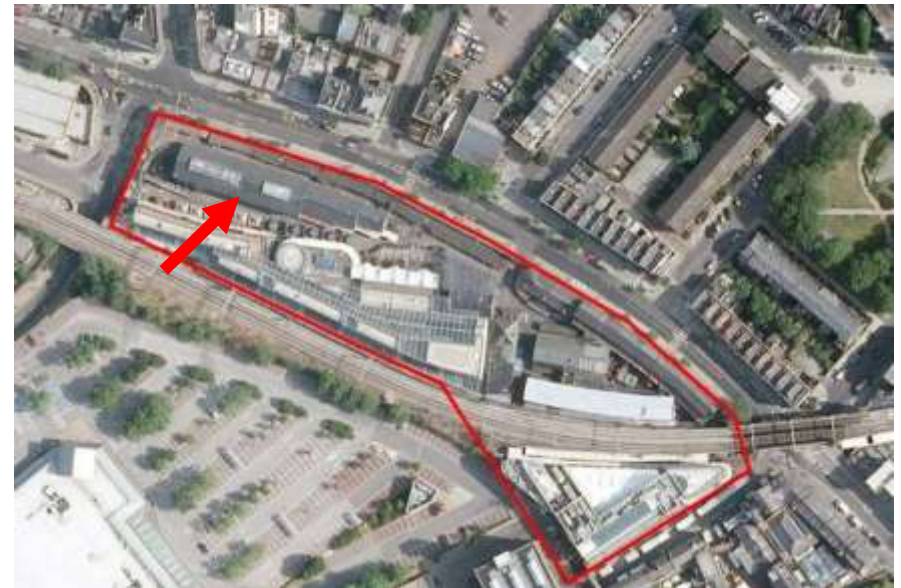
Figure 2: The Stables Market area shown within the red line and the Horse Hospital highlighted.

The area is bounded to the north by Chalk Farm Road (Hampstead Road as it was known until 1862), and is separated from the former lands of the goods yard to the south by the railway viaducts (Fig. 2 and 3).

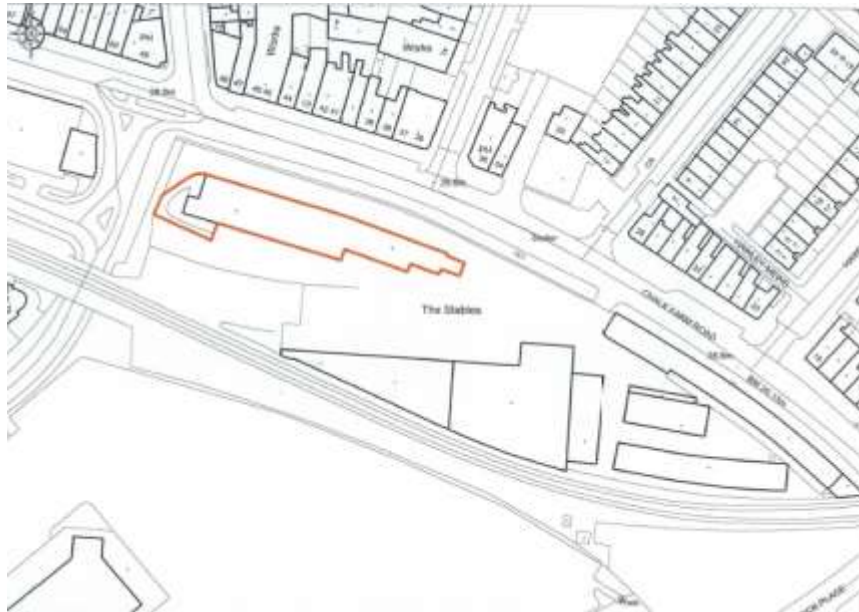
Figure 3: The site location Plan. The Horse Hospital shown within the red line.

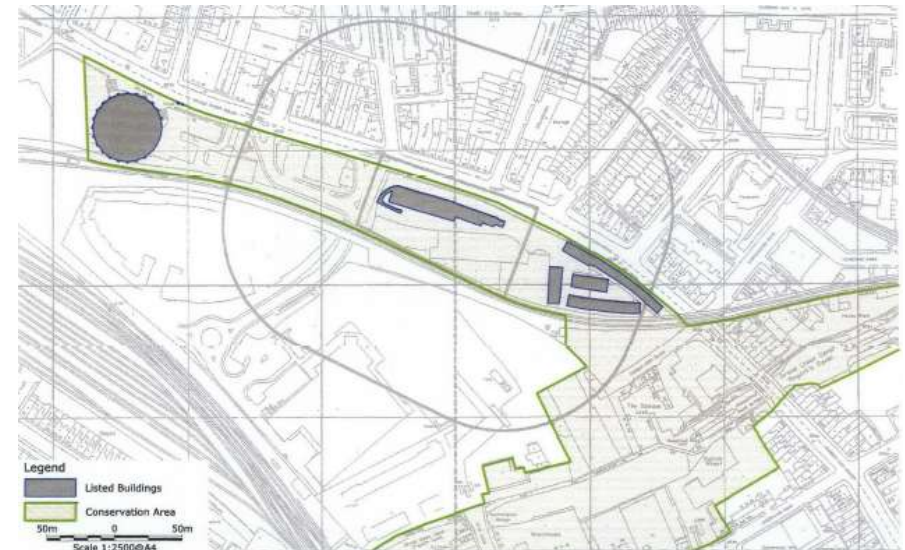
Figure 4: Map showing Regent's Canal CA and listed buildings.

Bonded Warehouse (fig.4)

- (South West Side) The Roundhouse ((fig.4)
- (South West side) Drinking fountain in wall next to the Roundhouse
- (South West side) Cattle through SE of the Roundhouse

The Regent's Canal Conservation Area (Fig. 4) was originally

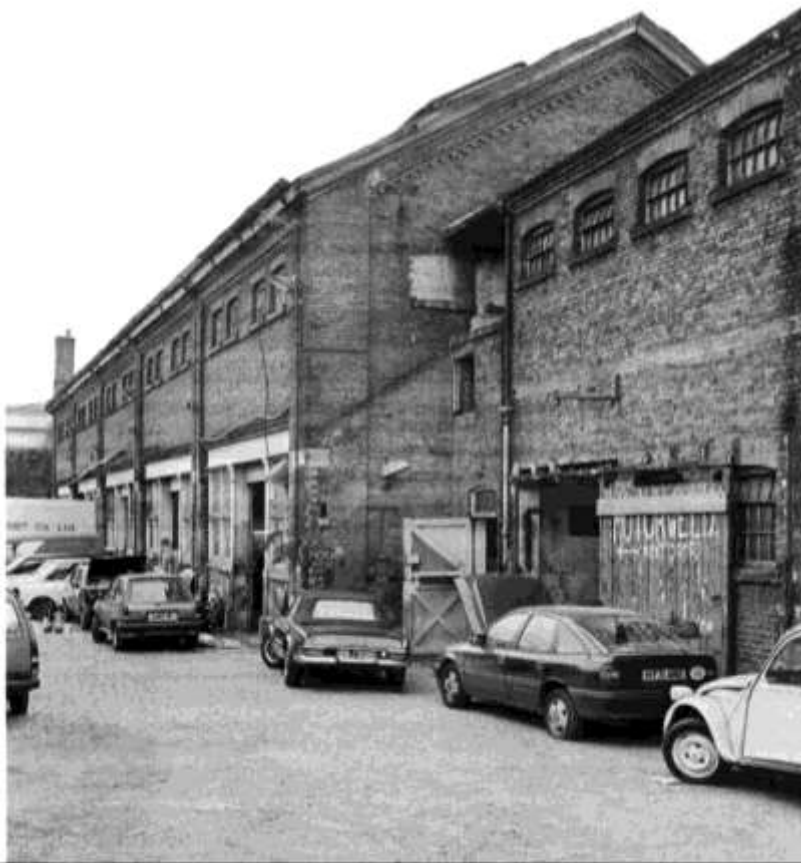
Figure 5: 1992 photograph of the south elevation looking towards Unit 92. Photograph from the National Monuments Record in the Historic England Archive in Swindon, taken by Derek Kendall of the former Royal Commission on the Historic Monuments of England (RCHME), on 08/10/1992 (Crown Copyright).

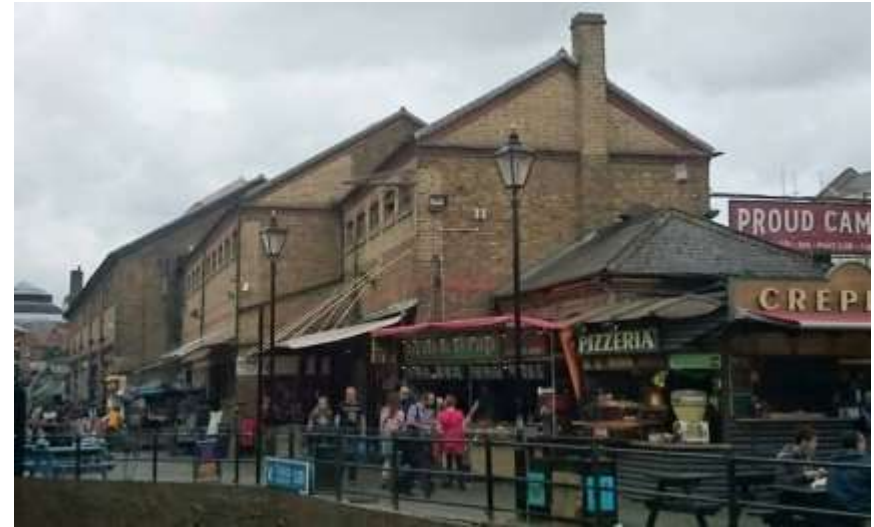
Figure 6: Horse Hospital - south and east elevation of Eastern ranges.

121	Replacement flush timber door with square headed frame installed into arched door opening (Fig 6)	Check record drawings and photographs for evidence of previous or original door to inform on appropriate follow up action	Significant harm	Reinstate a historic framed, ledged and braced stable door	beneficial/ moderate
South Elevation (Forming Part of East Range Single Storey Rear Addition) – Unit 94					
123	Advertisement panels and other similar displays fixed over entire brick elevation and windows (Fig 5-6)	Remove and make good damage to brickwork caused by fixings	Significant harm	As recommended	beneficial/ minor

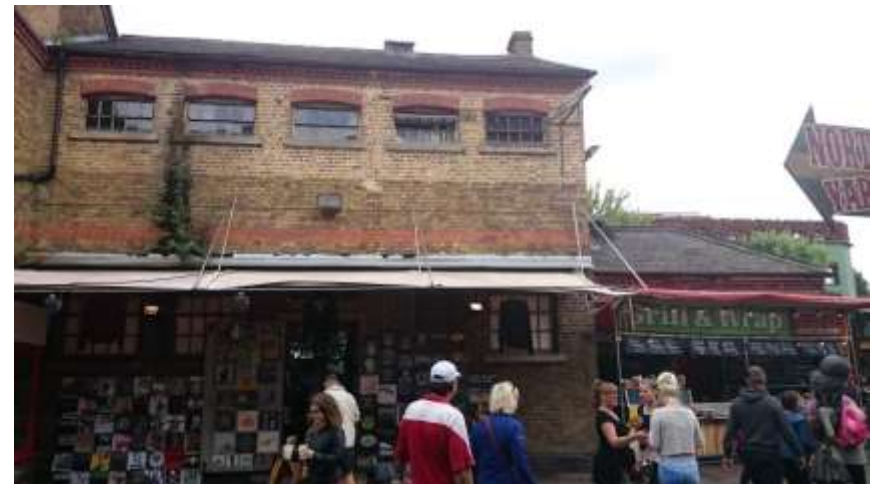
Figure 7: Units 93 and 94 (Eastern range – South elevation)

The units 93/94 comprise two interconnecting rooms each with access door arrangements to the south elevation. The units will receive an internal fitting out together with the replacement of the existing external flush timber doors and the provision of new drainage and extract servicing.

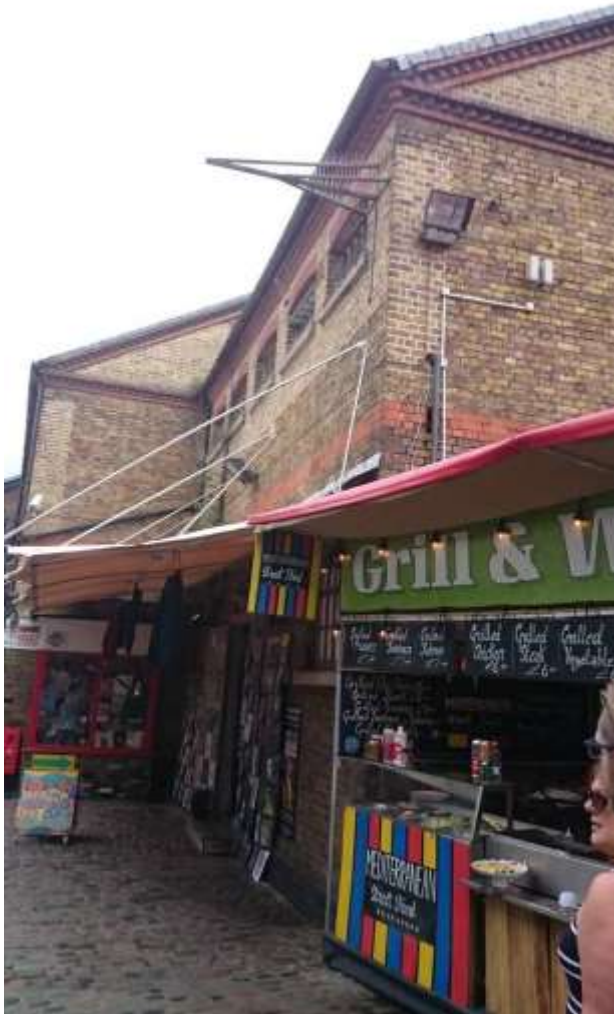
Figure 8: Units 93/94 - Unauthorised food stall and metal awnings on both units

Item No.	Location and Description of Breach	Comment and Recommended Remedial Action	Breach Rating	Proposed Works	Impact
South Elevation (Forming part of Eastern Range) – Unit 93					
115	Metal framed projecting awning and fixtures fixed to brickwork spanning full width of elevation above ground floor window heads (Fig 6-7)	Dismantle and remove. Make good damage to brickwork caused by fixings.	Significant harm	As recommended	beneficial/ substantial
116	Metal flashing inserted into brickwork across full width of elevation between ground and first floor levels (Fig 6-7)	Carefully remove as part of the awning removal. Repoint brick, bed-joints in flush lime mortar.	Significant harm	As recommended	beneficial/ moderate
117	Advertising poster panel fitted across ground floor window (Fig 6-7)	Remove and make good damage to framework caused by fixings	Significant harm	As recommended	beneficial/ minor
120	Glazing to 3 no. windows painted over (Fig 8)	Carefully remove / strip paint from glass	Significant harm	As recommended	beneficial/ minor

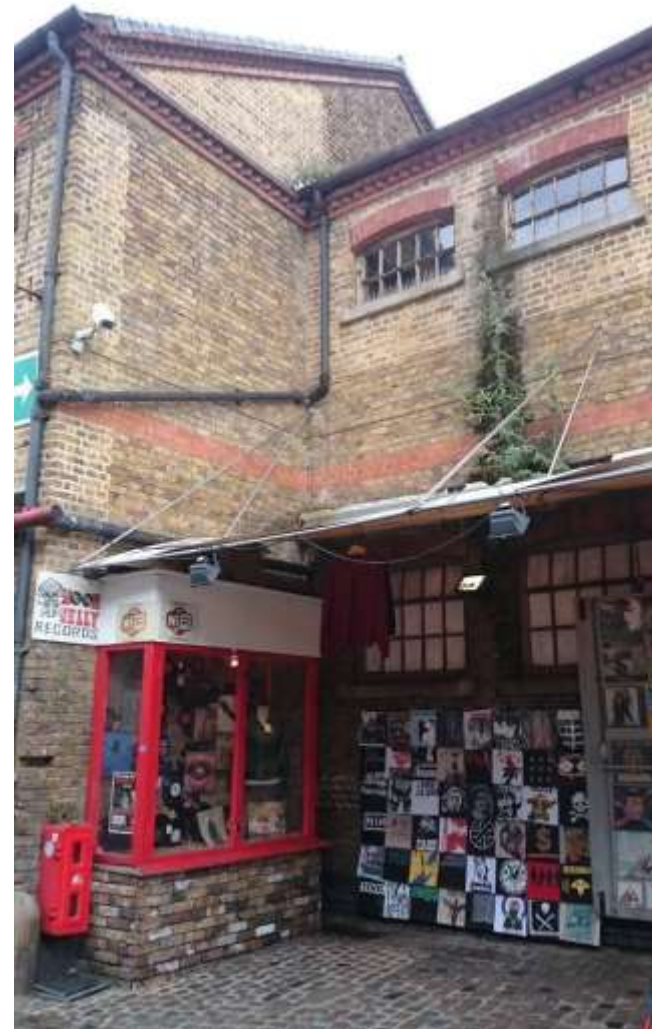
Figure 9: Unit 93 – shop display case and painted glazing at the windows

96	Modern replacement varnished timber door (Fig 10)	Check record drawings and photographs for evidence of previous or original door to inform on appropriate follow up action	Significant harm	Reinstate a historic framed, ledged and braced door	beneficial/moderate

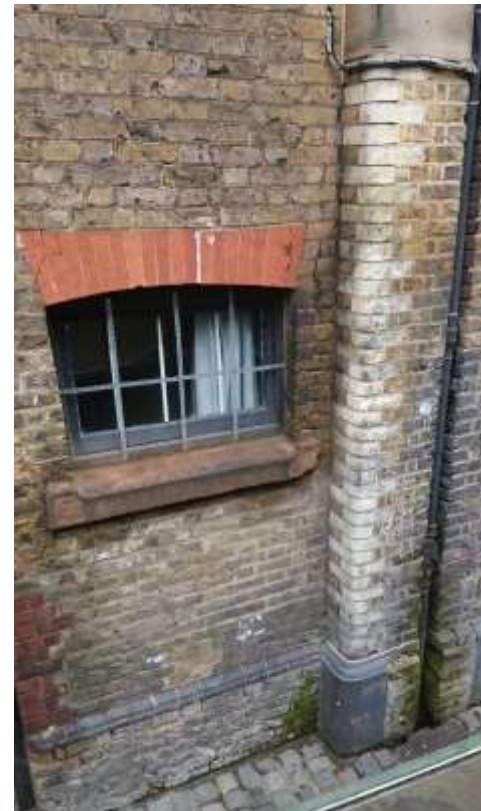
Figure 11: Unit 87 (South elevation) – metal straps fixed across window

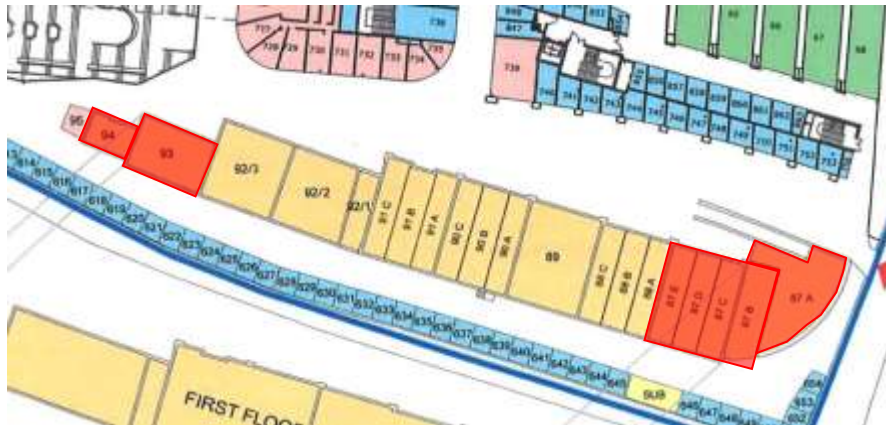
Figure 12: Horse Hospital - Units 87 and 93/94 highlighted in red

The units are currently used as shops (units 93 and 87 partly), sui generis, which is ancillary to Proud (unit 87 partly) and restaurant/food stall (unit 94). Units 87 (part of 1882 Western Range) and 93/94 (part of the Eastern range) at the Horse Hospital ground floor (Fig. 6), are proposed to be converted into single units and refurbished to facilitate their use as restaurants (A3).

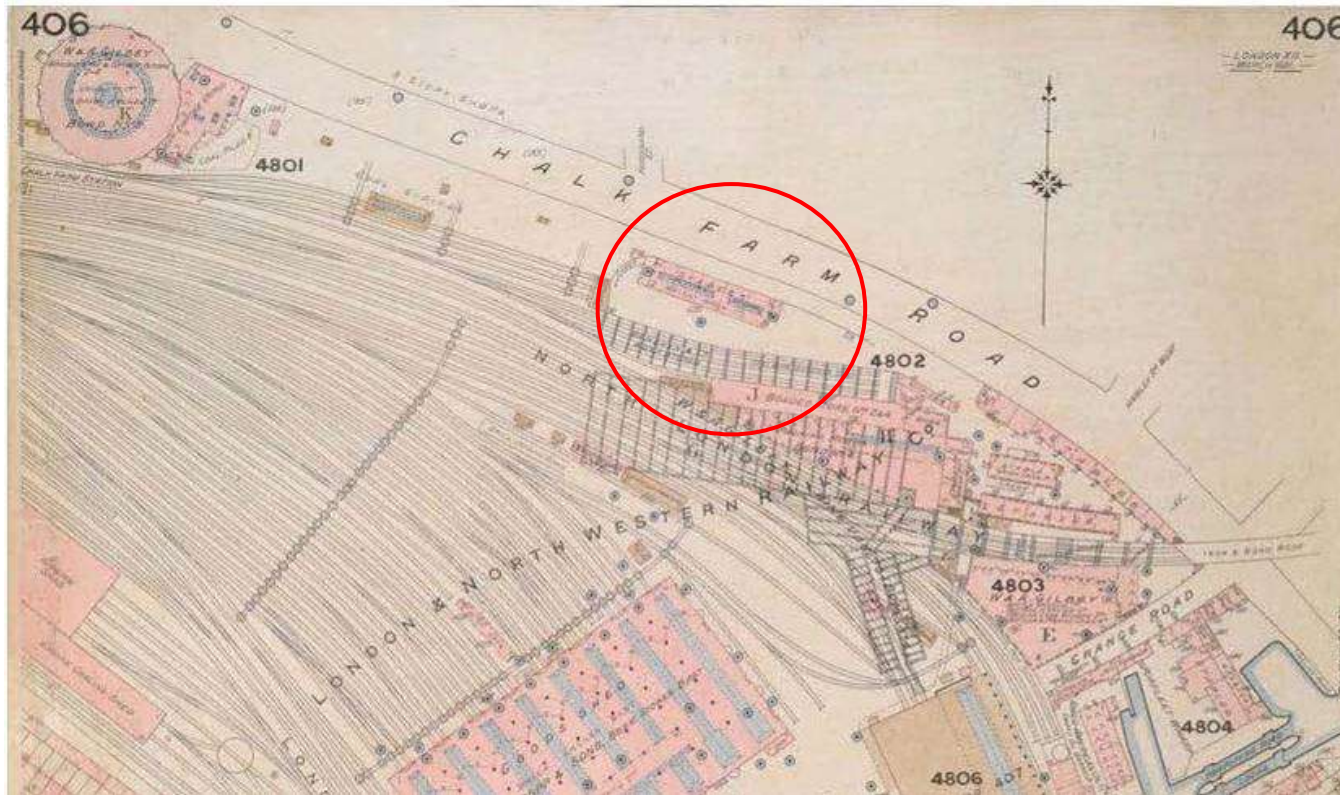
Figure 13: 1891 - Insurance Plan of London Vol. xi: sheet 406

The original 1883 section of this building - the western range - is five bays wide delineated by pilaster strips with two sets of two windows in each bay. It was constructed by the London and North-Western Railway's Engineer's Department as stables for 92 horses, with a curved ramp (horse creep) at the western end leading to the first floor level of stables. Now-vanished smaller curved ramp running at a right angle to the building may have been removed when the block was extended c.1895, also by the L&NW Engineer's Department. This extension can be seen when comparing the 1891 Goad Fire Insurance Plan and 1916 OS Map (see Appendix 1).

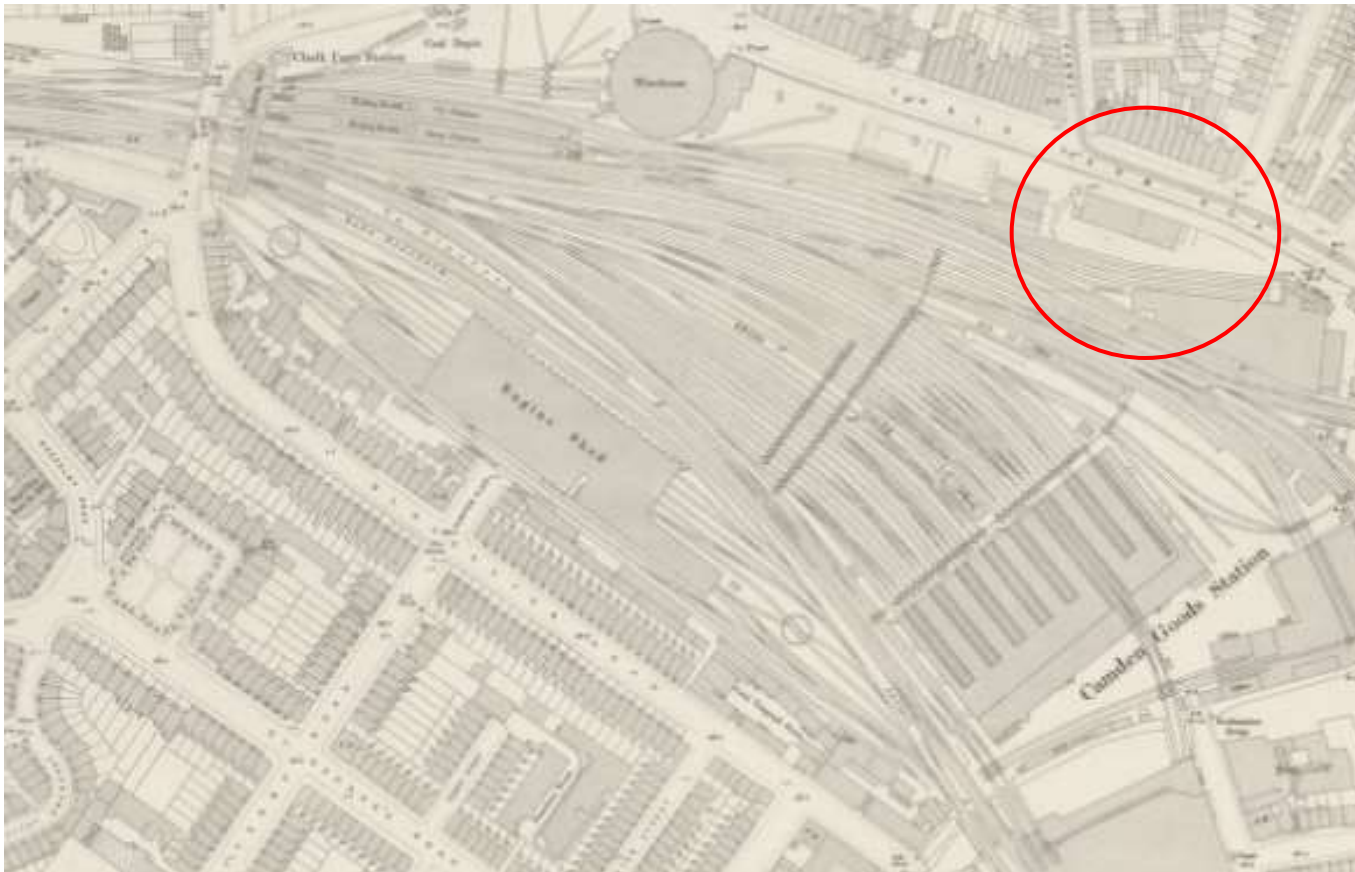
Figure 14: 1893-1895 OS Map

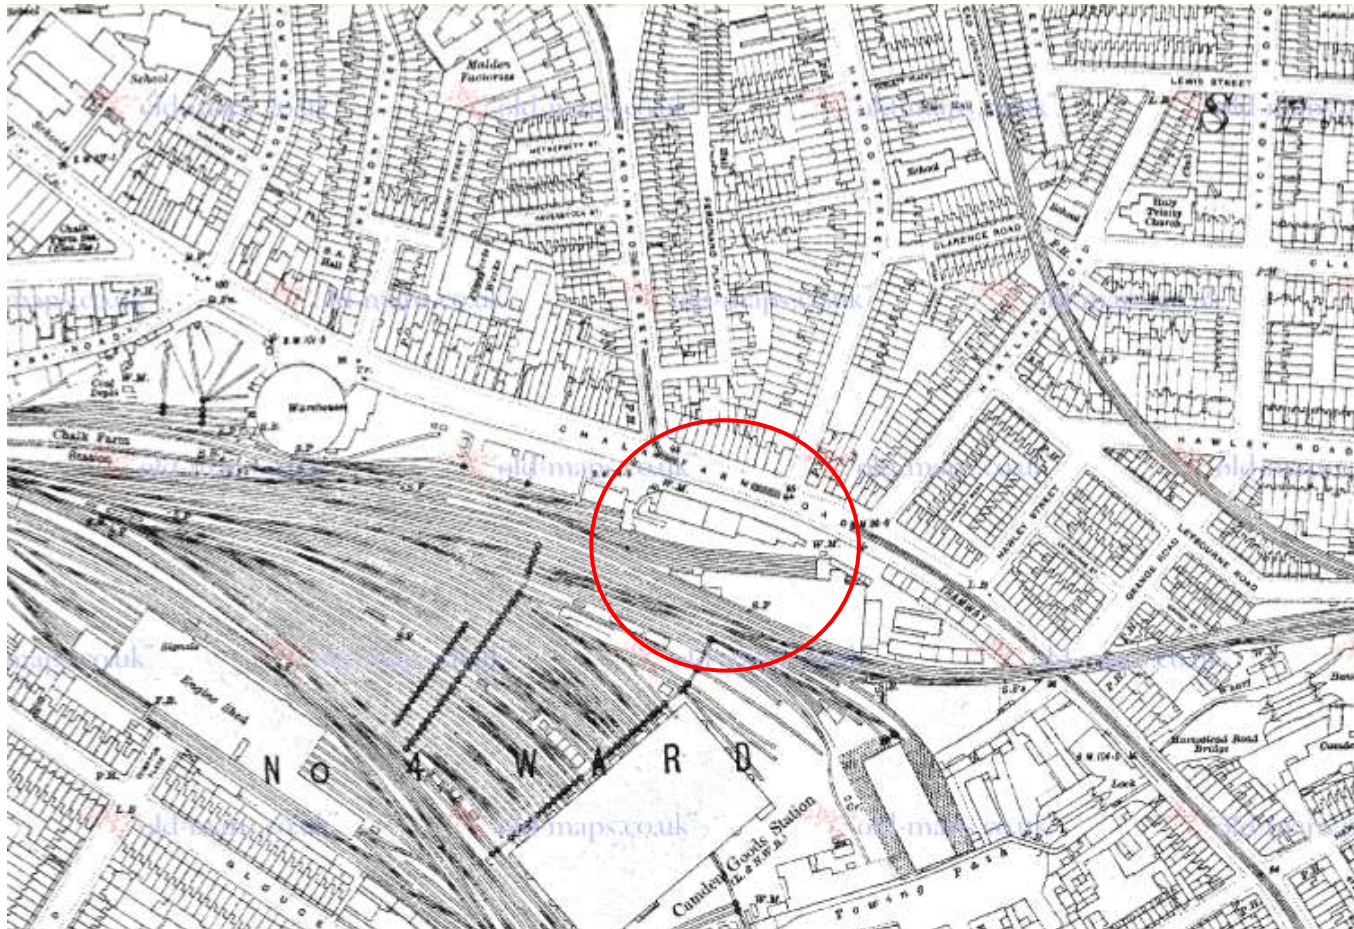
Figure 15: 1916 OS Map

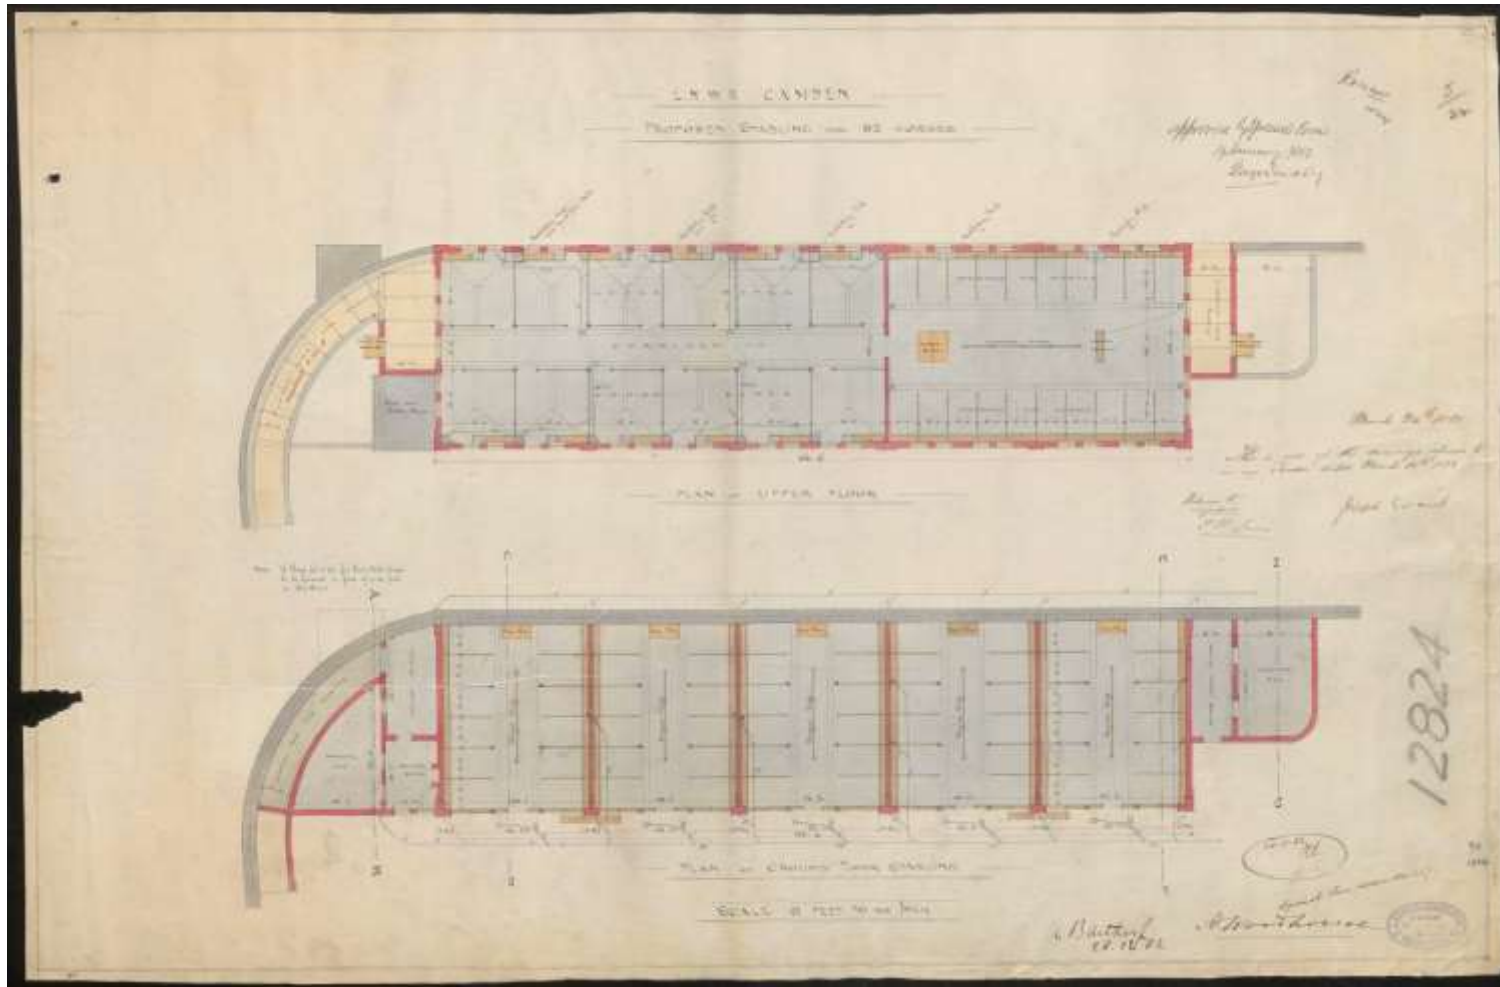
Figure 16: 1883 original plans.

and Northwest railway are shown in Appendix 3. These show both loose boxes and stables. A small harness room was located at the far eastern end and ventilation shafts appear along the length of the building.

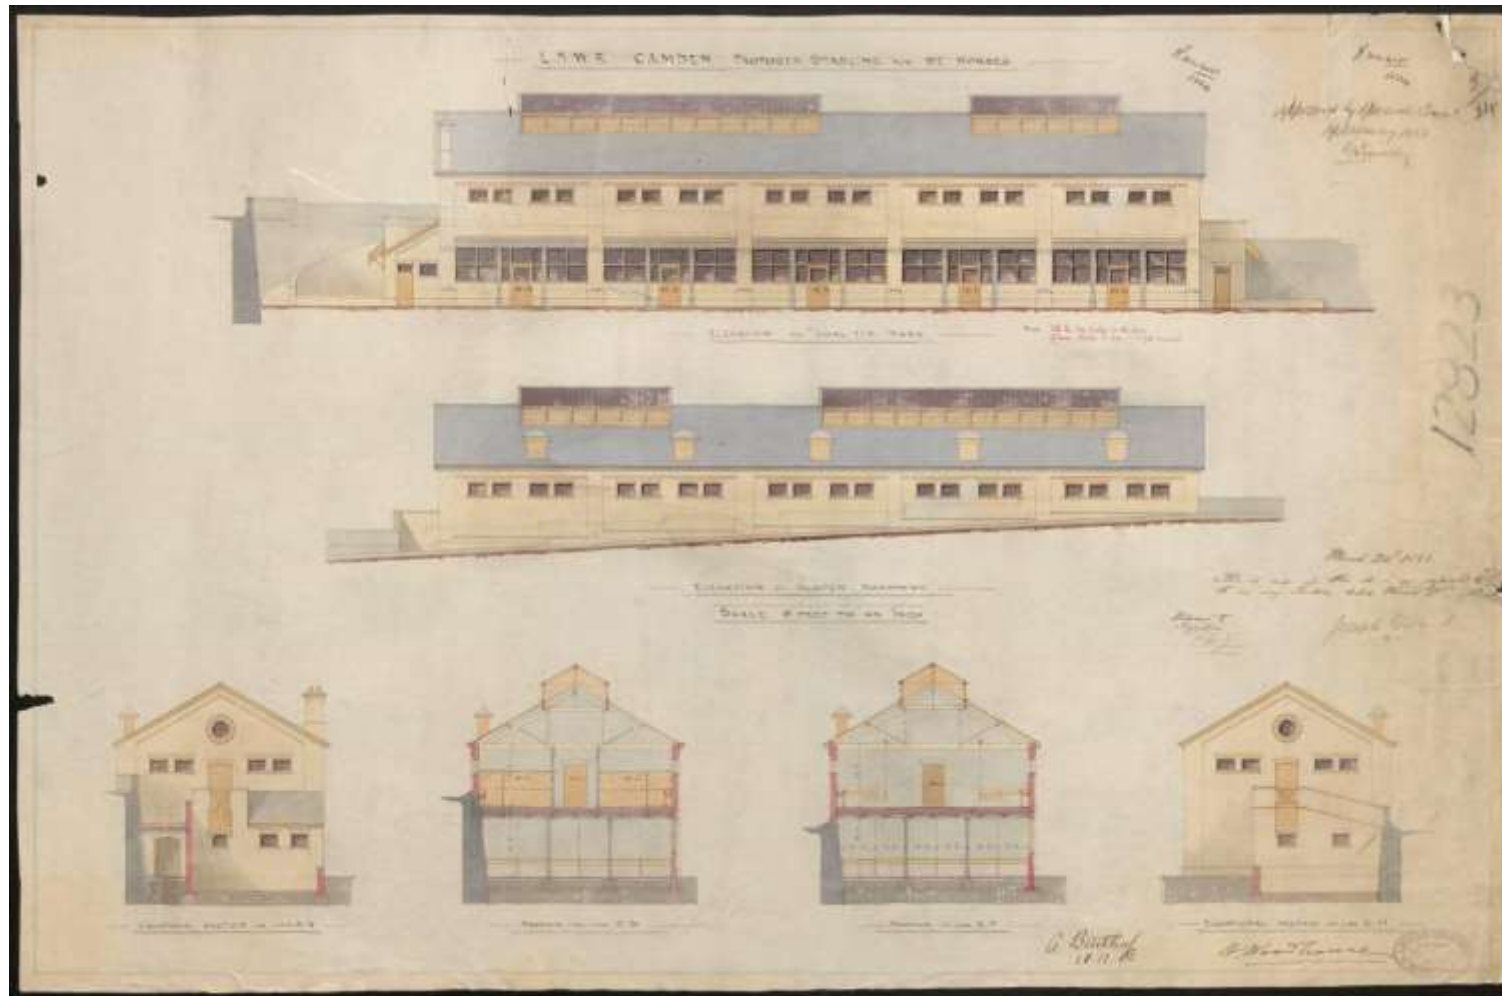
Figure 17: 1883 original elevations & sections.

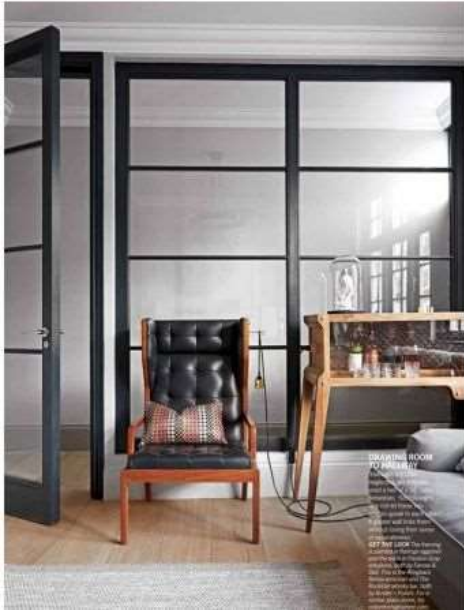
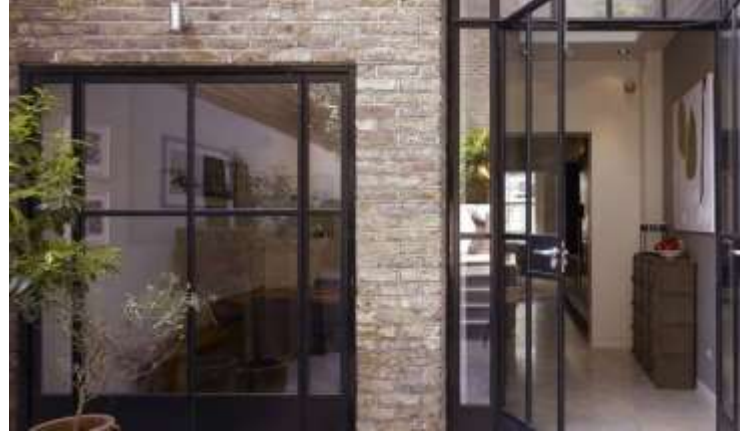
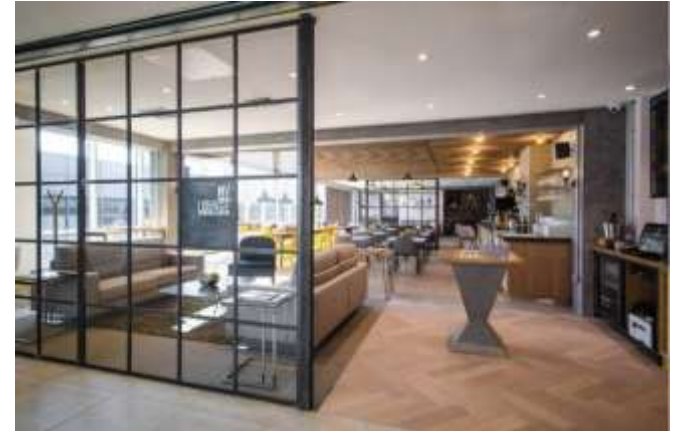
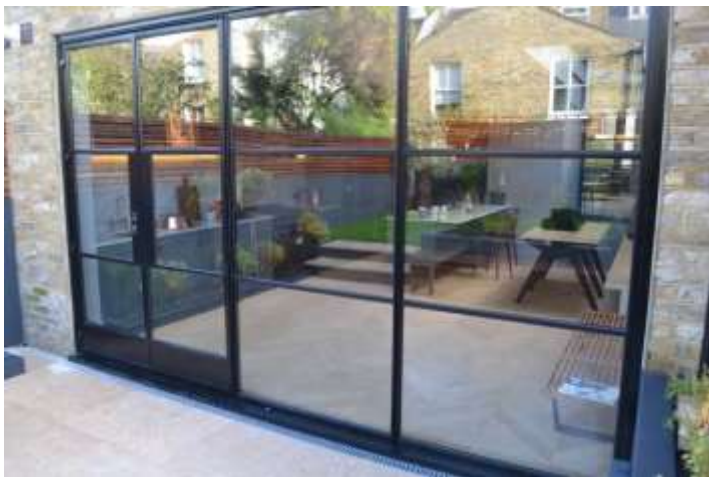
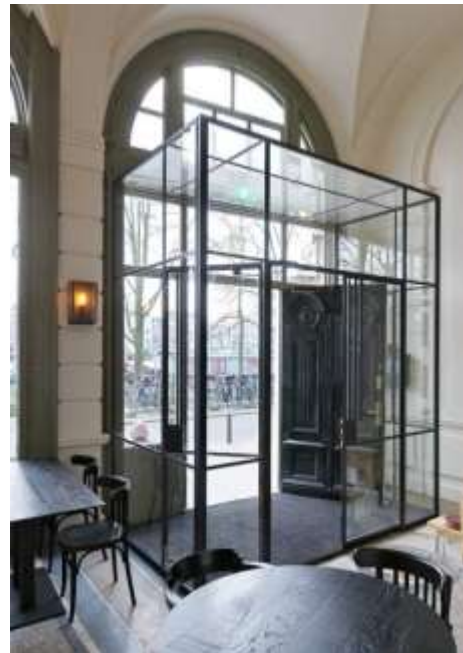
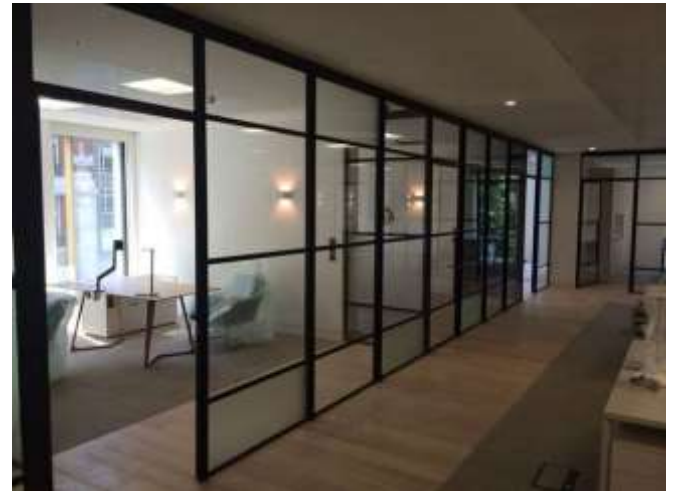
APPENDIX 4: Samples of 'Black steel framed glazed doors and screens'

In addition, the proposal includes the installation of a glazed steel framed door and screen inset internally in the lobby of unit 93, behind the external timber doors as detailed on the design drawings accompanying this application. The purpose of the inset glazed steel framed door/screen is to better regulate the environmental conditions within the unit (temperature and heat loss) and to function as a security and restaurant's front door because the lobby is shared with the first floor tenant as their emergency exit which means the external timber door need to stay unlocked.
