TITLE:
Generic Details for Timber Joists Vulnerable/Subject to Decay

PROJECT:
**Project No:11581
Kidderpore Avenue**

9100-DRG-00YY-DE004 A

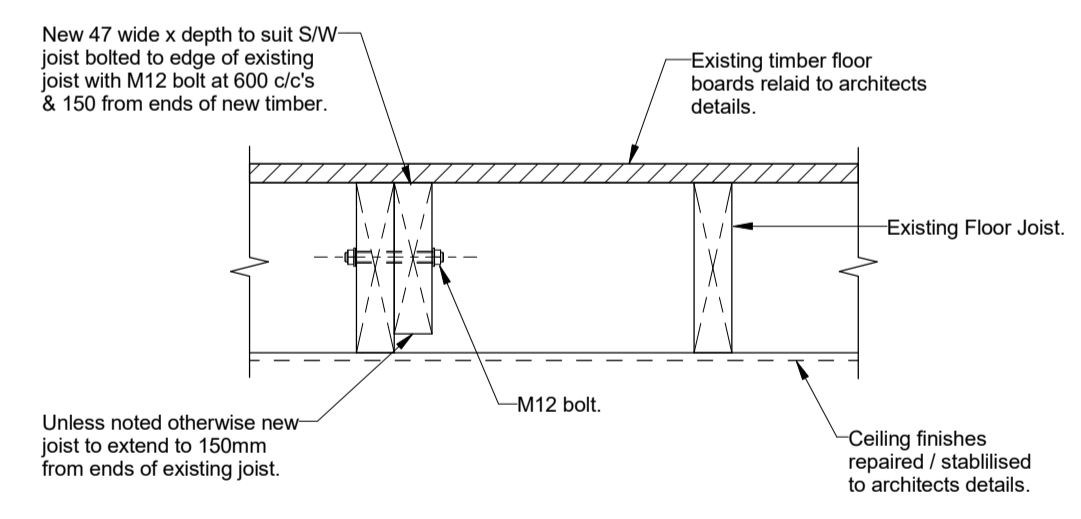
Detail 6: Double Up Floor Joists
scale 1 : 10
