8 Rothwell Street		Drawing Number: 1506_SK-LBC01
Listed Building C -	15.09.16	Photo sketch of re-formed opening in basement hearth
		Status: Listed Building Consent
Drawn by: LK	Date: 15.09.16	Rev: -
		1:25 @A3

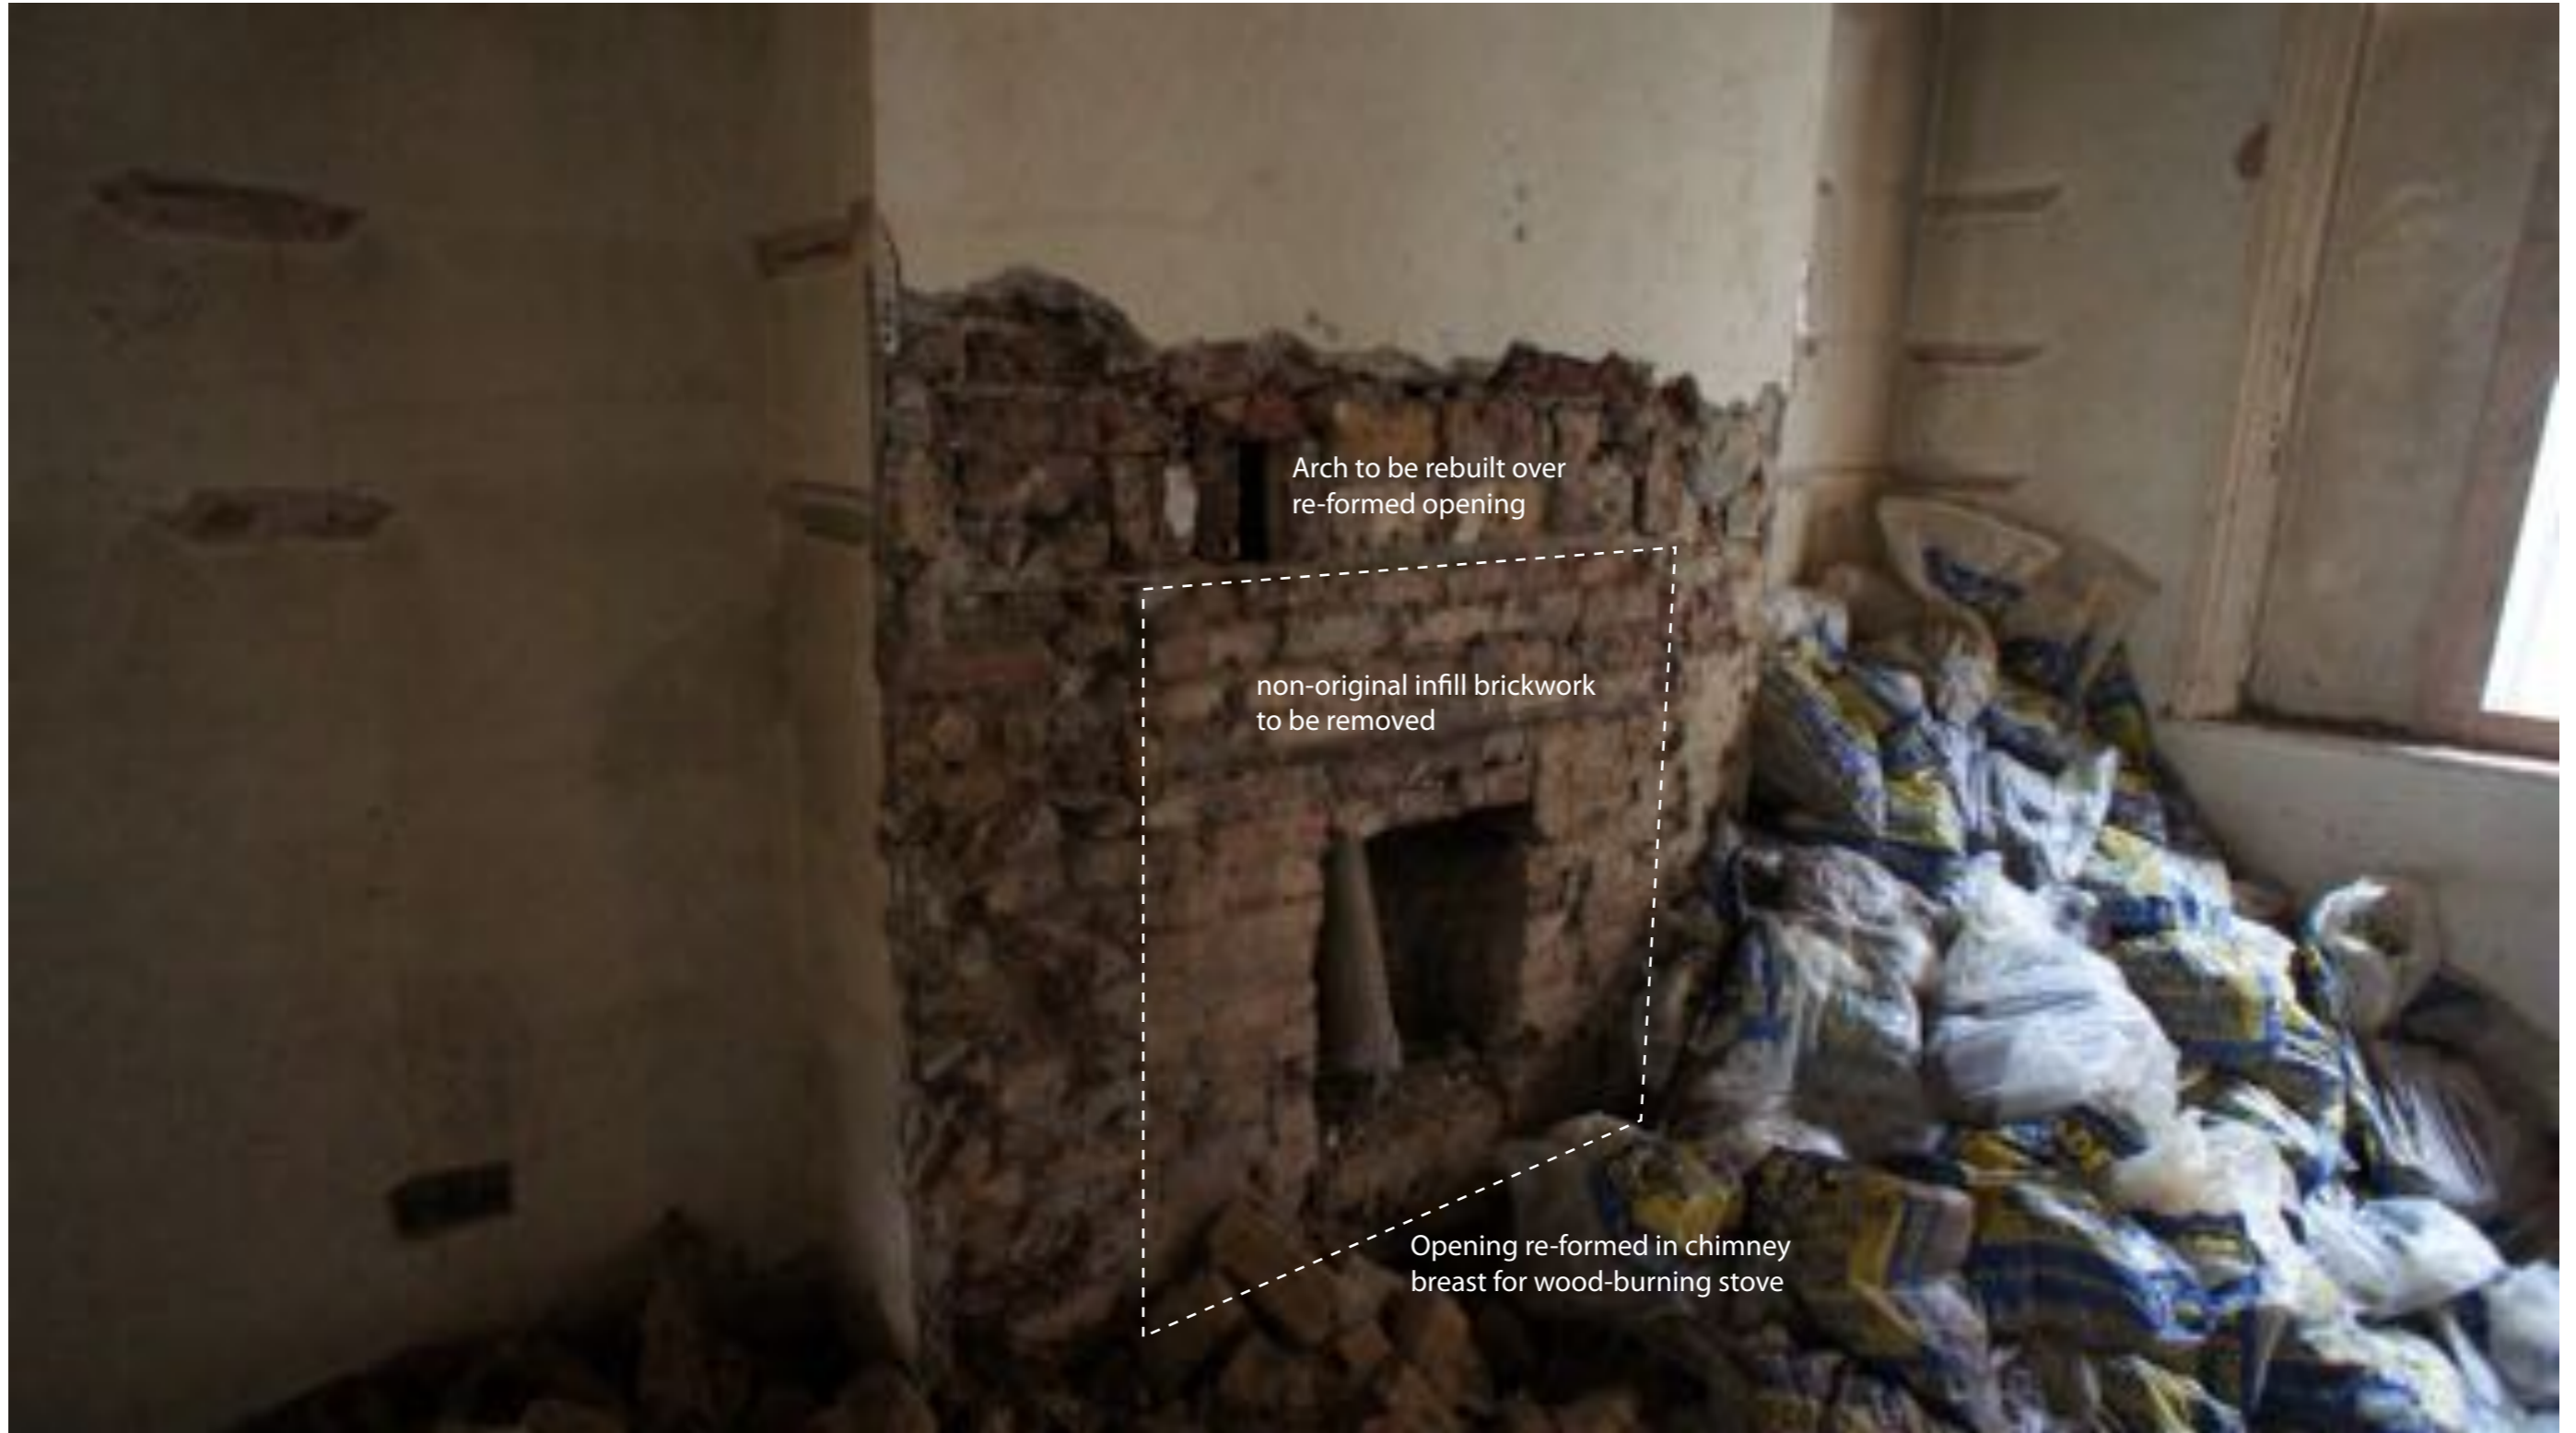
Arch to be rebuilt over
re-formed opening

non-original infill brickwork
to be removed

Opening re-formed in chimney
breast for wood-burning stove
