**Ref: 16/25552-2
September 2016**

**81 AVENUE ROAD,
LONDON, NW8 6HR**

BASEMENT IMPACT ASSESSMENT

Elliott Wood Partnership LLP

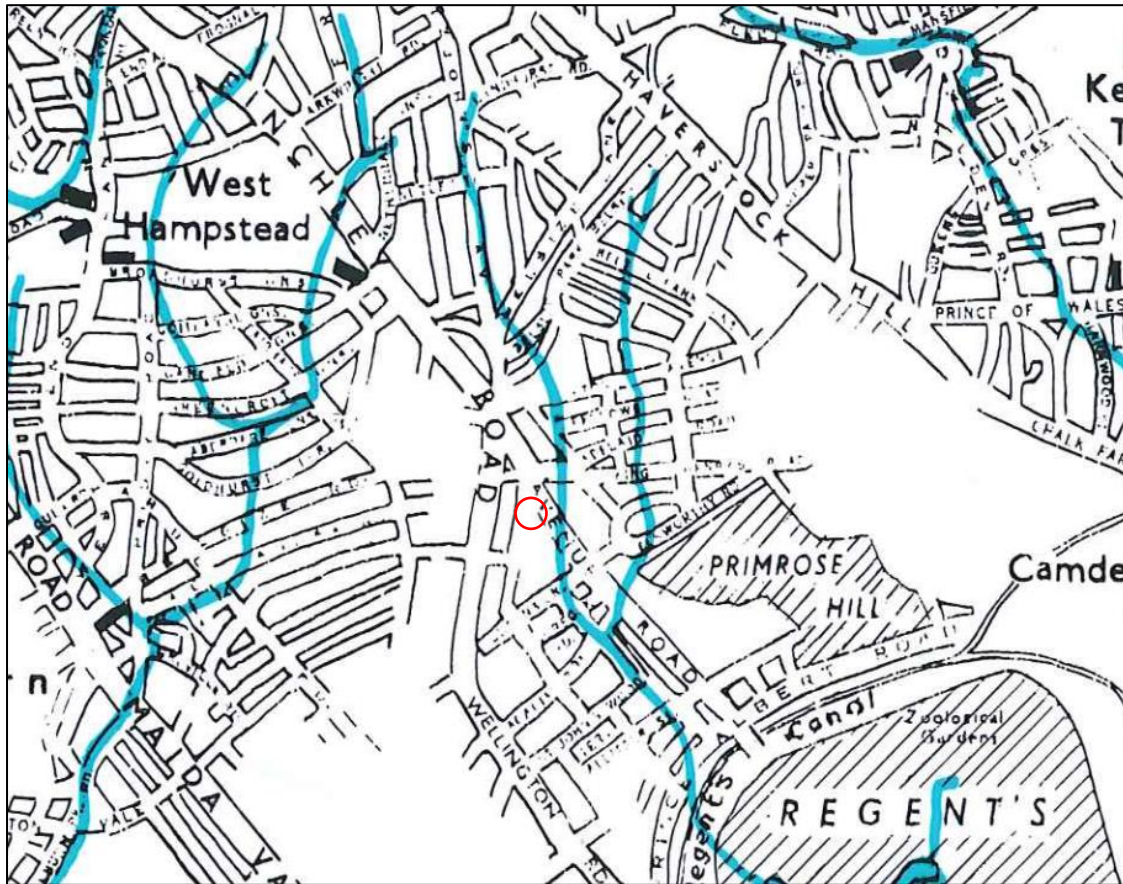
According to publications regarding Lost Rivers of London (Barton, 1992) and (Talling, 2011), the site is within 100m of a former river or watercourse, which is a tributary to The Tyburn approximately 40m east of the site. The closest surface water feature is a drain located 395m north of the site.

**Figure 3. Location of site relative to the ‘Lost Rivers’ of London
(Source: Barton, 1992)**

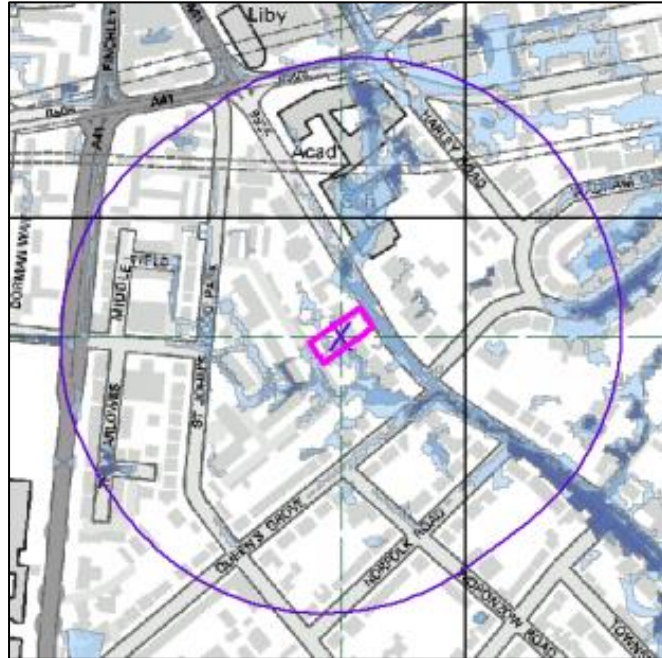
According to Environment Agency Surface Water Flood maps of the area the site is at a low risk from surface water flooding, but there is an area of high risk approximate 50m north of the site.

Figure 4. Extract from the Environment Agency's 'Risk of Flooding from Surface Water'. Ordnance Survey Crown copyright 2015. All rights reserved.

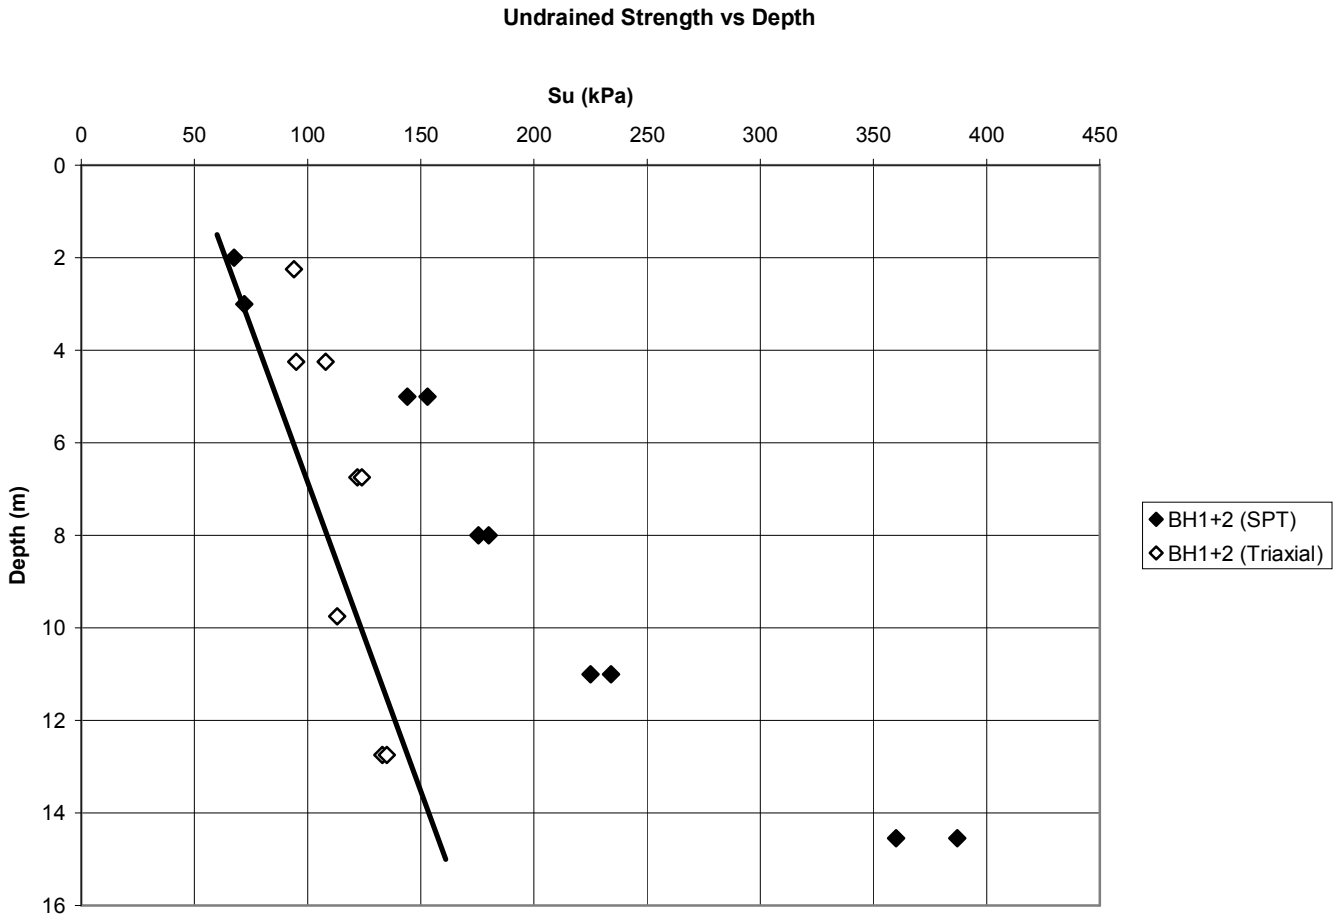
The use of this bilinear profile reduces any tendency for prediction of excessive strength (and stiffness) at depth. This profile is considered to be conservative.

Figure 3 – Undrained Strength vs Depth

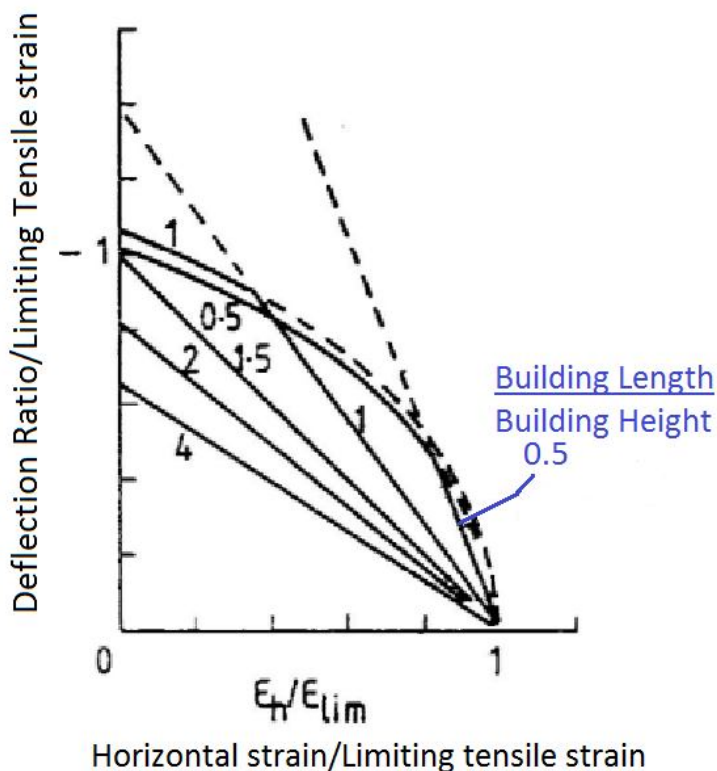
Figure 4 (from Ref 2)

stiffness of the wall has not been taken into account. The predicted level of damage to this wall is therefore considered to be ‘very slight’.

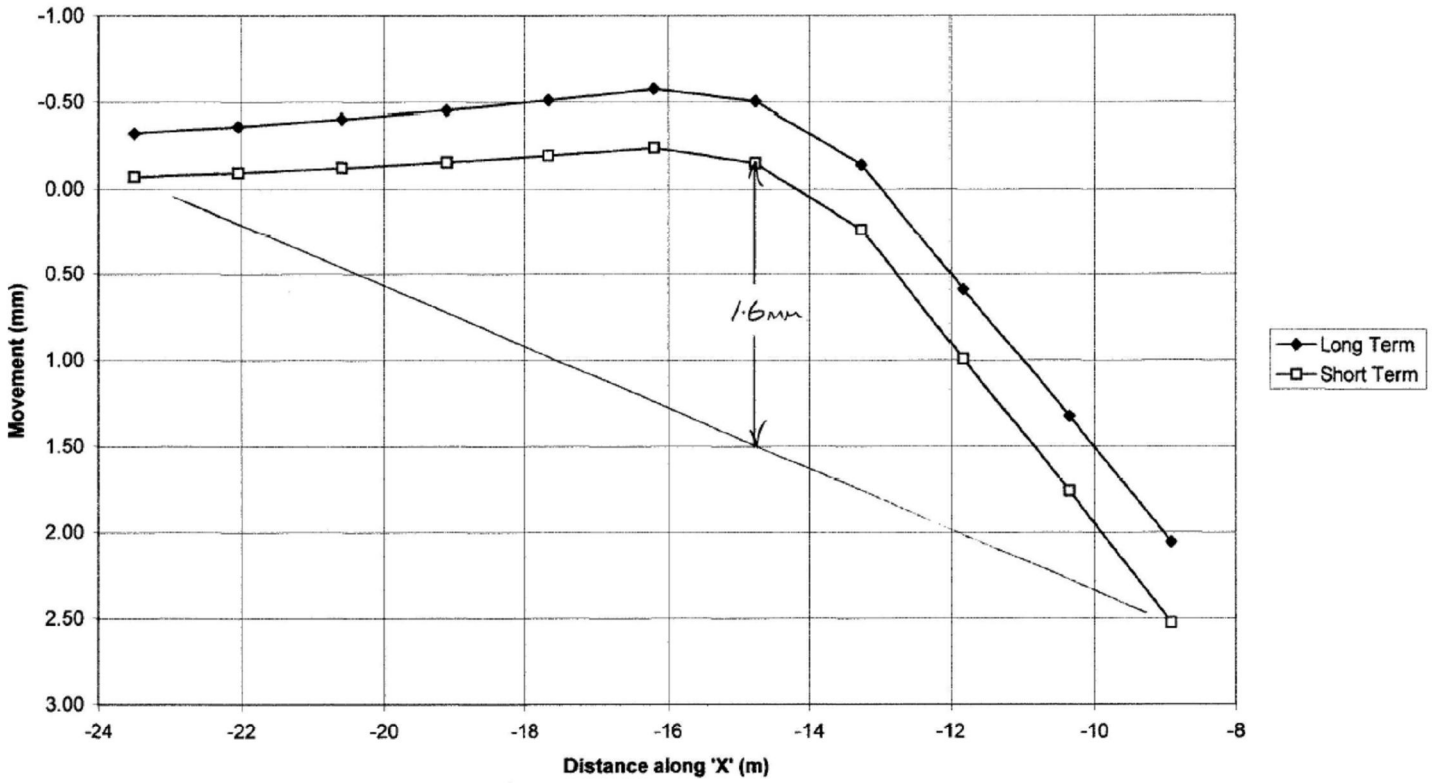
Figure 5

No79 Avenue Road, Front Wall
