ARBORICULTURAL IMPACT ASSESSMENT REPORT:

11 Prince Albert Road
London
NW1 7SR

Ref: HVL/11PAR/AIA/04

Date: 5th October 2016

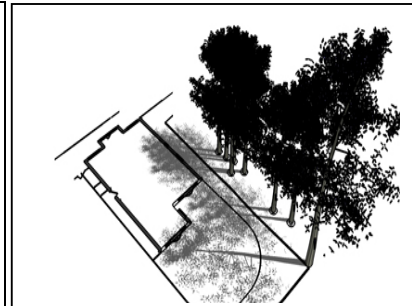
Figure 3 –
Generic Shading Constraints

4.2.1 The second type of constraint produced by trees that are to be retained is that the proximity of the proposed development to the trees should not threaten their future with ever increasing demands for tree surgery or felling to remove nuisance shading (Figure 3), honeydew deposition or perceived risk of harm.

4.2.2 The shading constraints are crudely determined from BS5837 by drawing an arc from northwest to east of the stem base at a distance equal to the height of the tree, as shown in the diagram opposite. Shade is less of a constraint on non-residential developments, particularly where rooms are only ever temporarily occupied.
