29 New End, Hampstead

Structural Report : Reconstruction of Lawn House Buttresses

Ref No: 24397

Date 10.10.2016

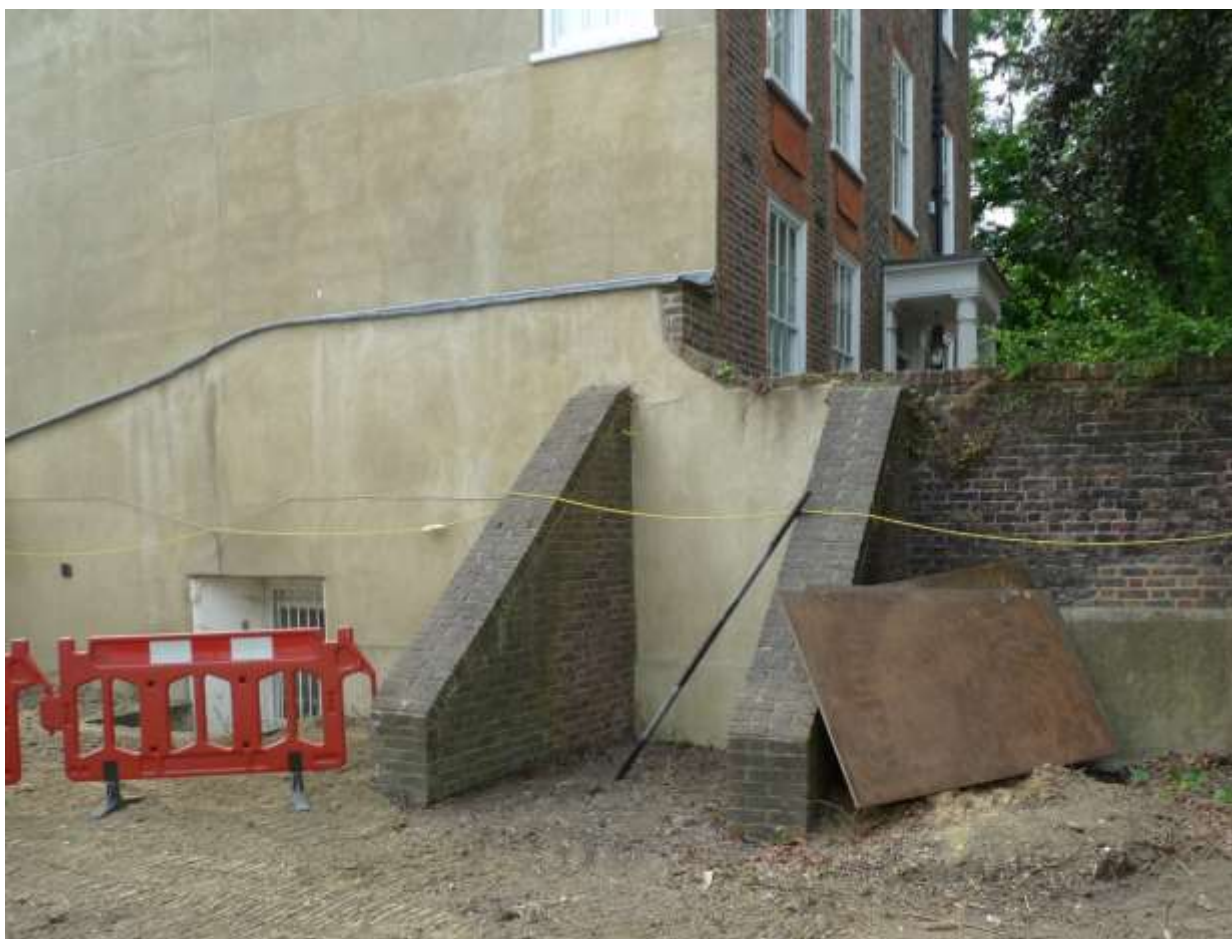
The buttresses are shown below, close to the Grade II Listed building of Lawn House which is adjacent to the site.

As part of the basement construction works it is proposed to reduce the encroachment into the site of two existing brick buttresses which abut the west boundary wall.

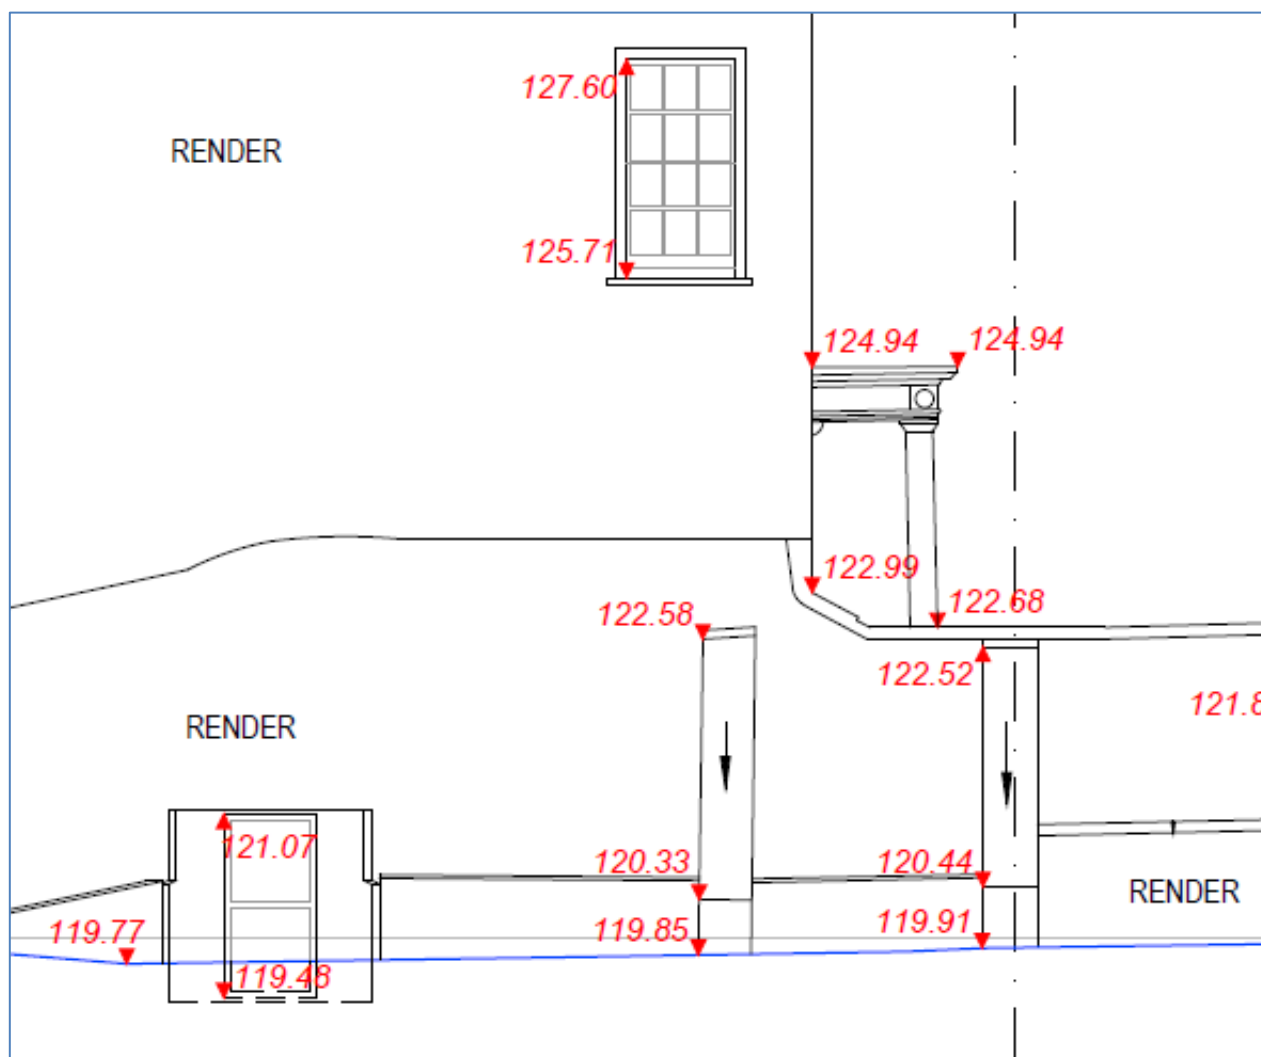
By this time the boundary wall would have been at the very least 70 years old, and possibly over 200 years old. It would already have been subject to stresses from the established beech tree and possibly unbalanced earth pressures due to site slopes, and likely to be showing distress. Trial pits have shown the footings to be limited to simple shallow brick corbels.

The northern buttress location aligns with the now removed East-West garden wall therefore is likely to have been constructed as a substitute for any lateral stability provided by the wall being removed, and/or to address any lean.

The southern buttress aligns approximately with change in height of the boundary wall, a step of 0.75m. The buttress is offset from the north façade of Lawn House, which is on the far side of the boundary wall, by 0.5m. Lawn House also extends to a height of 12m, five times greater than the buttress height.

It is reasonable to conclude the buttresses were provided as an effort to ensure lateral stability of the brick boundary wall and are unlikely to provide any significant restraint to the house beyond.

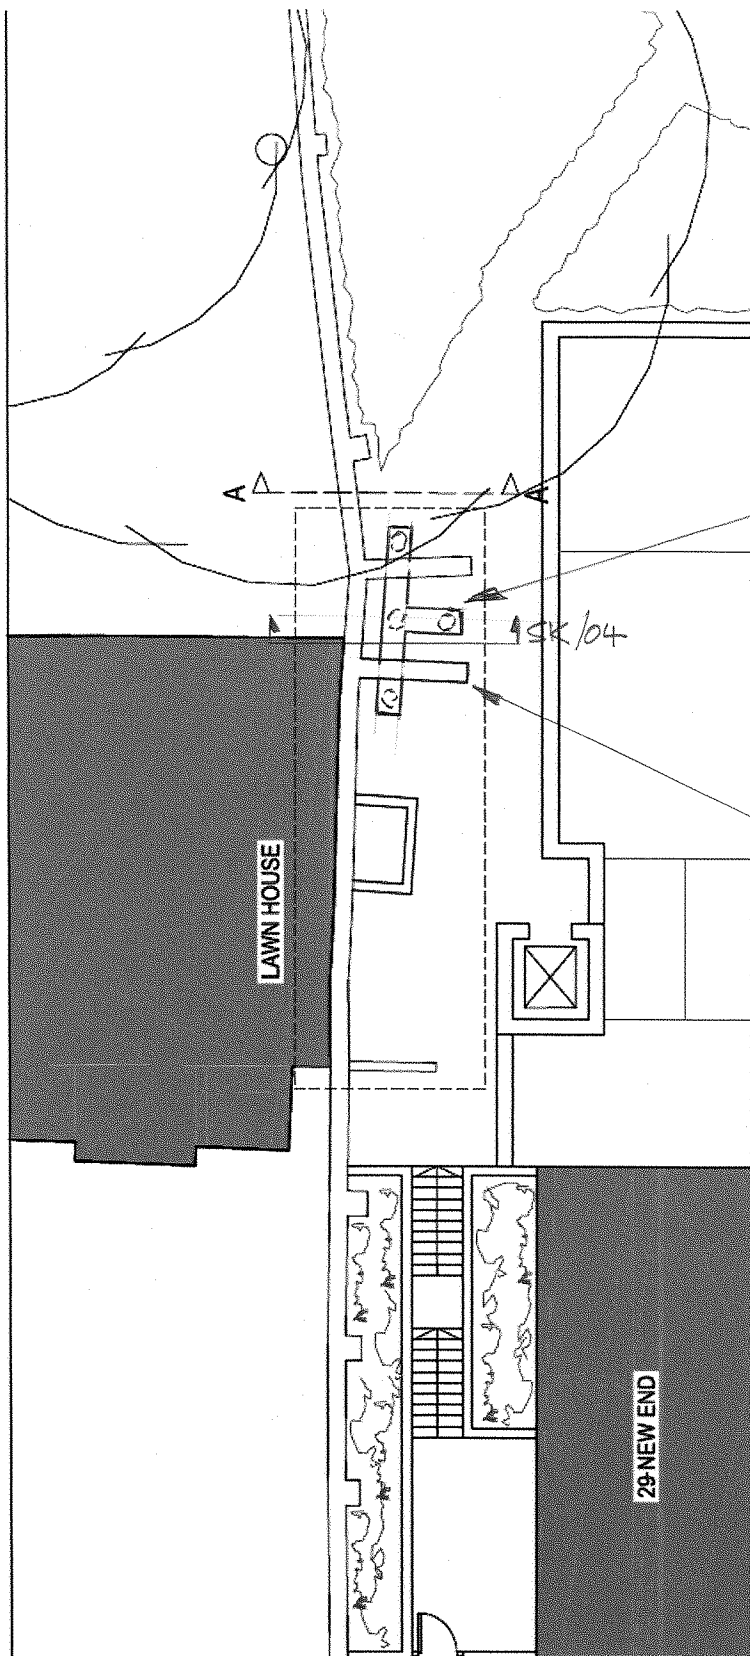
Project: 29 NEW END NW3 IJD
 Title: BUTRESS RECONSTRUCTION - LOCATION PLAN
 Job No. 24397 Date: 27.7.16 Dwn By: RNS
 Sheet No. SK/06 REV: T2 Chk By: -

PROPOSED MINI
PILED FOUNDATION.

EX BUTRESSES
TO BE
REDUCED (2Nº)

To be read in conjunction with KSR Architects drawing 15031-LB-001 and Fluid Structures drawings 24397/SK04T2 and SK06T2
