Balcap Re Limited

Land to the rear of 159-163 Kings Cross Road
Basement Impact Assessment
Parmarbrook

Prepared by BP and RSC
Checked by BP
Verified by CP
Document ref PB-1676-BIA00 - 159-163 Kings Cross Road - Basement Impact Assessment [REV0]
Revision: 0

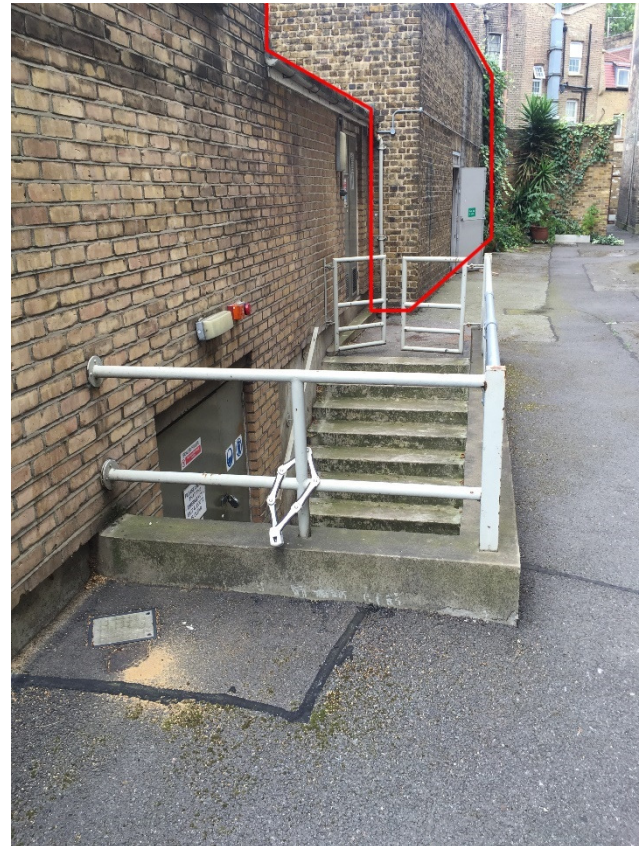
Site Photo 1
Derby Lodge
(South Boundary)
Photo facing East

There is a tarmac path separating our site and the neighbouring buildings of Derby lodge which is over 4m in width, this can be seen in Site Photo 1 overleaf.

The existing boiler house which serves Derby Lodge can be seen in Site Photo 1 and 2 overleaf. This building is predominantly constructed of masonry and concrete and incorporates a basement which directly borders our site.

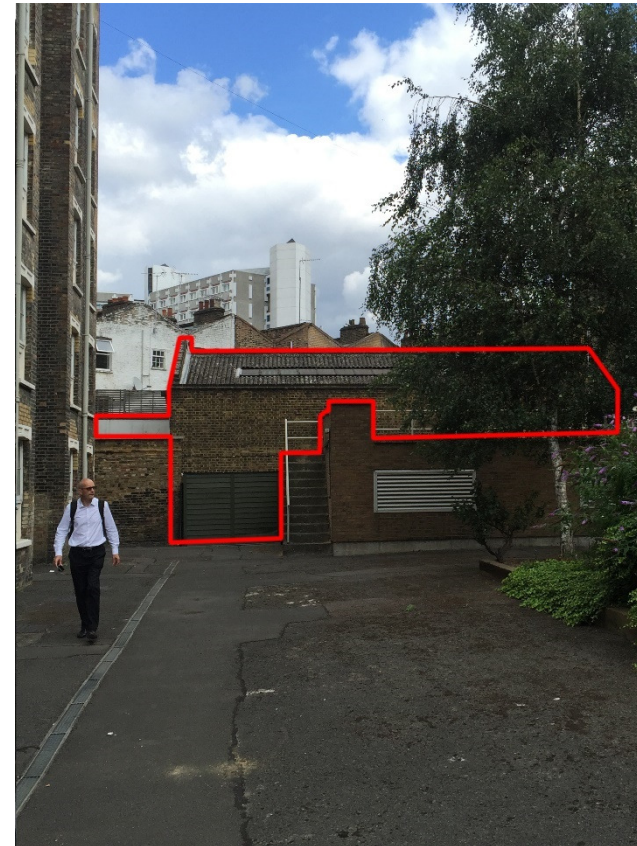
Site Photo 2
Derby Lodge
(West Boundary)
Photo facing East

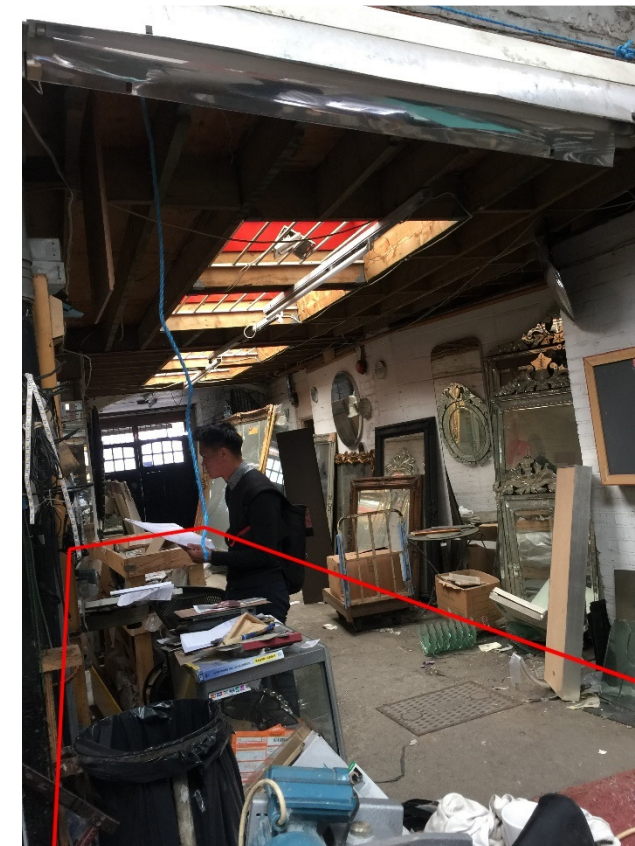
Site Photo 3
Interior of the Land to the rear of 159-163 Kings
Cross Road
(North-East and North-West Boundary)
Photo facing North

The existing buildings are 3 storey Victoria terraces of traditional construction, basements are present in both 1 and 3 Britannia Street, it is believed that the former has been historically extended with underpinning while the latter is in its original Victorian half height basement form. This boundary can be seen in Site Photo 3 overleaf and in the photo below.

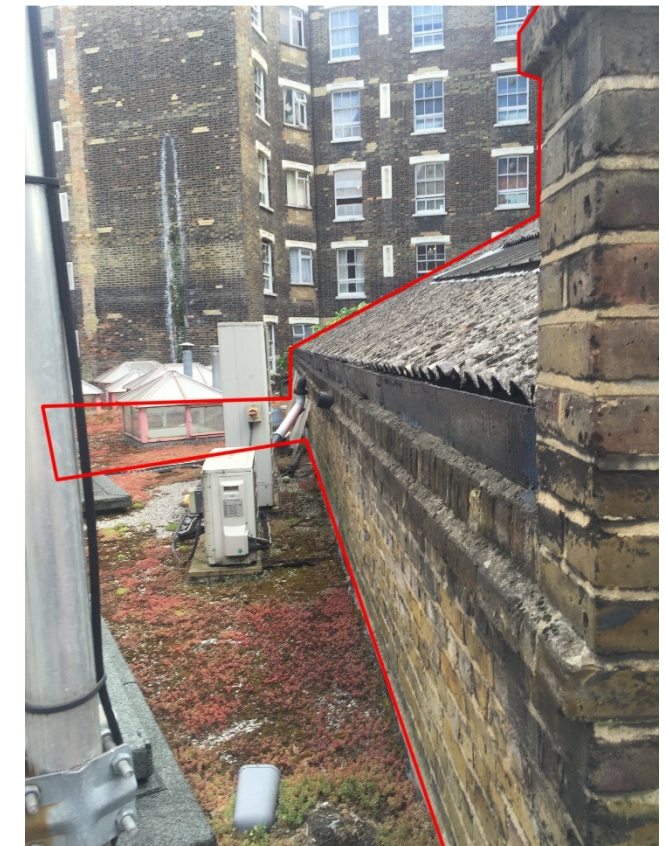
Site Photo 4
Exterior of the Land to the rear of 159-163 Kings
Cross Road
(East Boundary)
Photo facing South

This row of Victorian terrace is of mixed commercial and residential use. Buildings of the kind were typically constructed of loadbearing masonry on masonry corbel footings and timber floors, however it is common for them to have had a range of historical modifications and renovation. This boundary can be seen in Site Photo 4 overleaf
