Ref: 216177  
Project: 43-45 Bedford Square  
Title: No. 43 Cantilever Stone Staircase Newel  
Post Remedial Details

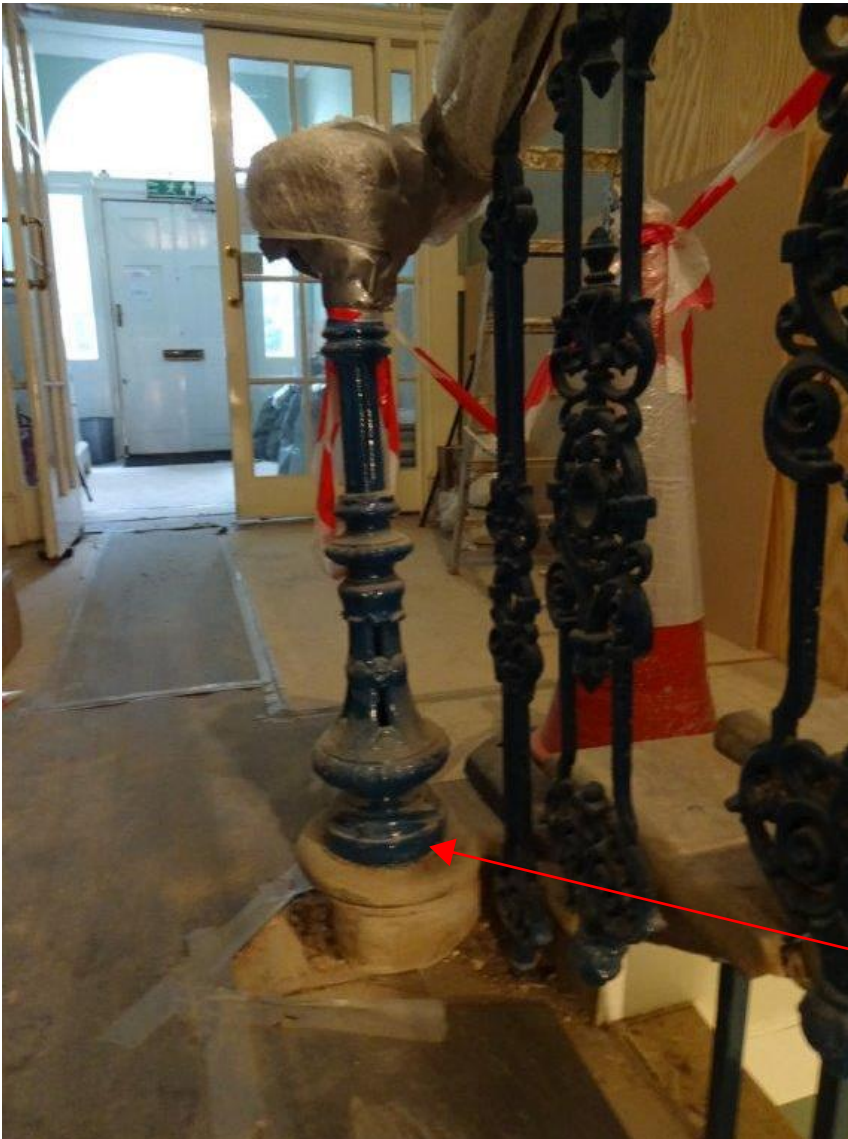
Location where repair is to be carried out.

**Methodology for Repairing Newel  
Post Base Fixing:**

1. Carefully remove existing lead caulking by continuously drilling out around base of newel post.
2. Replace with SBD Epoxy Plus low viscosity resin leaving 4mm recess.
3. Fill recess with soft lead shavings carefully heated with fine jewelry maker's blowlamp to match original detail.
