Mr and Mrs Saleh

**17 East Heath Road,
London**
*Basement Impact Assessment –
Revision 2*

November, 2016

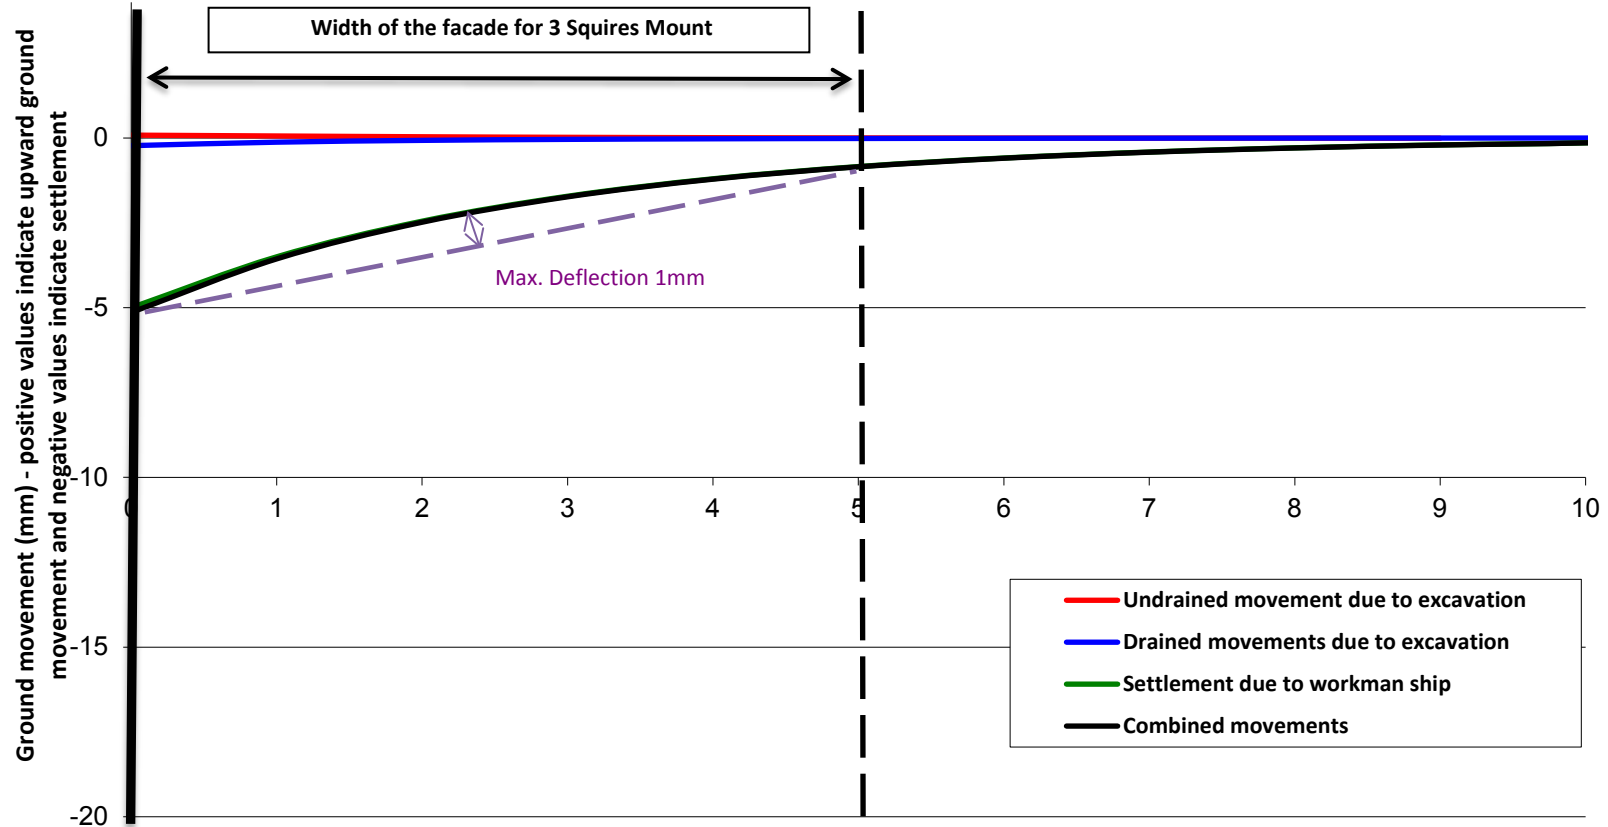
Title Combined vertical movement profile – Section 2-2	Figure 9

- Undrained movement due to excavation
- Drained movements due to excavation
- Settlement due to workmanship
- Combined movements

Critical Section 2-2

It is identified that the maximum impact and ground movement for Section 2-2- is noted at the party wall between 3 Squires Mount and 17 East Heath Road where 5mm of settlement is accumulated mainly from the proposed mass concrete underpin workmanship.

The differential settlements which are expected to be imposed on the adjacent buildings are of the order of 5mm. Based on available information the width of the building is 5m, this differential movement corresponds to an angular distortion of 1/1000 which is within published limits for preventing excess cracking and damage to load bearing walls and
