client: project address: 66-67 Guilford Street, London WC1N 1DF
drawing title: Window & Door Schedule 4
scale: 1:25 @ A1 (1:50 @ A3)

job no. 16009 dwg no. 413 revision A

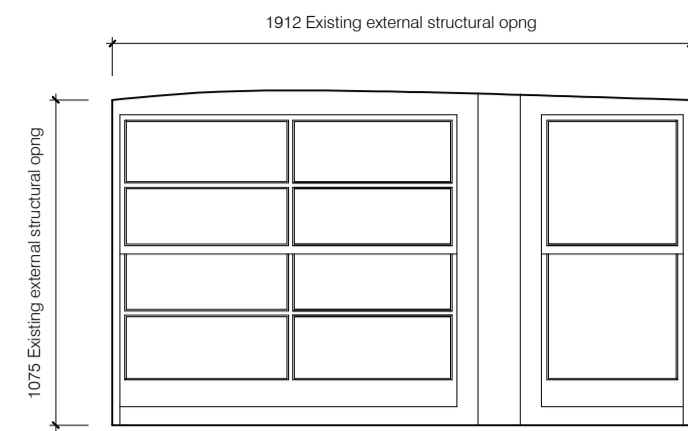
01 As Existing (Photo 1)
1:25 @ A1 (1:50 @ A3)

Window No: WX.3.05

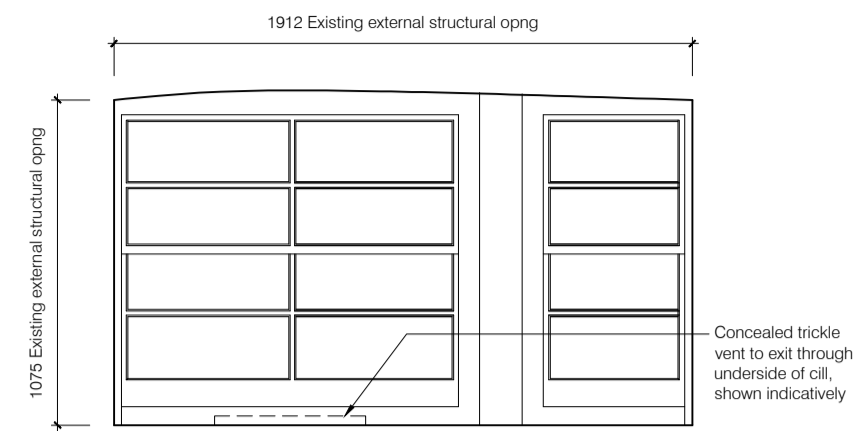
02 As Proposed
1:25 @ A1 (1:50 @ A3)

Window No: WX.3.05 (NEW WINDOW W/ TRICKLE VENT)

- All windows drawn from outside
- New sash windows proposed where existing windows are beyond repair
- To be conservation type timber box sliding sash windows to match existing
- All windows to be glazed with 10mm single glazed acoustic laminate
- Trickle vents to be fitted on selected windows as drawn
- All windows to have white painted finish
- Refer to Scope of Works for further details

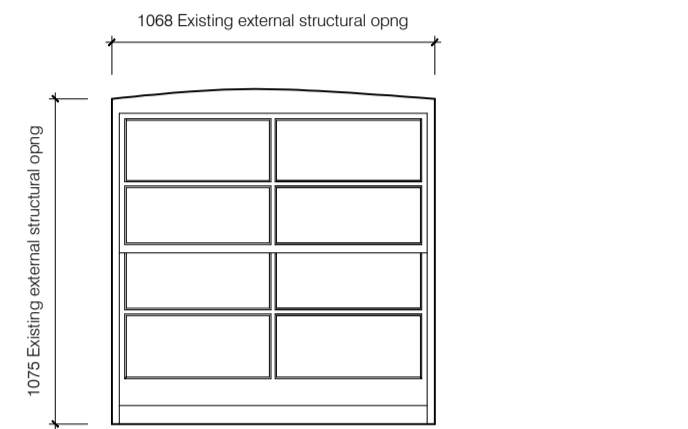
03 As Existing (Photo 2) & As Proposed
1:25 @ A1 (1:50 @ A3)

Window No: WX.3.04 (NEW WINDOW)

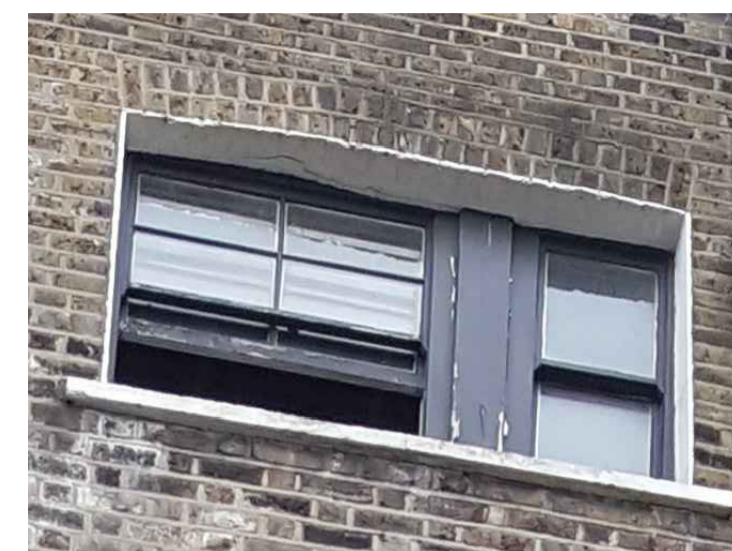
PHOTO 1
No 66 3rd Fl Rear Left Window
Window No: WX.3.05

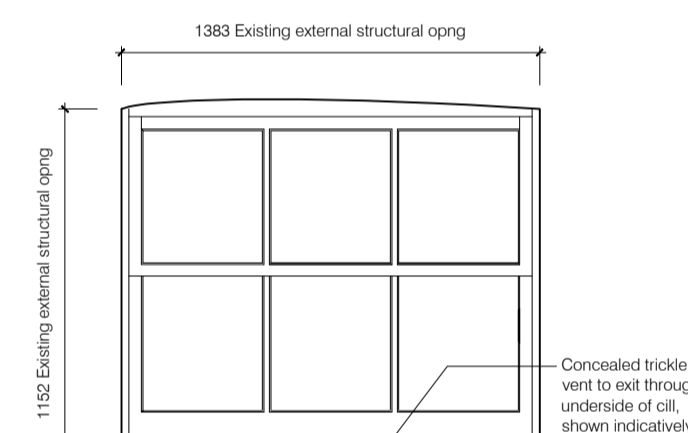
04 As Existing (Photo 3) & As Proposed
1:25 @ A1 (1:50 @ A3)

Window No: WX.3.24 (NEW WINDOW W/ TRICKLE VENT)

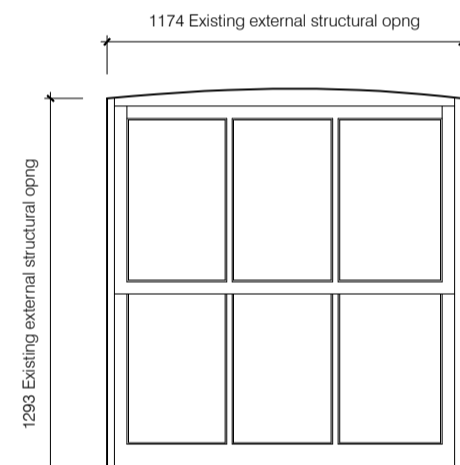
05 As Existing (Photo 4) & As Proposed
1:25 @ A1 (1:50 @ A3)

Window No: WX.3.23 (NEW WINDOW)

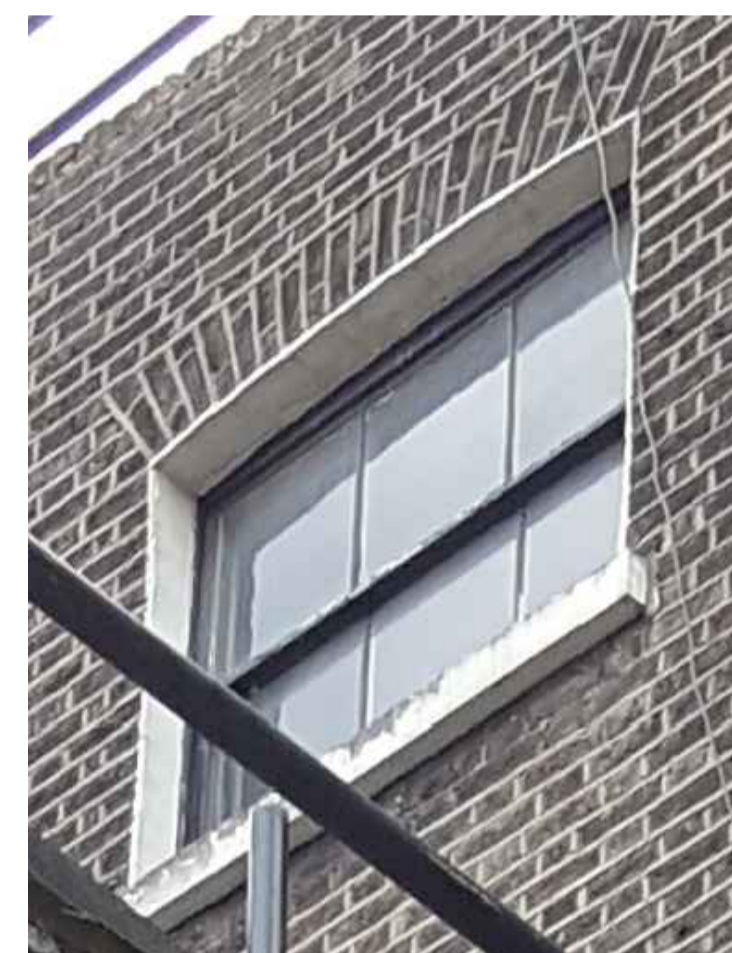
PHOTO 3
No 67 3rd Fl Rear Left Window
Window No: WX.3.24

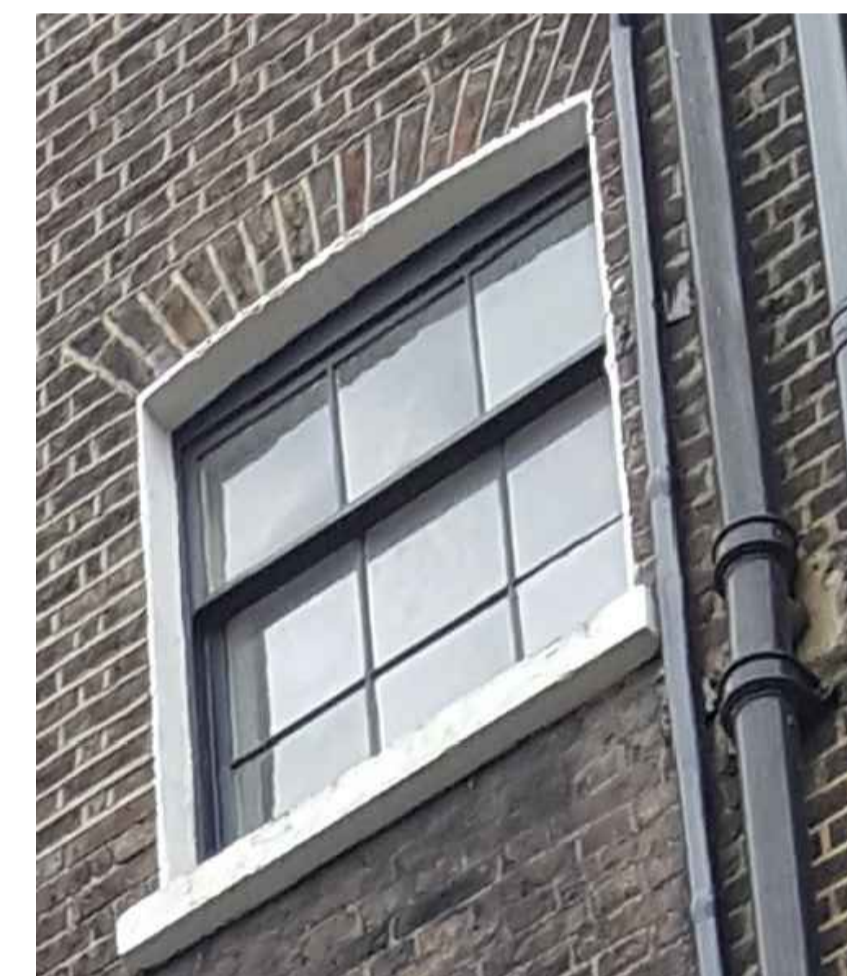
PHOTO 4
No 67 3rd Fl Rear Right Window
Window No: WX.3.23

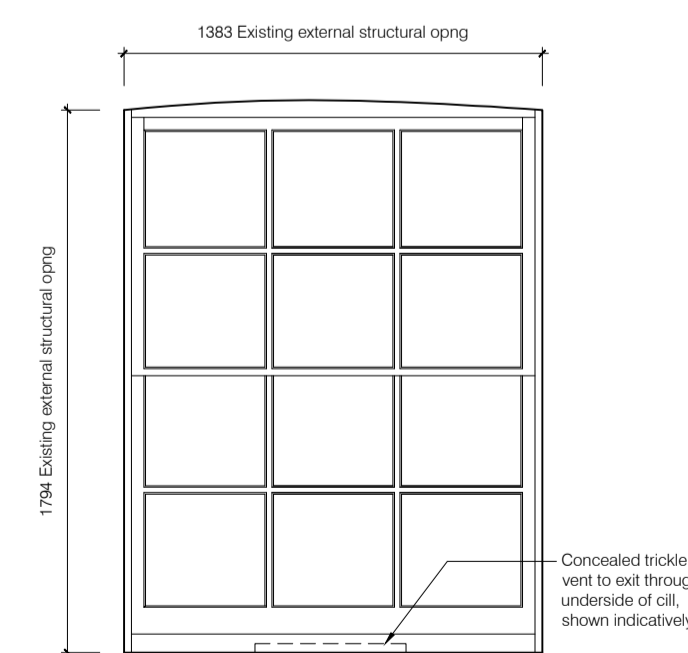
06 As Existing (No Photo) & As Proposed
1:25 @ A1 (1:50 @ A3)

Window No: WX.2.24 (NEW WINDOW W/ TRICKLE VENT)

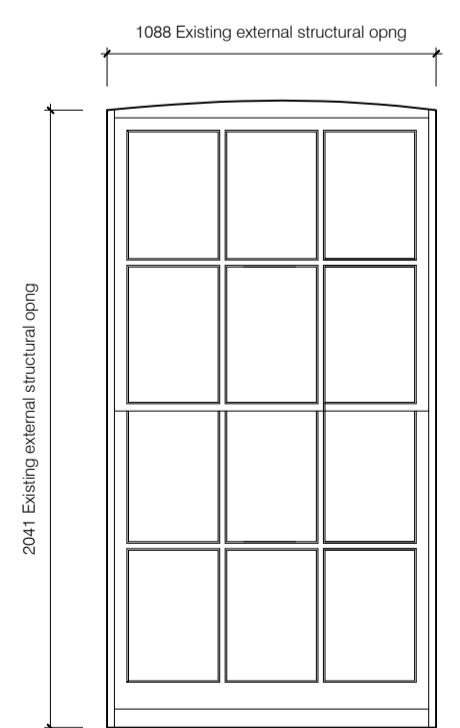
07 As Existing (Photo 5) & As Proposed
1:25 @ A1 (1:50 @ A3)

Window No: WX.2.23 (REFURBISHED WINDOW)

- All windows drawn from outside
- New glazing bars to be fitted to existing frames where amended glazing divisions are proposed
- All existing glass to be replaced with new 10mm single glazed acoustic laminate
- All windows to have white painted finish
- Refer to Scope of Works for further details

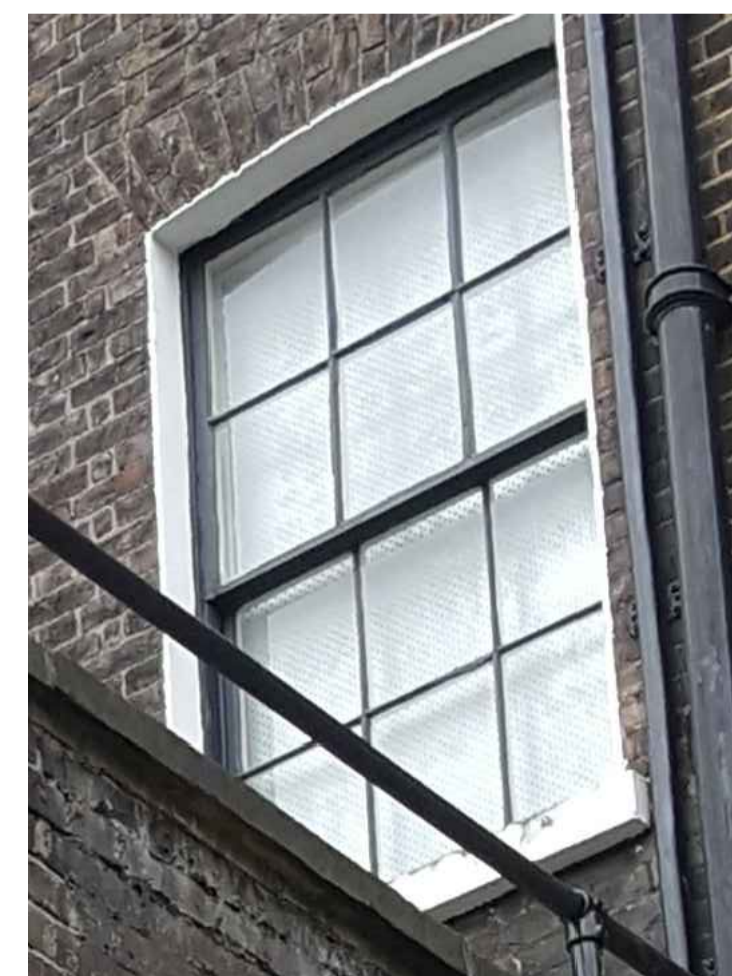
PHOTO 5
No 67 2nd Fl Rear Right Window
Window No: WX.2.23
