FOR PLANNING
 St. Katharine's, The Danish Church
 Proposed Access to Clock Chamber Hatch

Job No. 043 Drawing No. ACC02 Rev. 00
 Scale: 1:20@A3
 Date: 09 December 2016

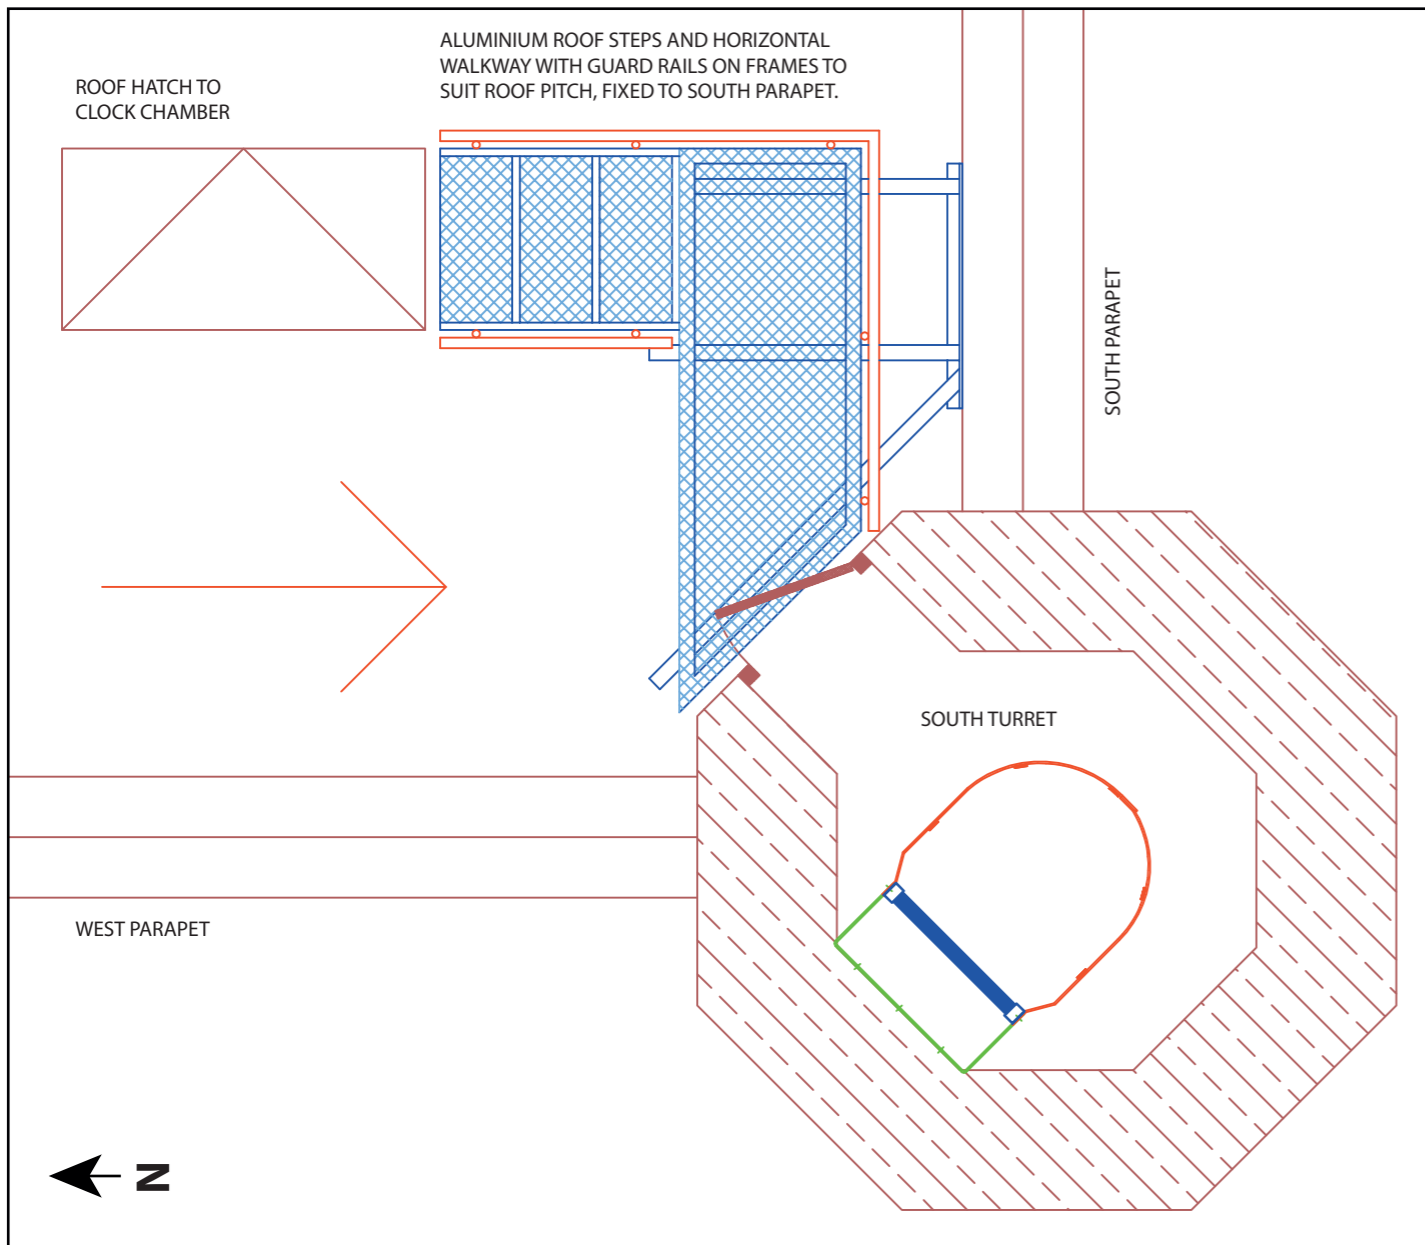
PLAN AS PROPOSED - SOUTH TURRET AND ROOF ACCESS HATCH TO CLOCK CHAMBER

Allow for bespoke access solution to include metal horizontal walkway with guard rail to the east and south, and metal roof steps with guard rail to east and west, all on frames to suit roof pitch.

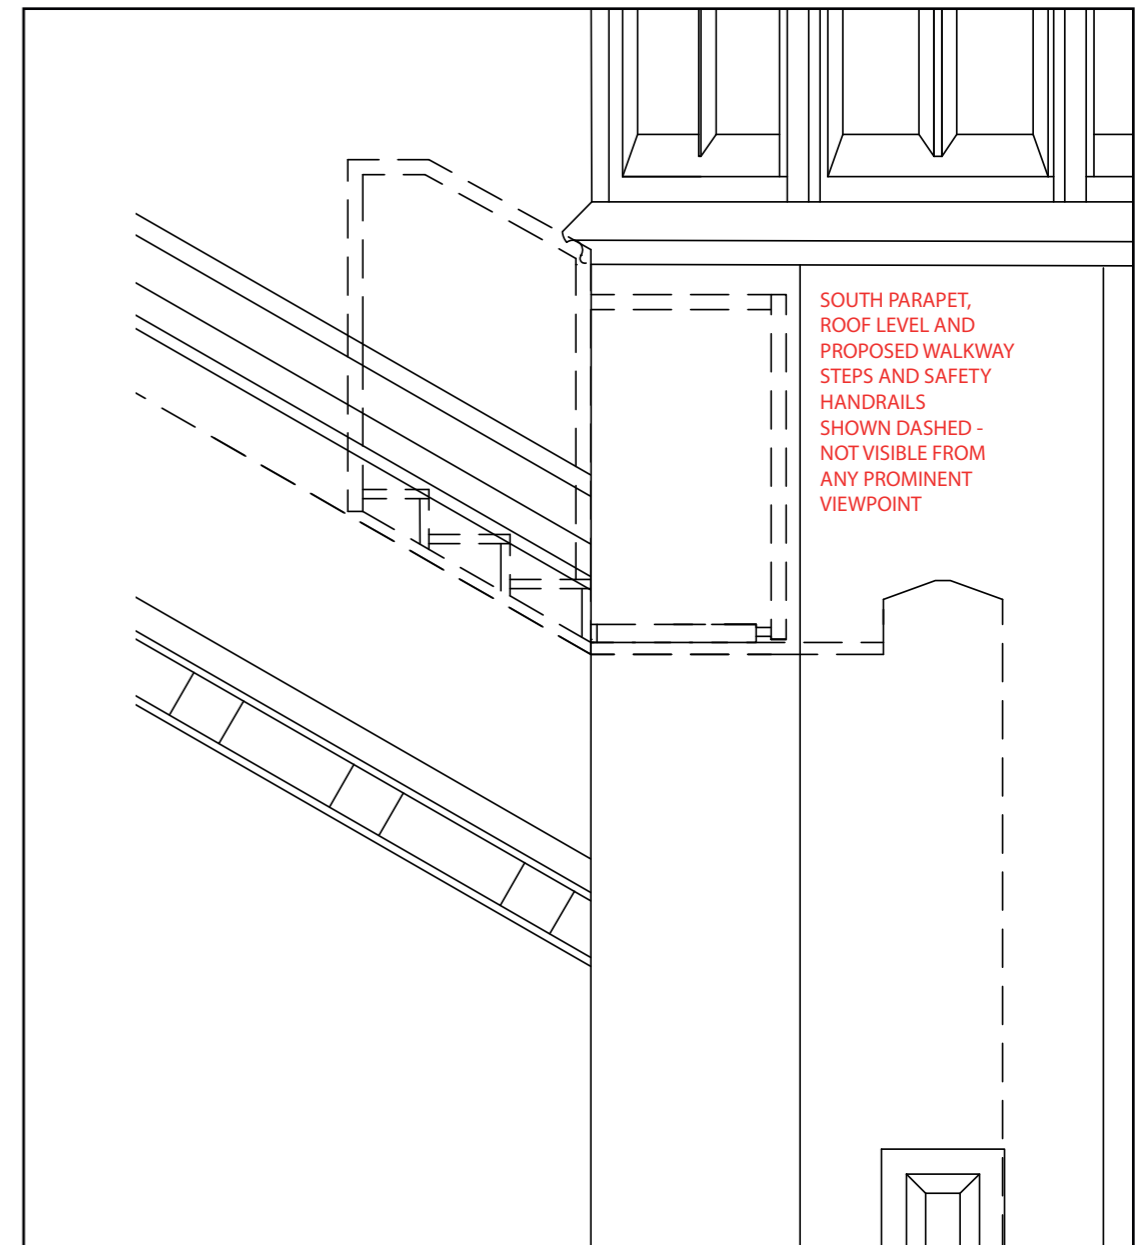
WEST ELEVATION AS PROPOSED - ACCESS WALKWAY HANDRAIL SHOWN DASHED IS NOT VISIBLE FROM ANY PROMINENT VIEWPOINT

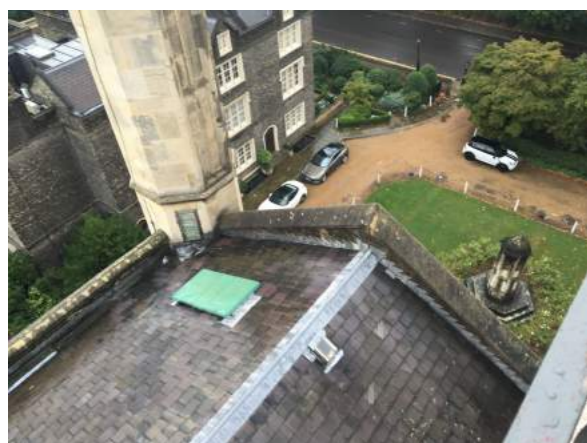
REFERENCE PHOTO (FROM NORTH EAST) OF ROOF ACCESS DOOR FROM SOUTH TURRET AND CLOCK CHAMBER LUNCH

GENERAL NOTES:
 Access to the nave roof space and clock chamber is presently limited to a roof hatch on the southern roof pitch adjacent to the south turret. It is presently a health and safety concern due to the low south parapet and multiple courses of slipped slates beneath the hatch.
