**St. Katharine's - The Danish Church in London**  
**Rectified Elevation**

**Drawing 043-E2-S01-01**  
**Issue date Sept 2016**  
**FOR TENDER**  
**Scale 1:10@ A1**

**St. Katharine's - The Danish Church in London**  
**EXTERNAL MASONRY REPAIR**

**Drawing 043-E2-S01-02**  
**Issue date Oct 2016**  
**FOR TENDER**  
**Scale 1:10@ A1**

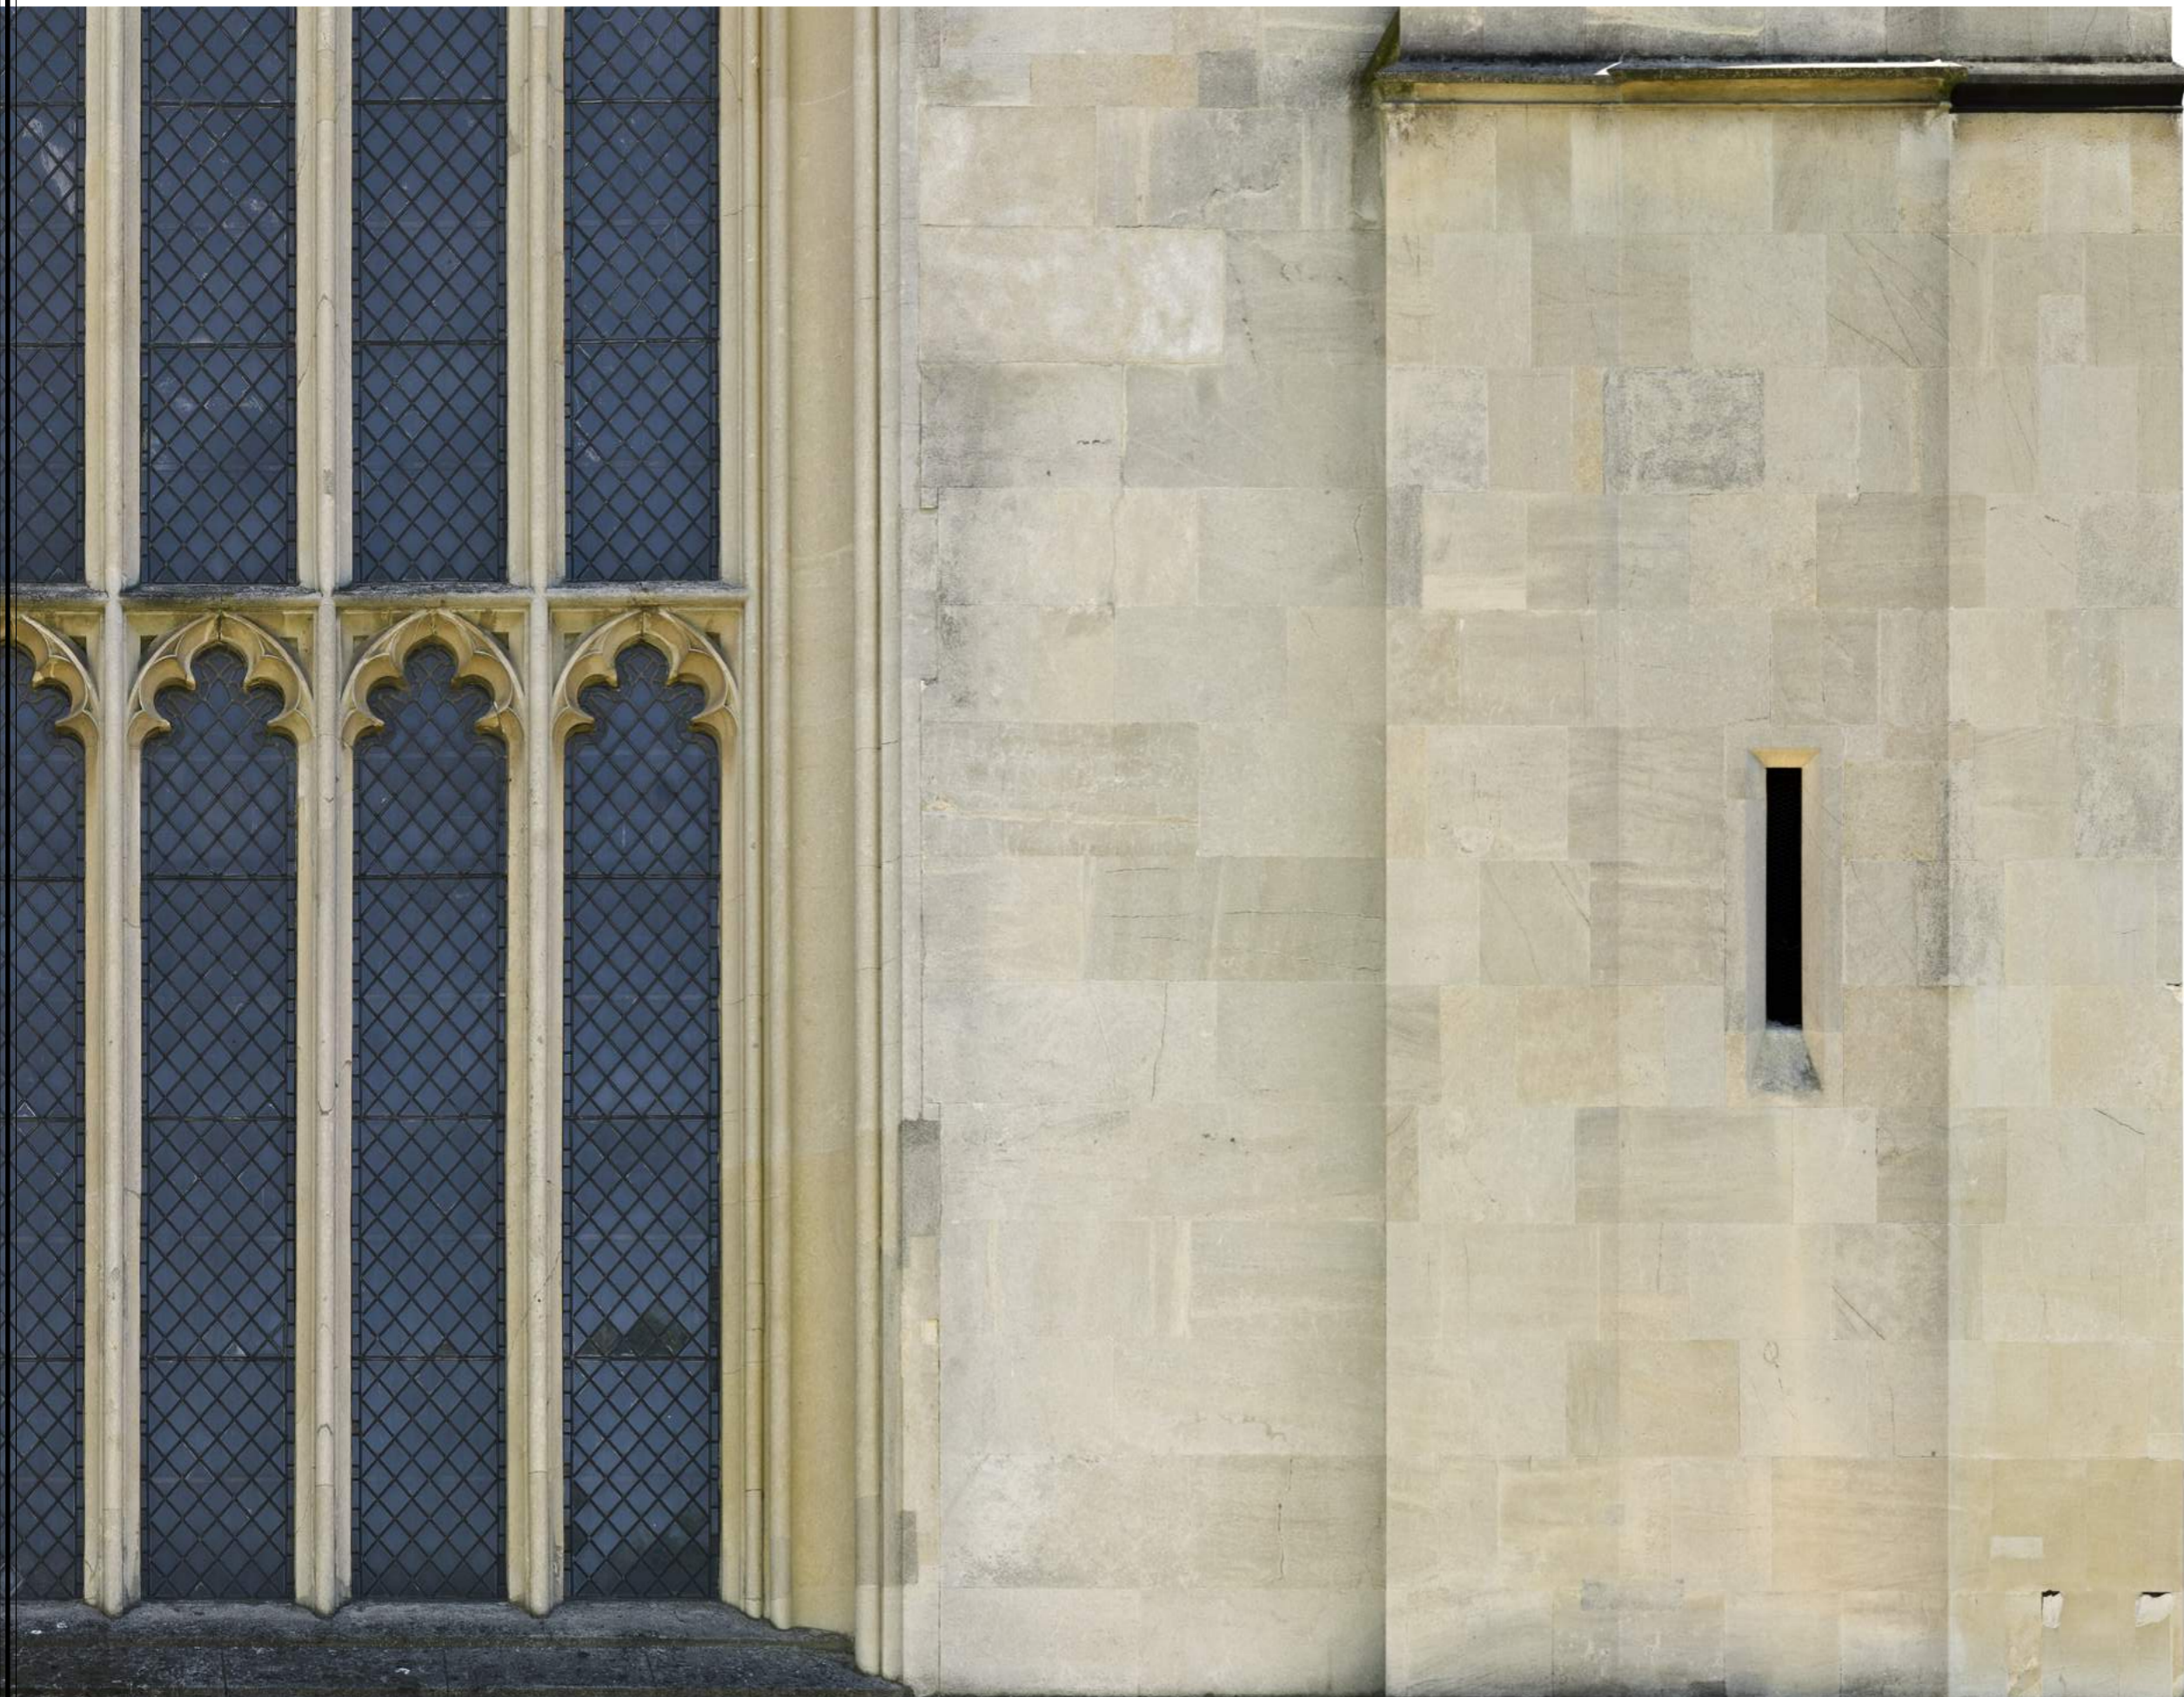
**Drawing 043-E2-S02-01**  
**Issue date Sept 2016**  
**FOR TENDER**  
**Scale 1:10@ A1**

**St. Katharine's - The Danish Church in London**  
**Rectified Elevation**

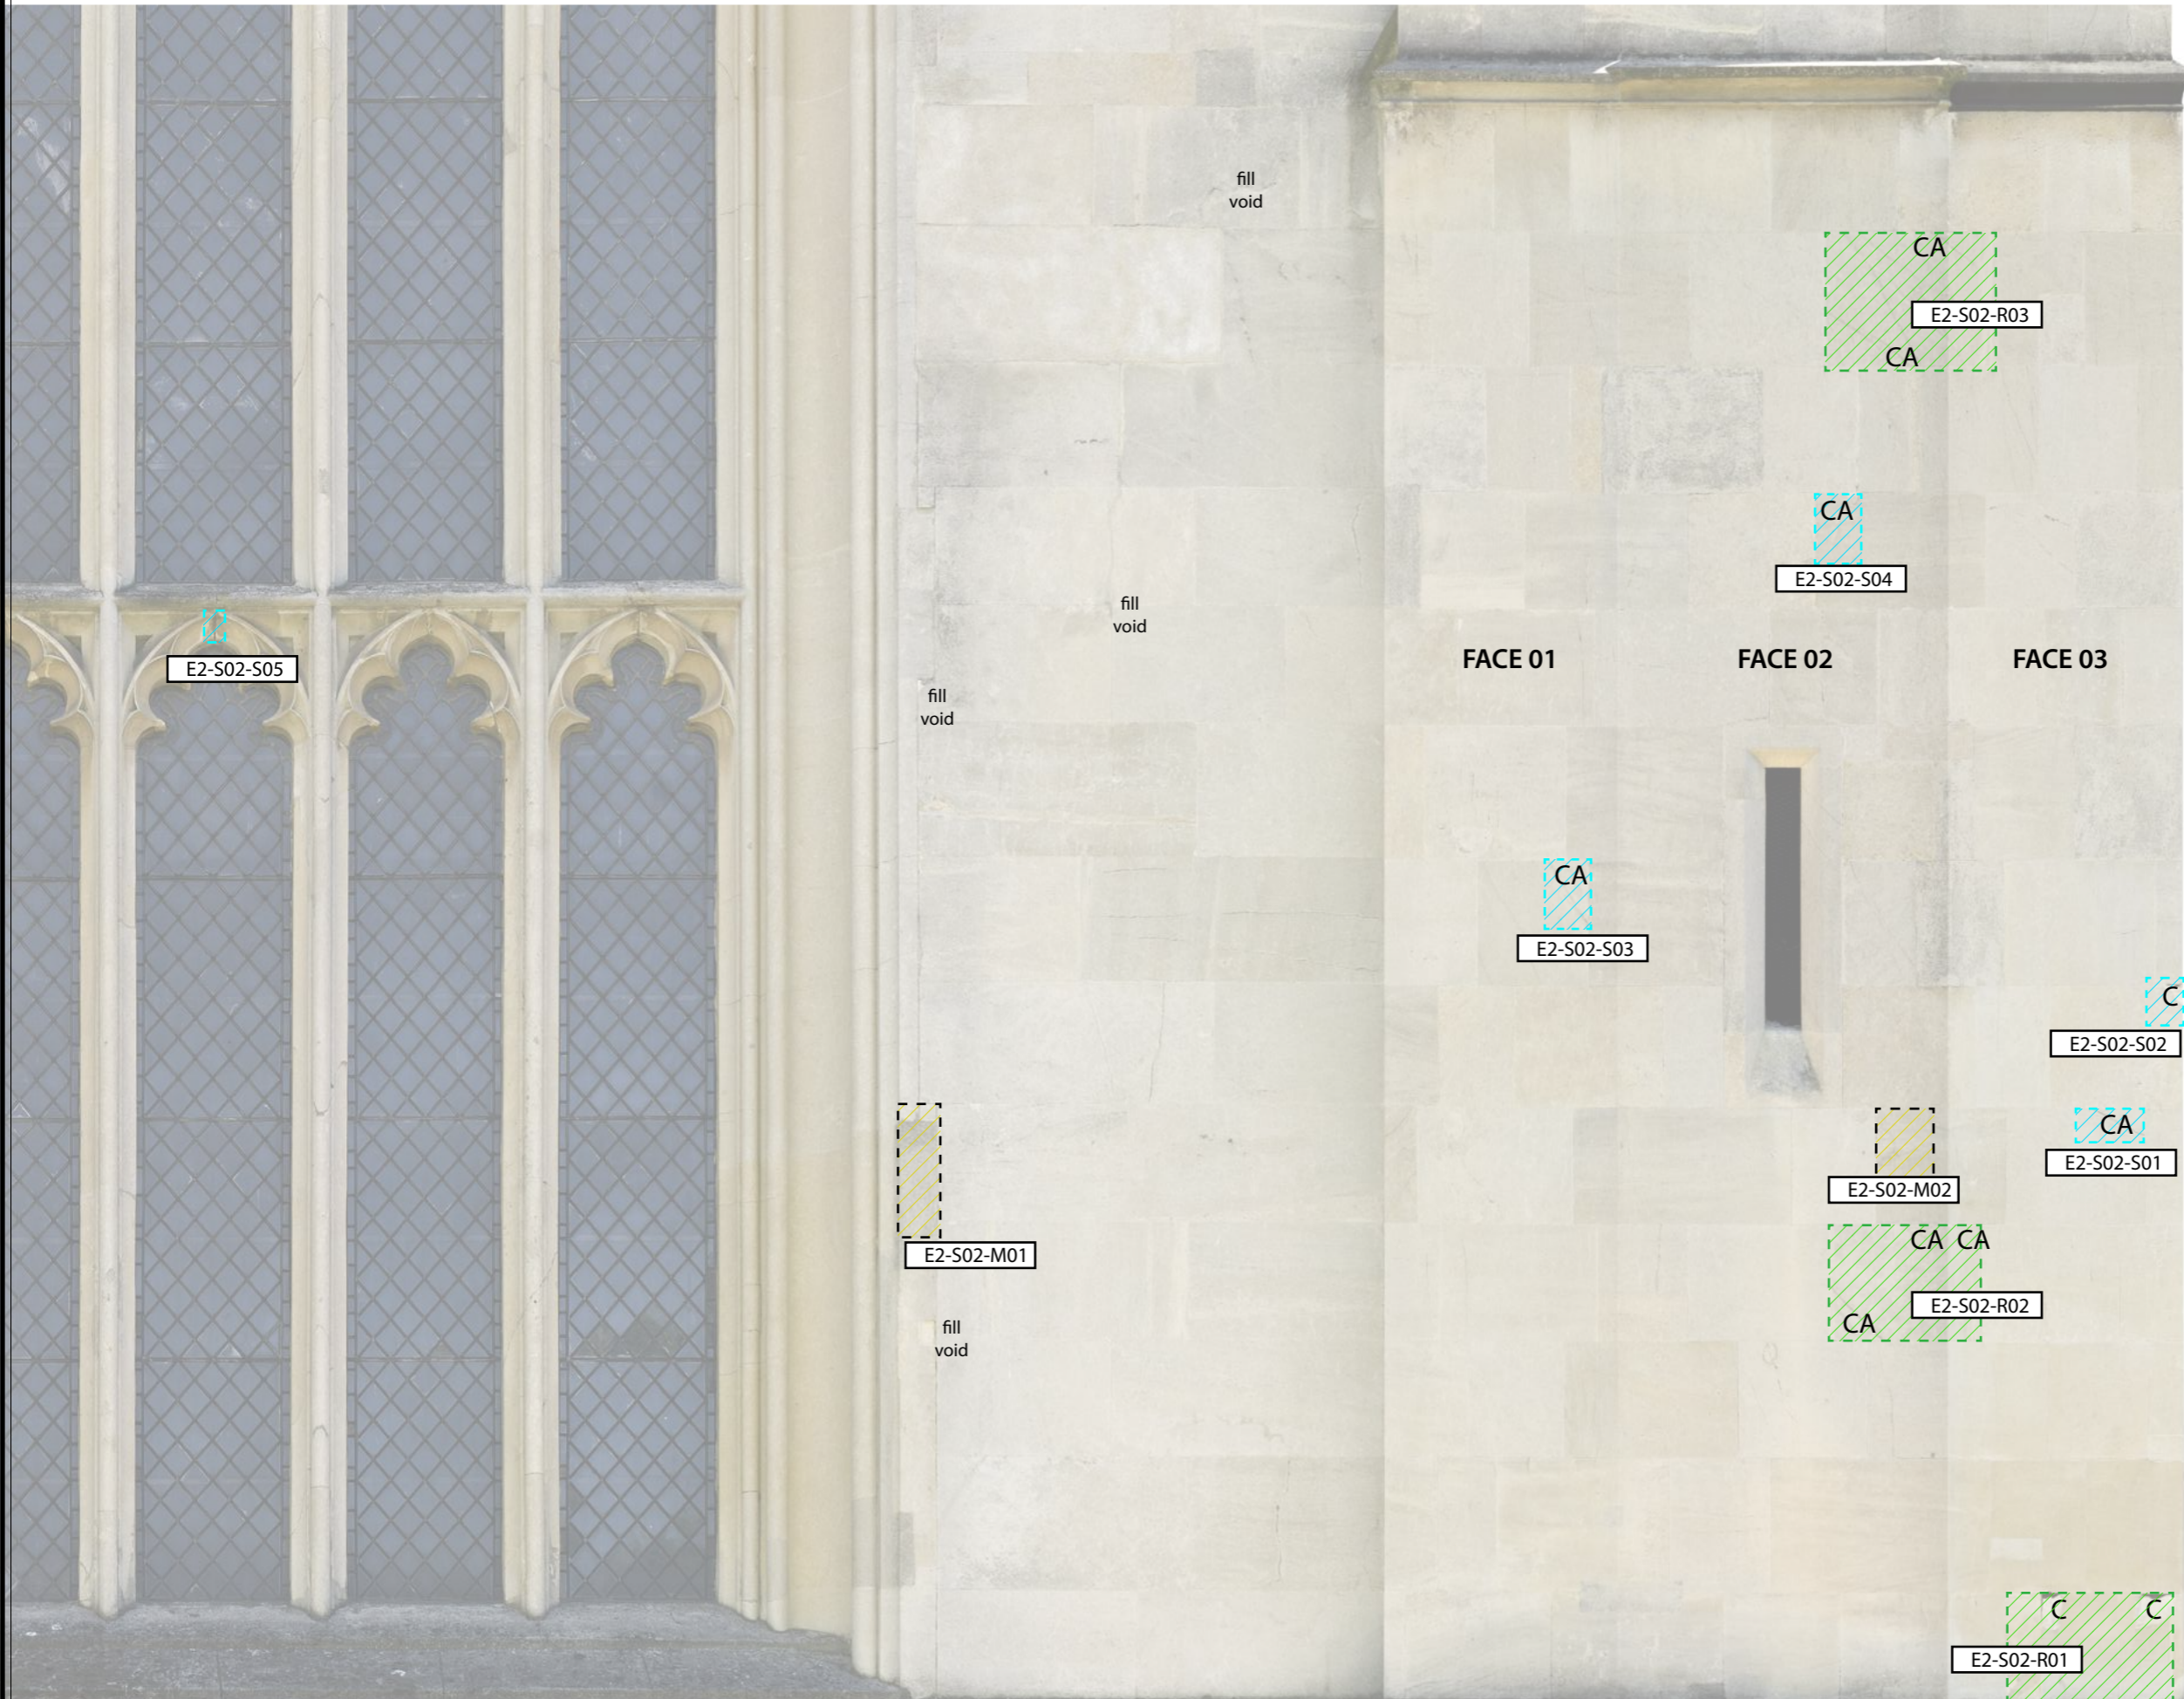
Drawing 043-E2-S02-02

### EXTERNAL MASONRY REPAIR
