**St. Katharine's - The Danish Church in London**  
**Rectified Elevation**

**Drawing 043-E2-S05-01**  
**Issue date** Sept 2016  
**FOR TENDER**  
**Scale 1:10@ A1**

## St. Katharine's - The Danish Church in London EXTERNAL MASONRY REPAIR

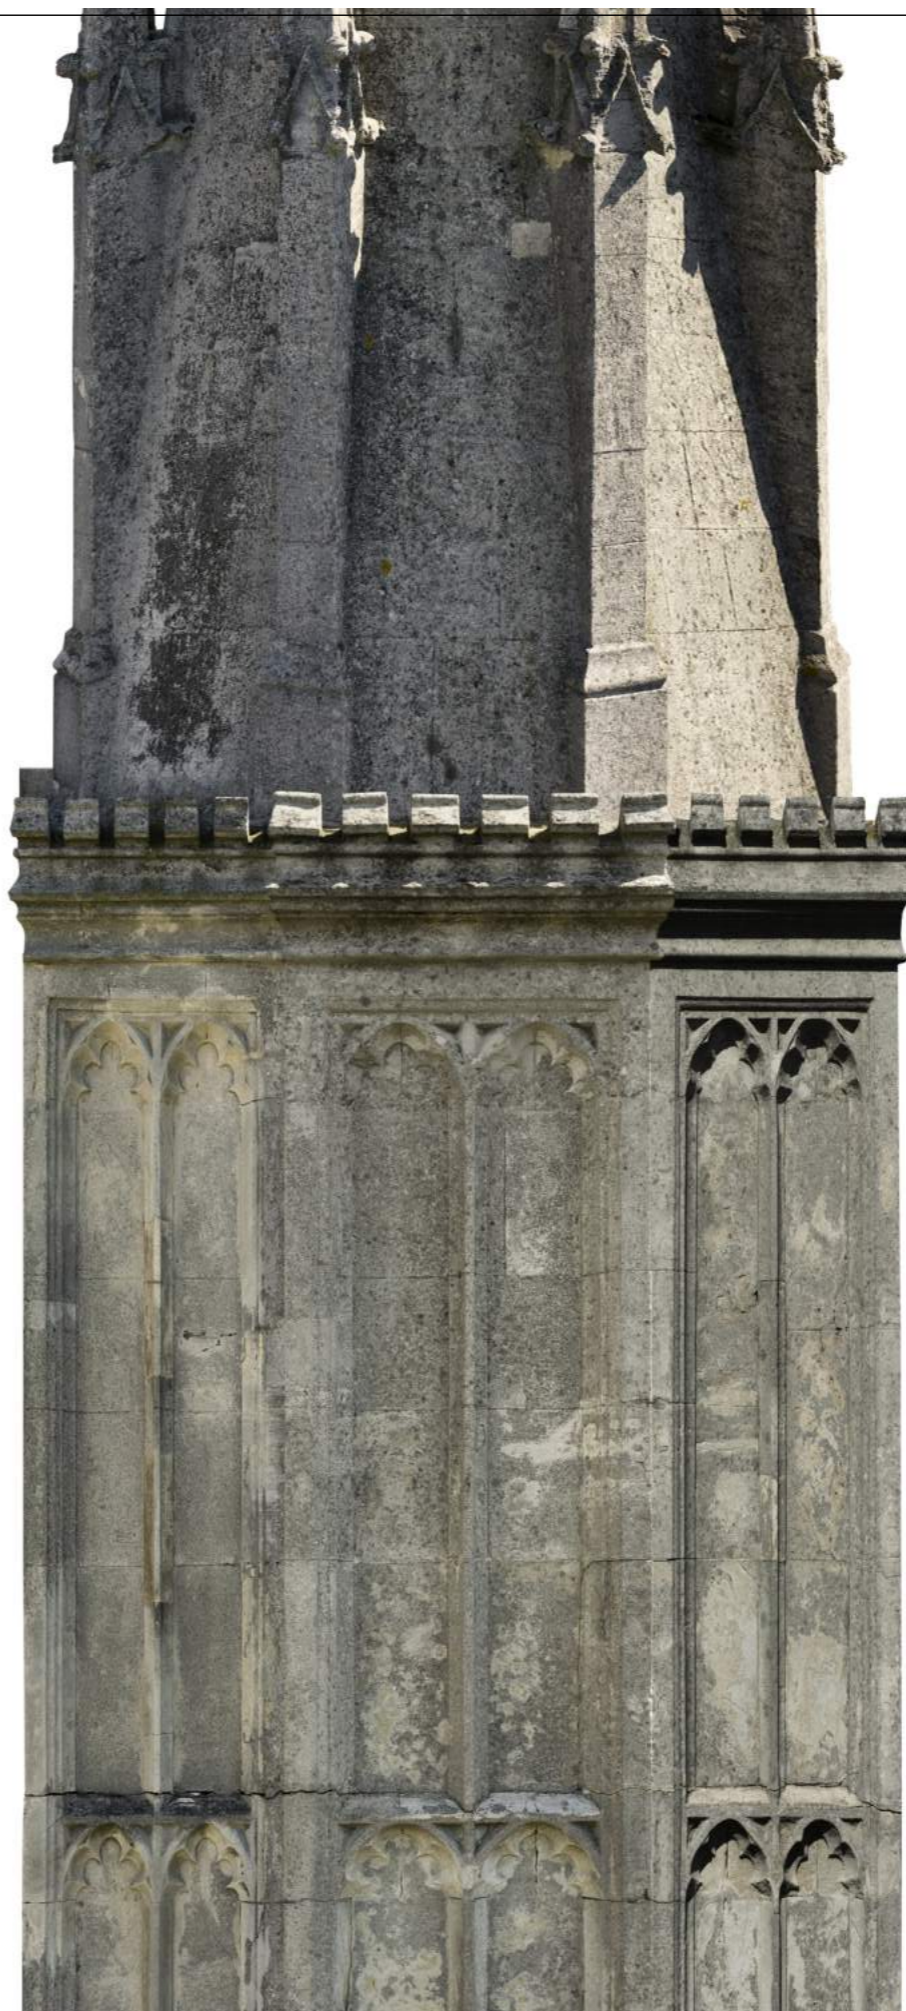
External cleaning to be completed prior to commencement of stonework repairs, following approved external cleaning trials with DOFF steam as per spec A12r/460 in consultation with CA.

Allow for ashlar repointing to open joints only (approximately 50% of total surface area) as per specification Z21r/490. All hairline fissures to ashlar and retained rendered surfaces to be filled where possible, in consultation with CA.
