SOUTH TOWER

St. Katharine's - The Danish Church in London
Rectified Return Elevations - South Tower

Drawing no.043-E5-02-01
Issue date Oct 2016
Issue status FOR TENDER
Scale **1:10@ A1**

St. Katharine's - The Danish Church in London EXTERNAL MASONRY REPAIR

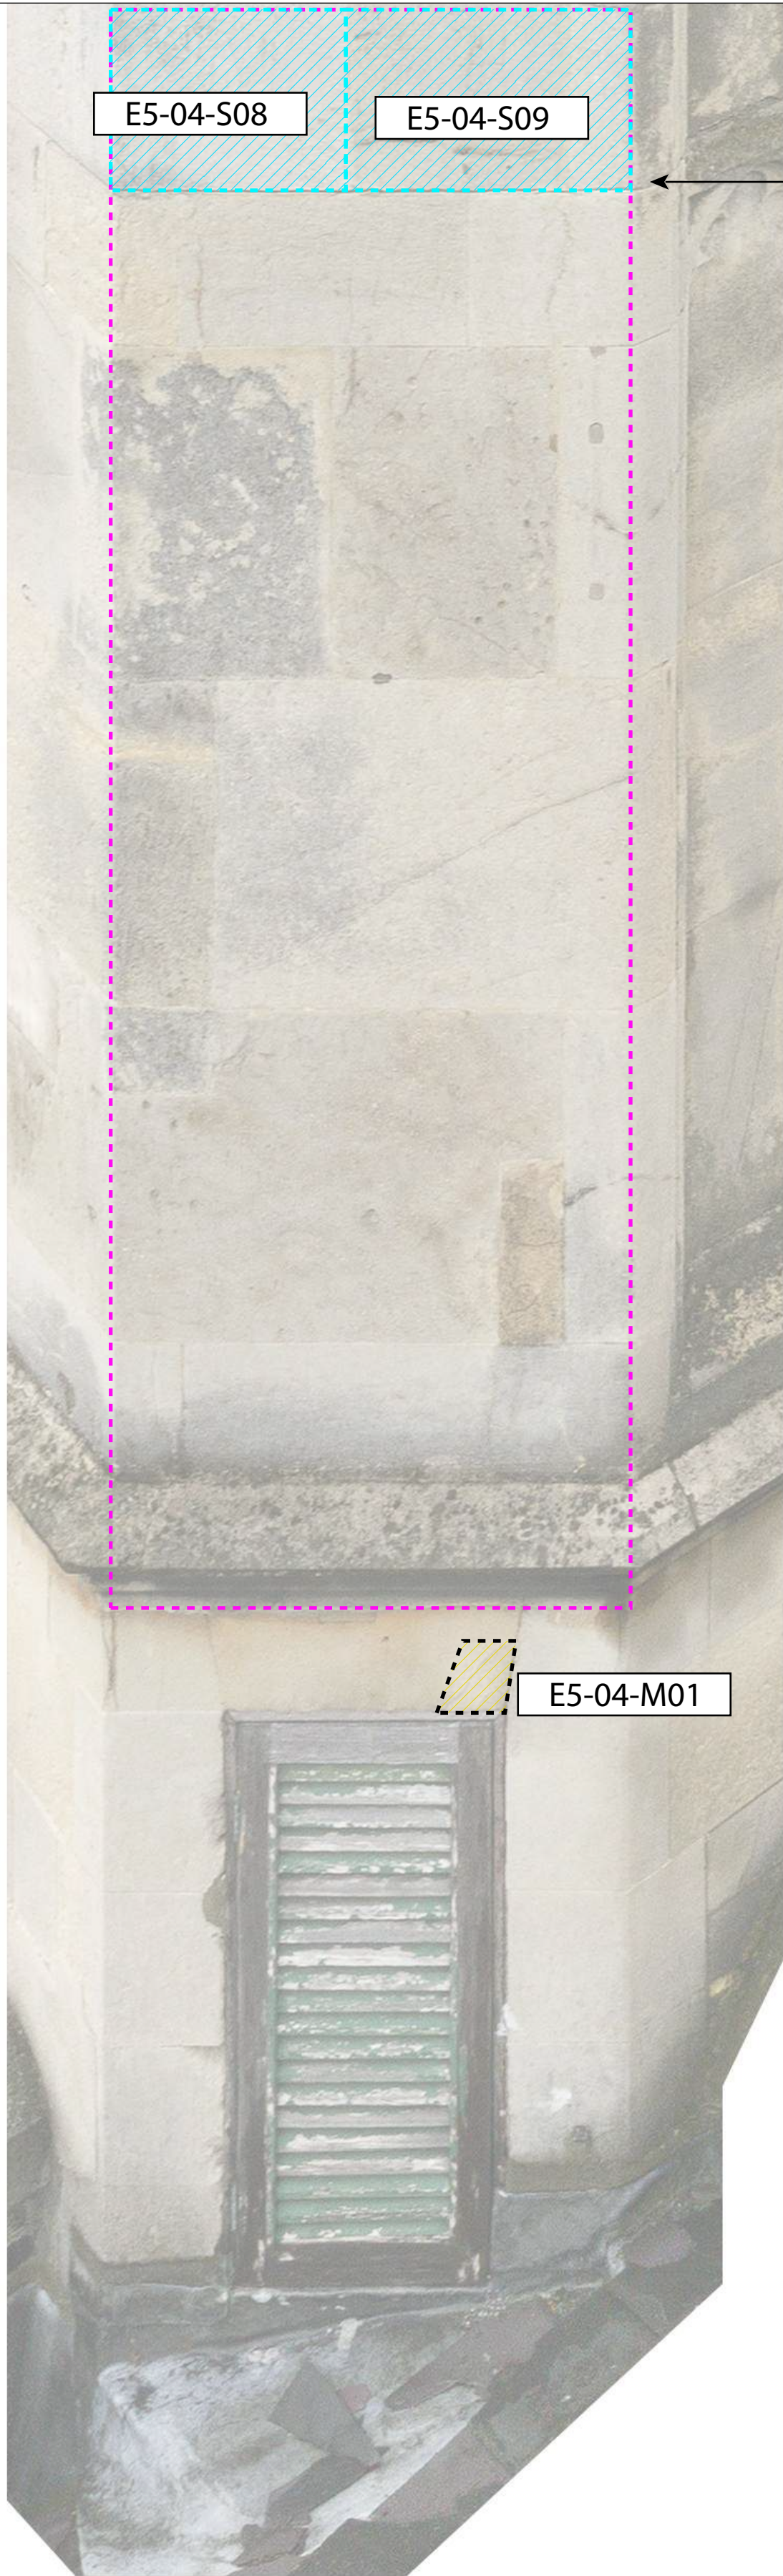
Allow for to stone indent repairs and renewal as shown in order to remove the ring beam in situ below, all to SE detail. Refer to Structural Engineer's drawing 1601/212/03 for suggested sequence.
