St. Katharine's - The Danish Church in London
Rectified Elevation

Drawing 043-E2-N03-01
Issue date Sept 2016
FOR TENDER
Scale 1:10@ A1

St. Katharine's - The Danish Church in London
EXTERNAL MASONRY REPAIR

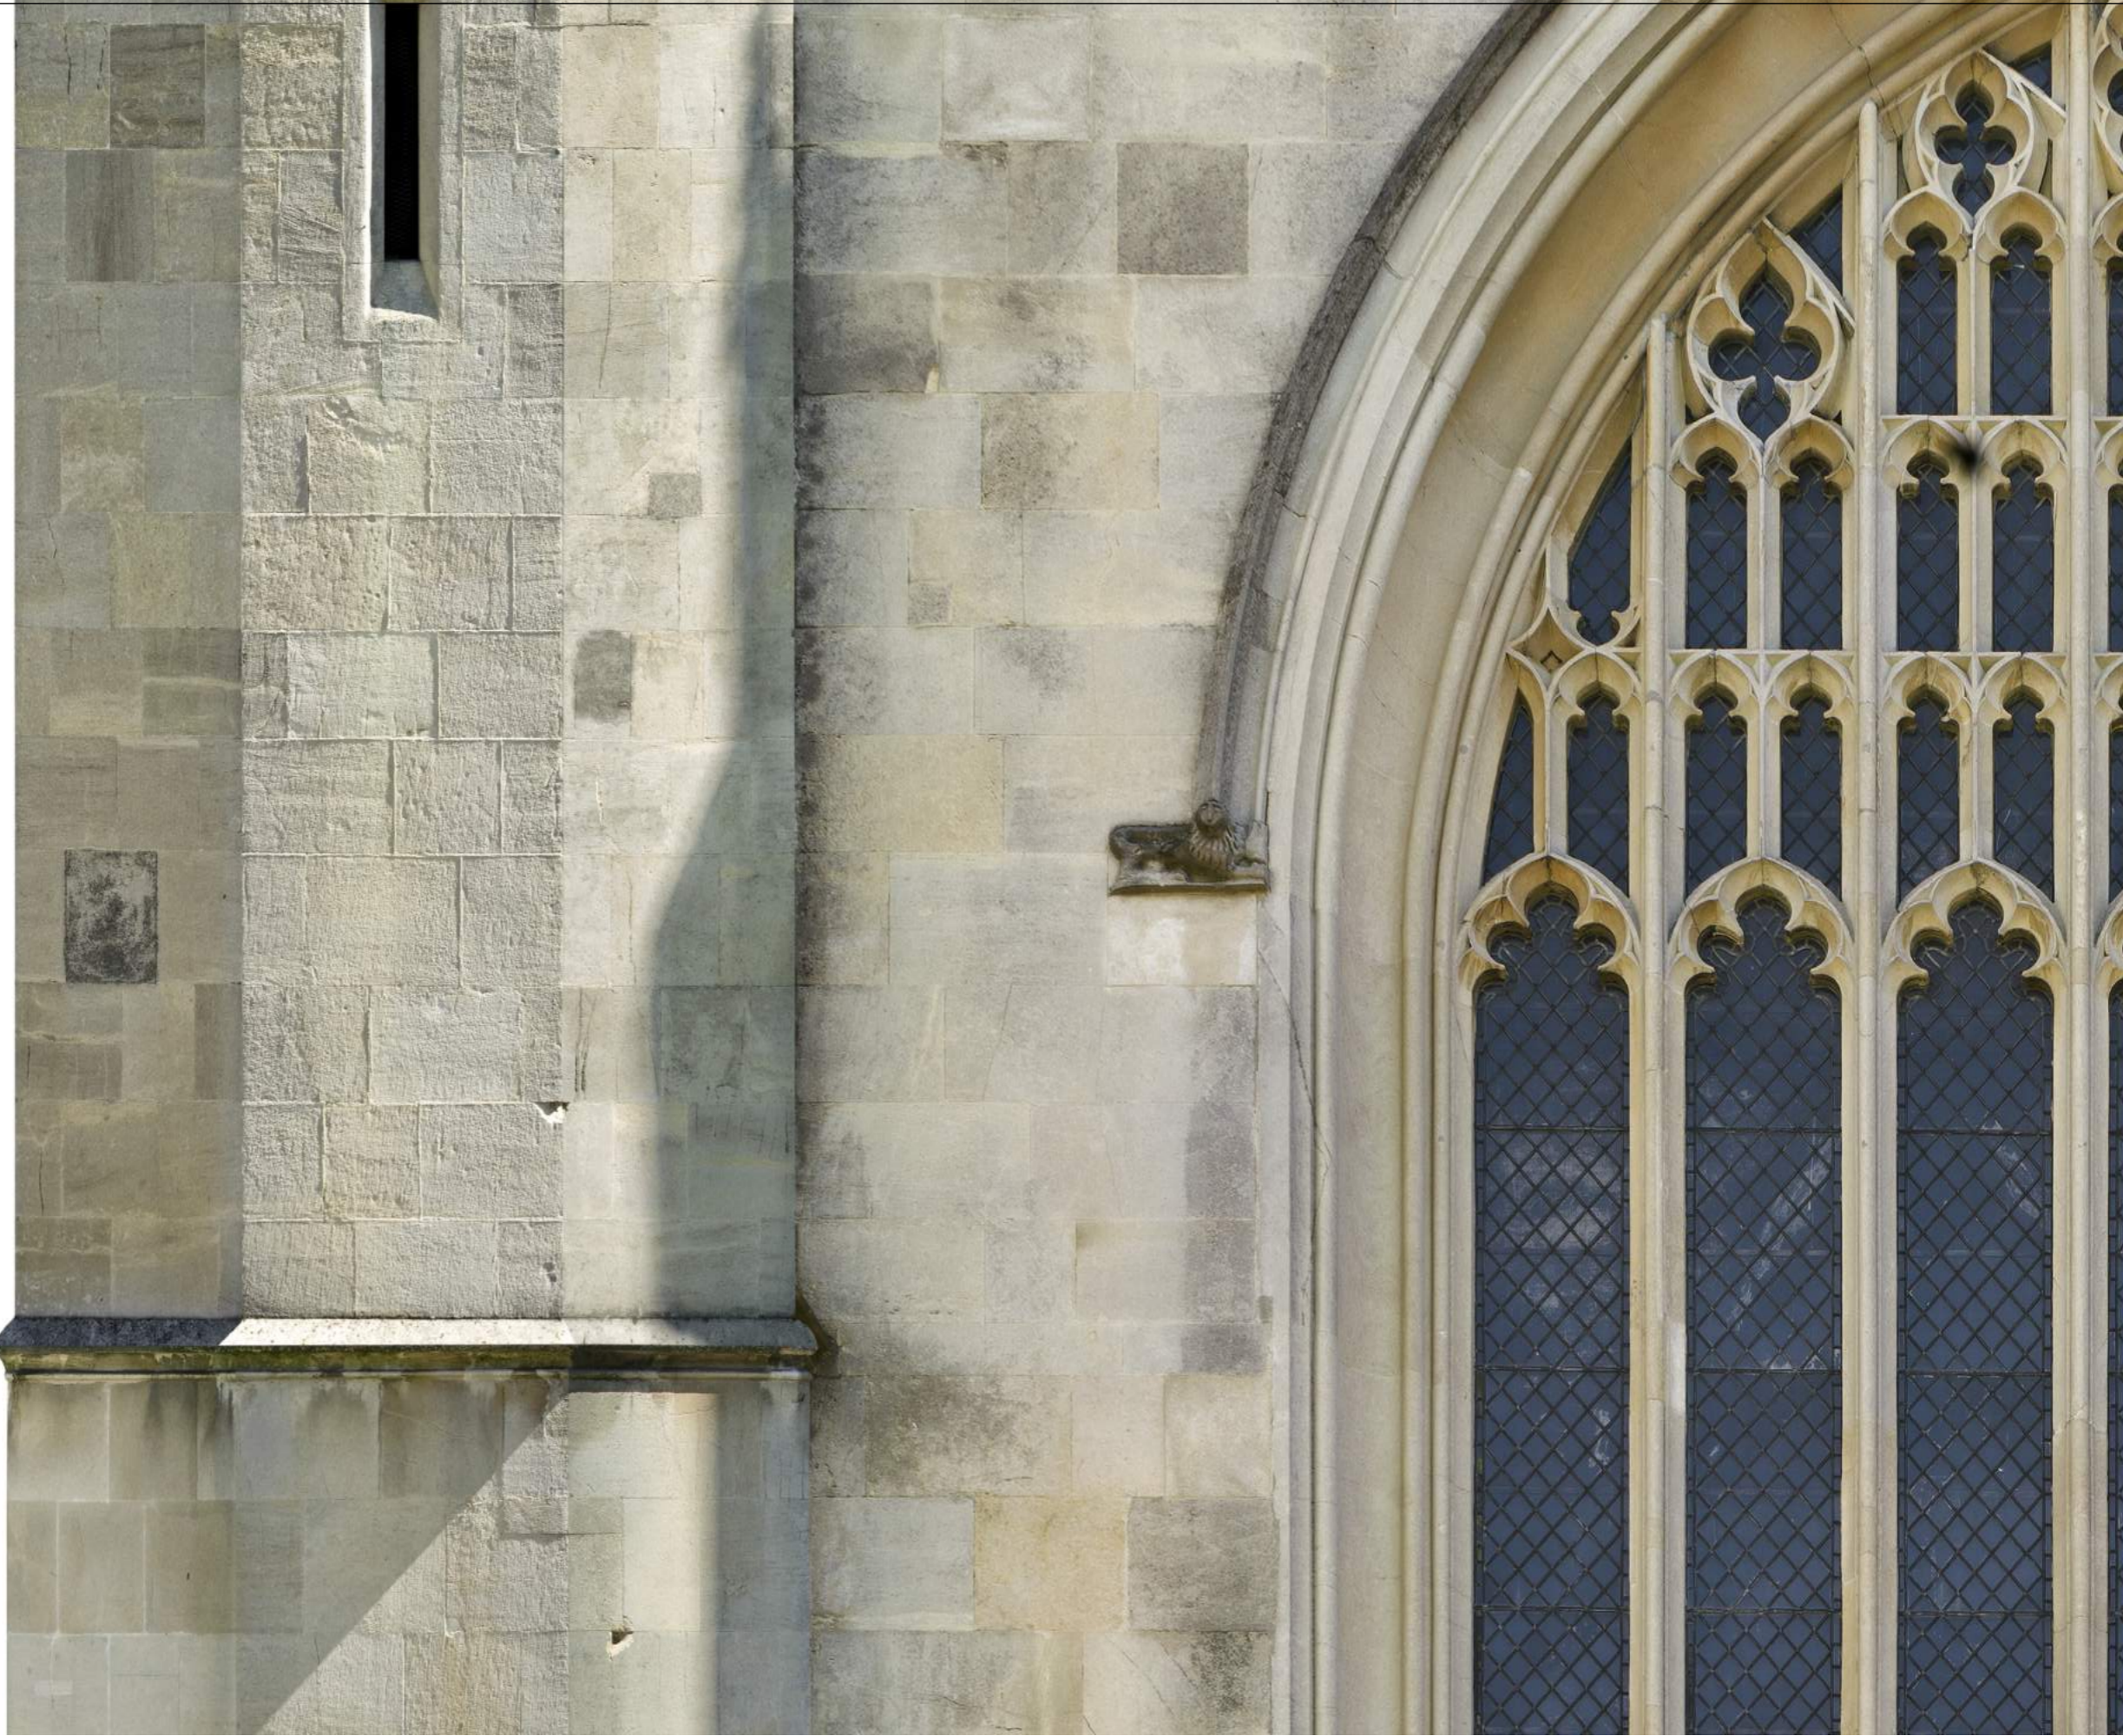
External cleaning to be completed prior to commencement of stonework repairs, following approved external cleaning trials with DOFF steam as per spec A12r/460 in consultation with CA.

Allow for ashlar repointing to open joints only (approximately 50% of total surface area) as per specification Z21r/490. All hairline fissures to ashlar and retained rendered surfaces to be filled where possible, in consultation with CA.

CA **Cramp Assumed**
Evidence suggests corrosion of embedded cramp within face stonework. Area to be investigated by specialist stonemason. Allow for careful removal of cramp and cramp replacement as per specification F21r/610, and stone replacement, indent repair or mortar repair as scheduled.

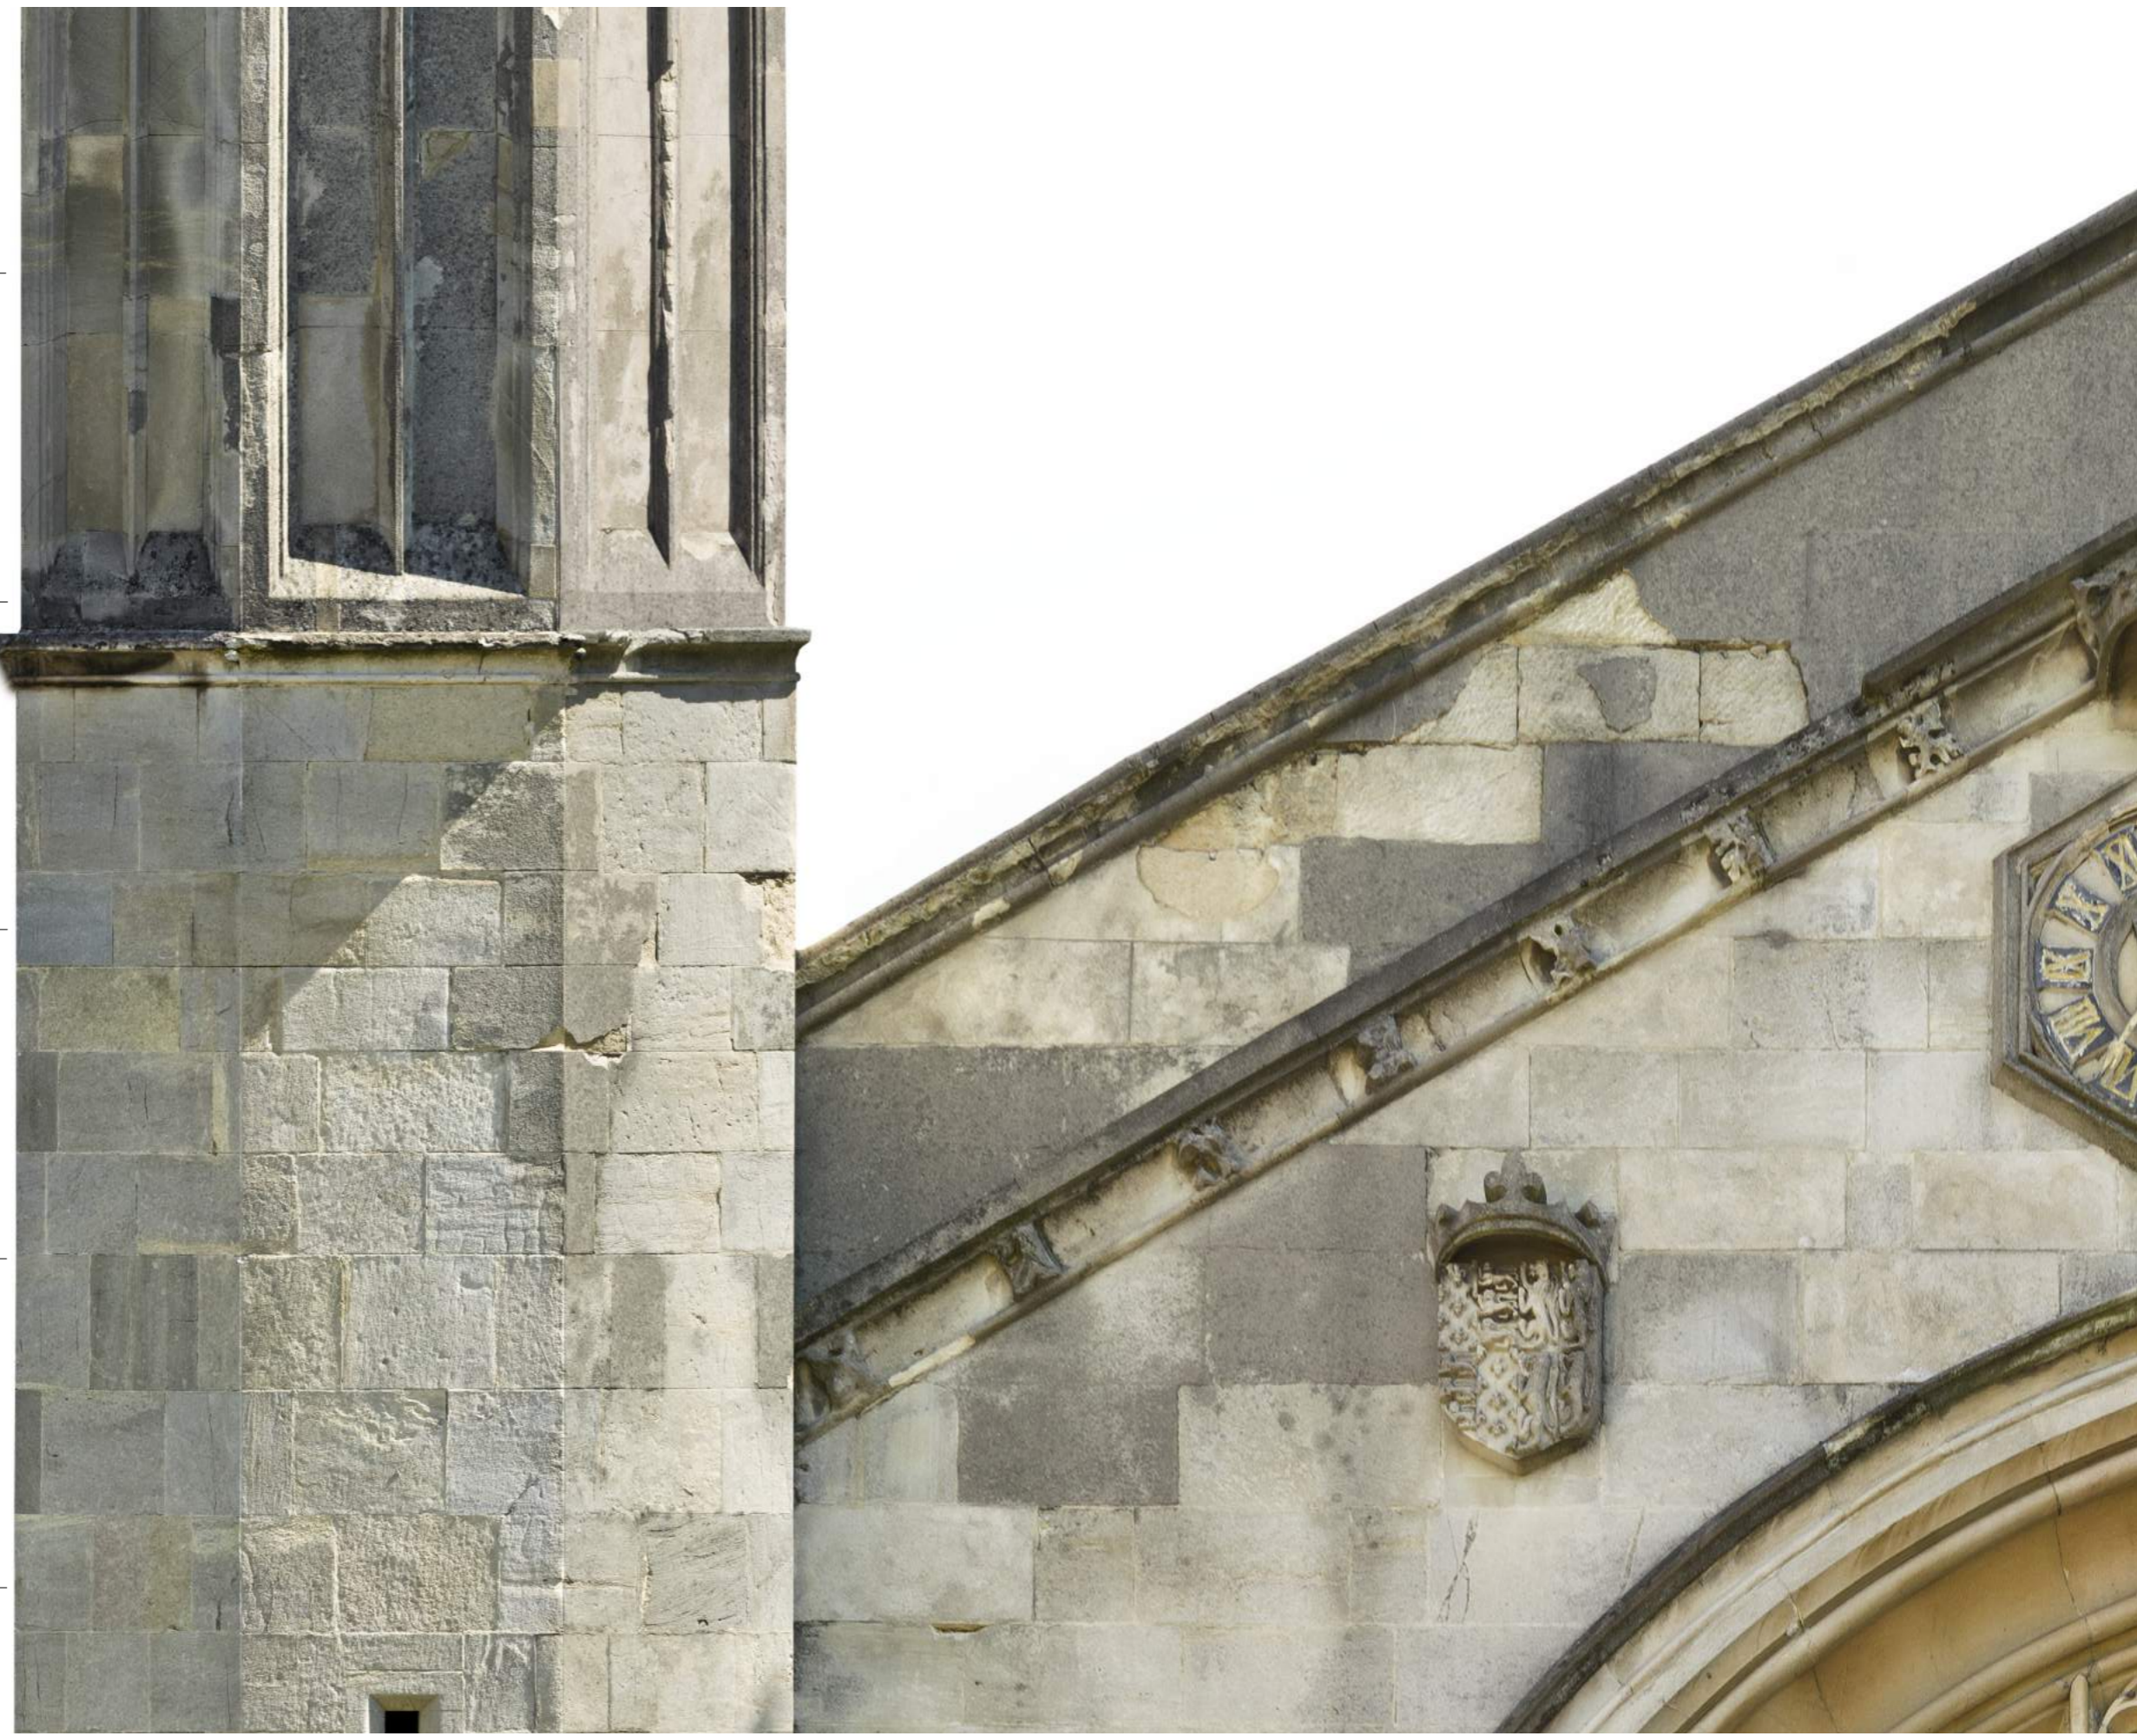
Drawing **043-E2-N04-01**
Issue date **Sept 2016**
FOR TENDER
Scale **1:10@ A1**

St. Katharine's - The Danish Church in London
Rectified Elevation

External cleaning to be completed prior to commencement of stonework repairs, following approved external cleaning trials with DOFF steam as per spec A12r/460 in consultation with CA.

Allow for ashlar repointing to all open joints only (approximately 50% of total surface area) as per specification Z21r/490. All hairline fissures, open joints to mortar repairs and other small voids to be filled where possible, in consultation with CA.

- CA** **Cramp Assumed**
Evidence suggests corrosion of embedded cramp within face stonework. Area to be investigated by specialist stonemason. Allow for careful removal of cramp and cramp replacement as per specification F21r/610, and stone replacement, indent repair or mortar repair as scheduled.

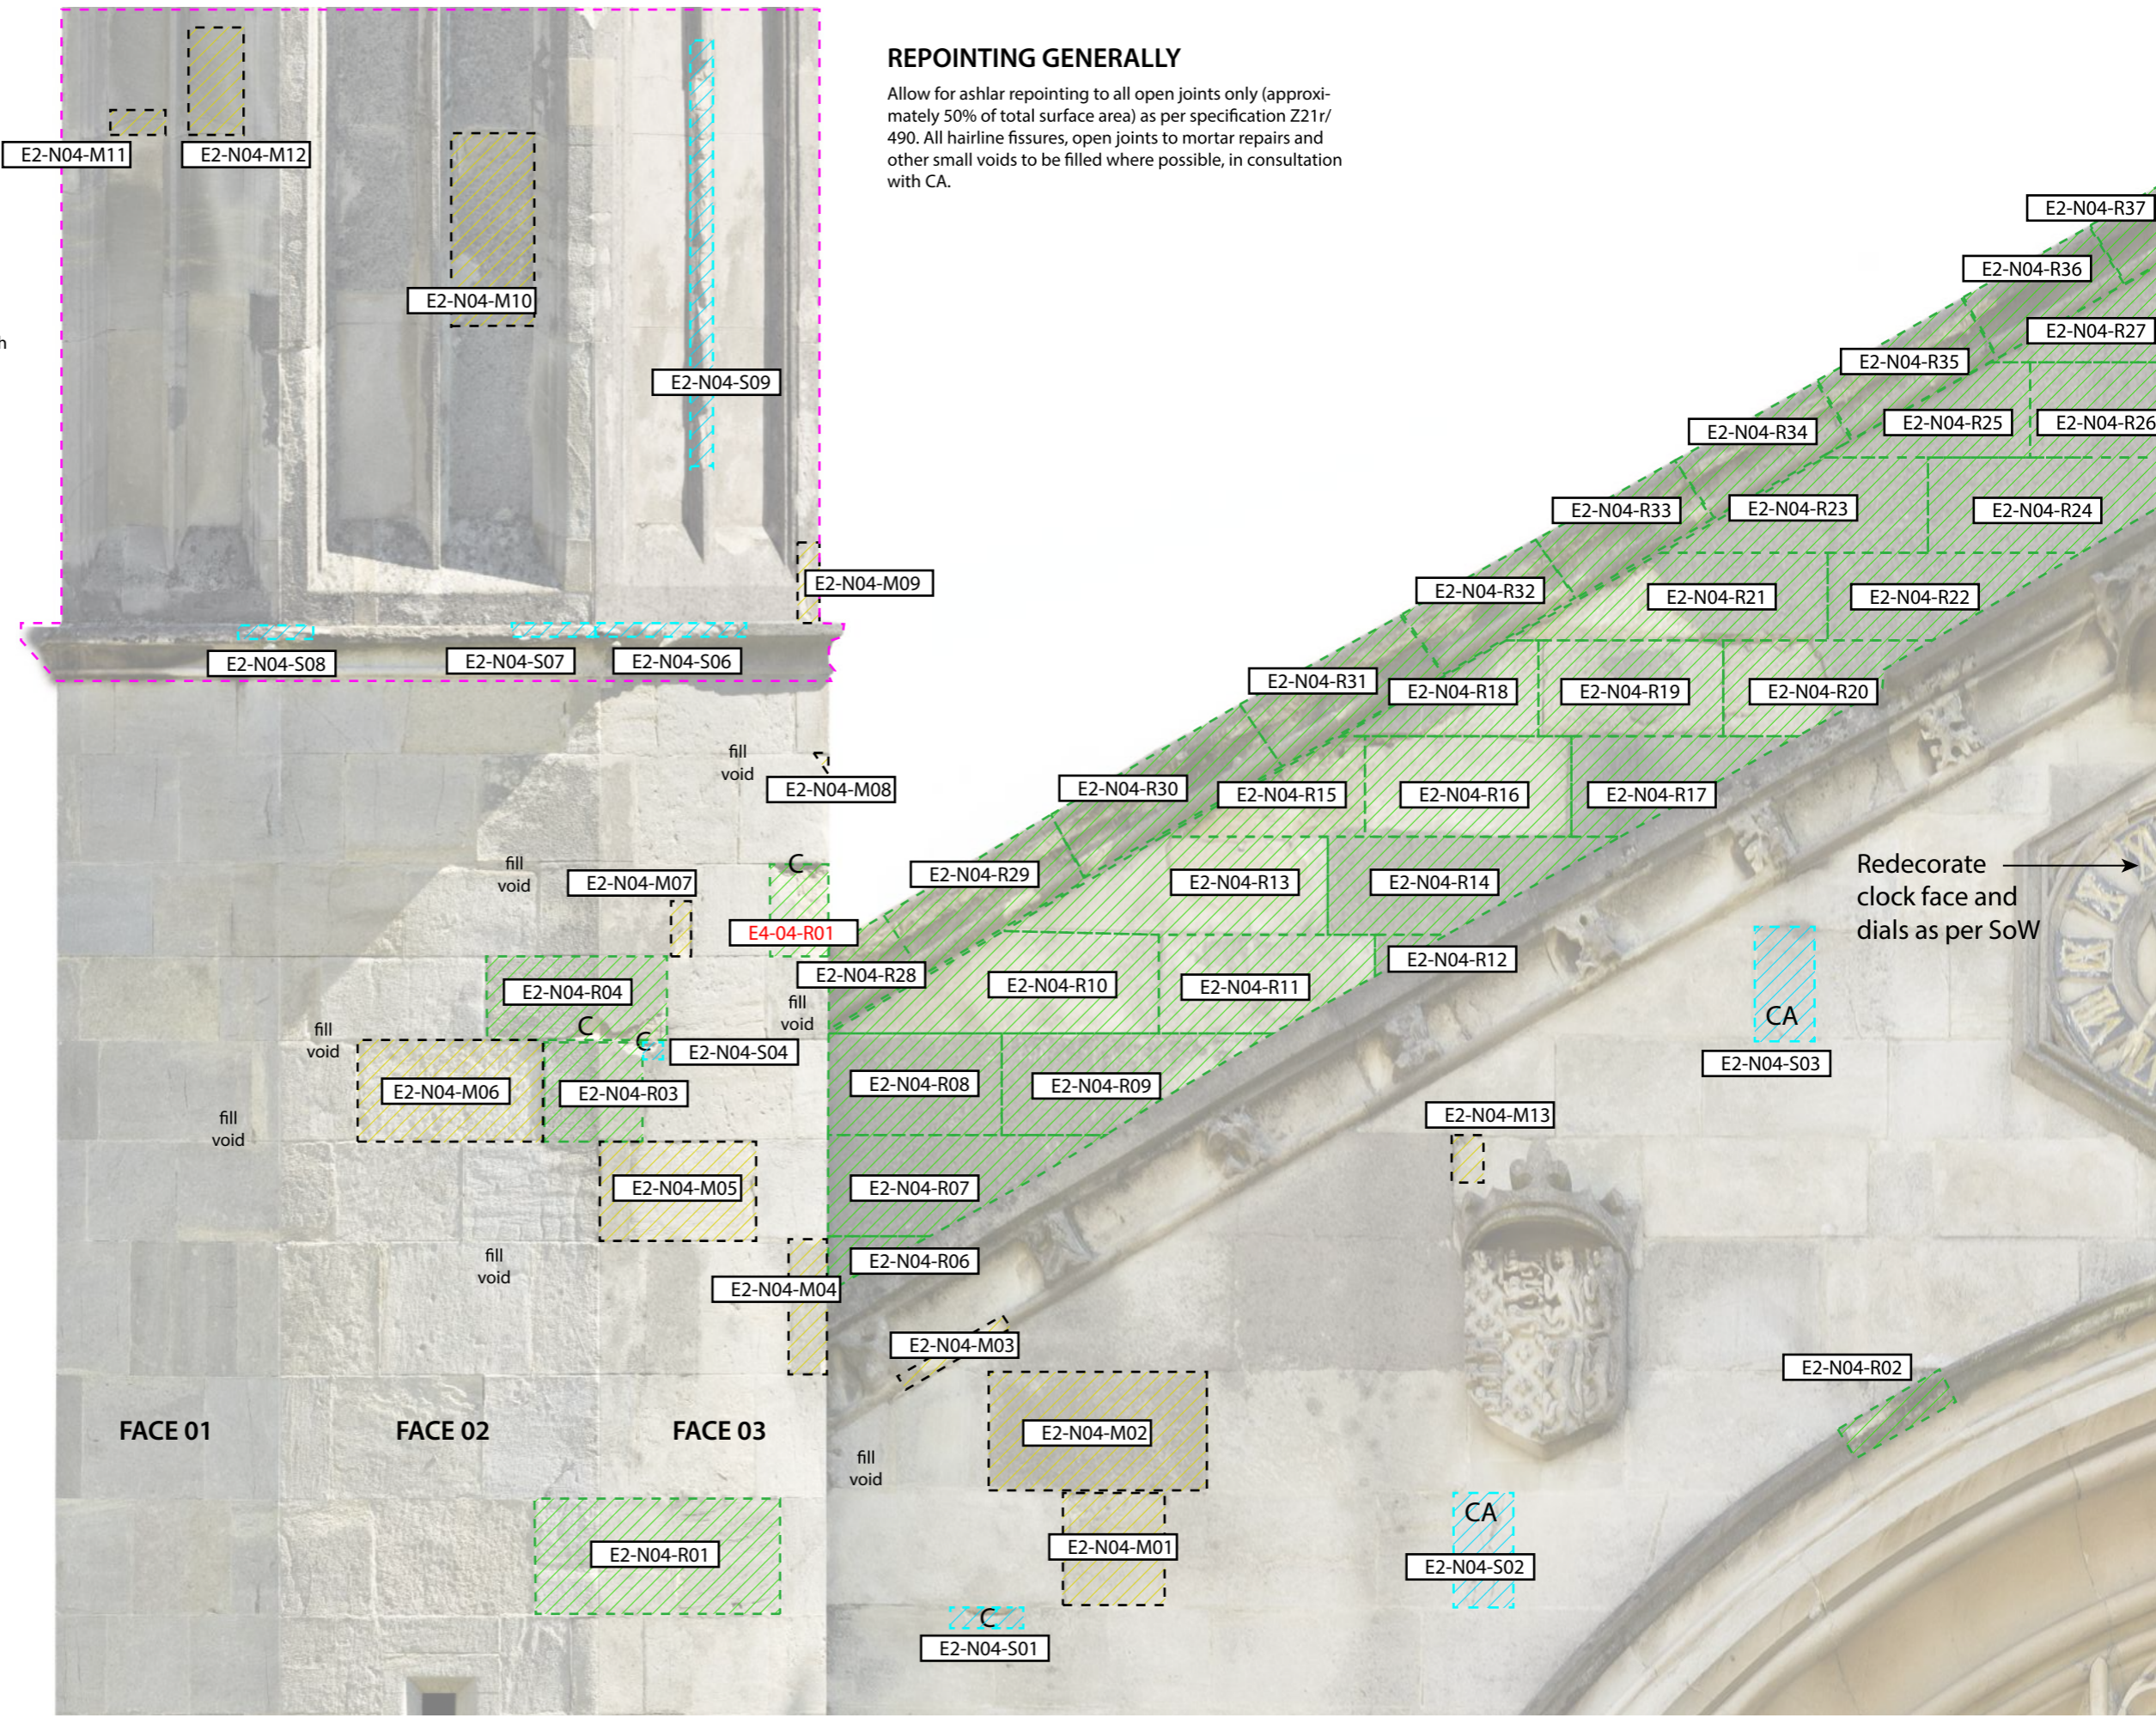
Drawing 043-E2-N04-02
Issue date Oct 2016
FOR TENDER
Scale 1:10@ A1

St. Katharine's - The Danish Church in London
EXTERNAL MASONRY REPAIR
