TITLE:  
**Generic Roof Repair Details**

PROJECT:  
**Project No:11581  
Kidderpore Avenue**

DRG NO.    REV.  
**9100-DRG-00YY-DE011    A**

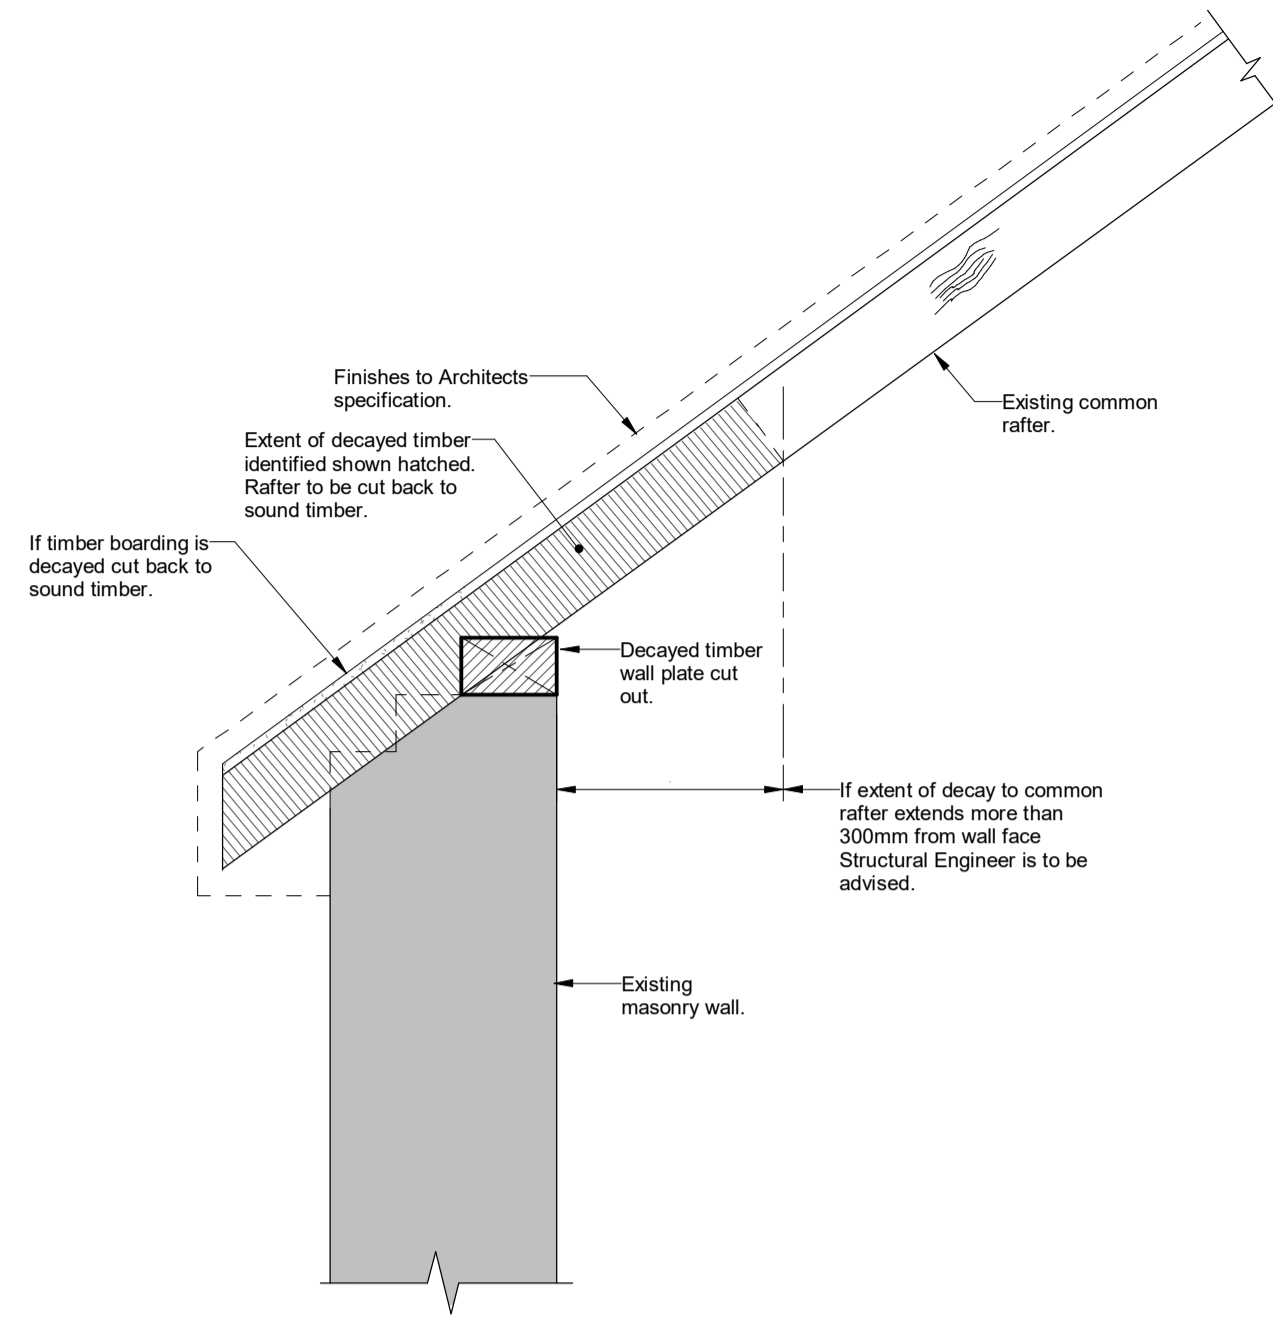
**Detail 1: Decayed Common Rafter and Wall Plate Existing Detail**  
scale 1 : 10
