The Kings College Campus on Kidderpore Avenue, Hampstead,
London, NW3 7ST

METHOD STATEMENT FOR Portico dismantle, storage & reassembly

Kiddepore Ave - Portico Outline scaffold sketch

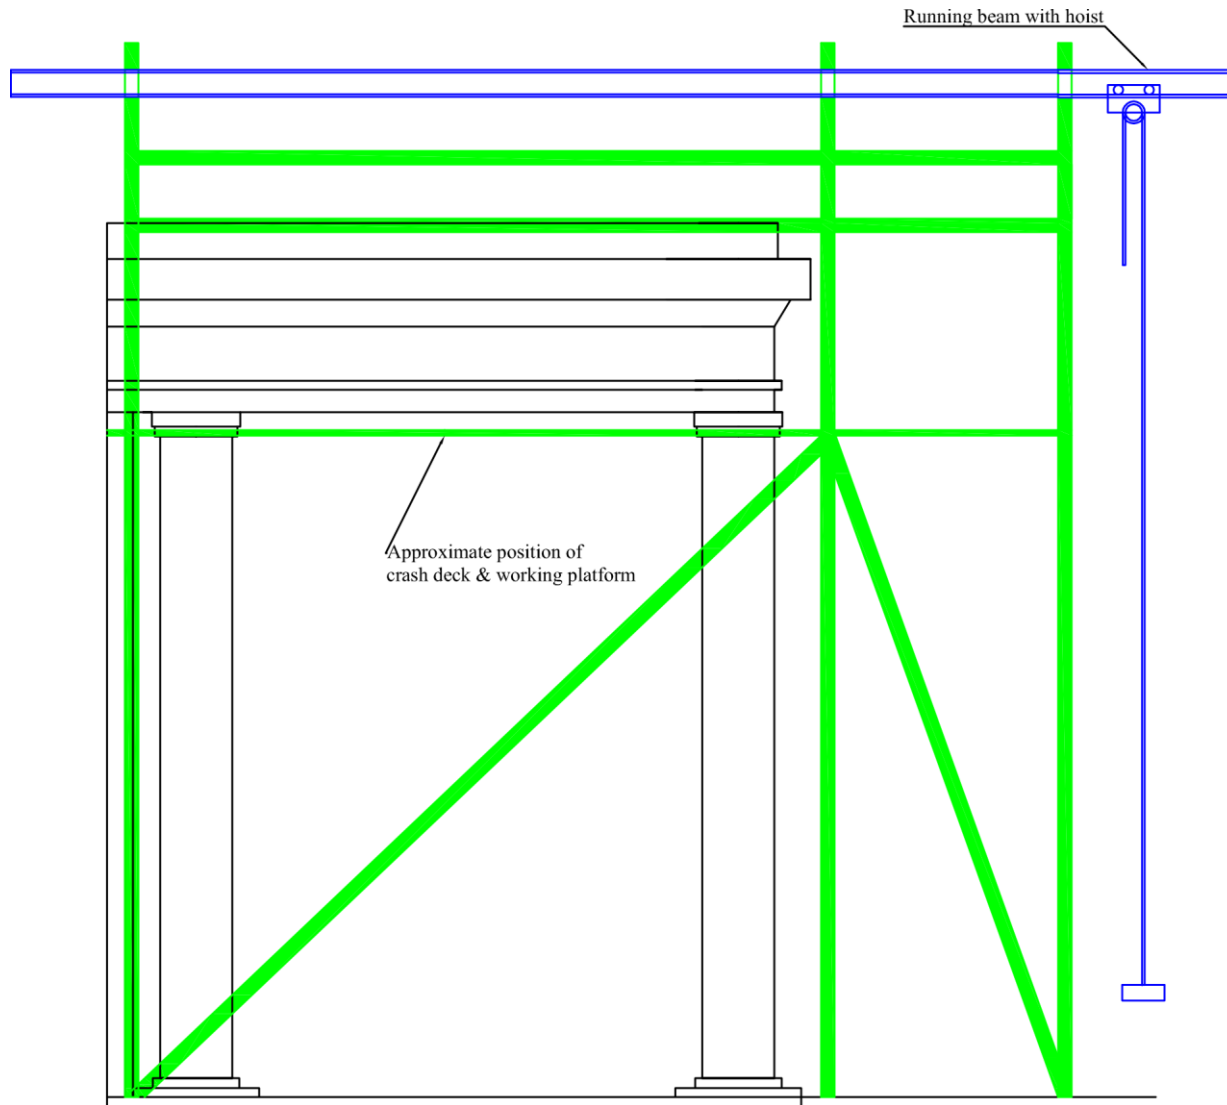
Drawing No:
002

Erect scaffolding to allow full clear access to all parts of the portico. There will be a handrail fitted to the perimeter of the top lift. The top lift position will be just below the column capitals which will also incorporate a crash deck to prevent stones or operatives accidentally falling through the roof structure (see appendix A – Sketches)

Crash deck installed below the roof structure.
Timber boards on the ground below the working area.

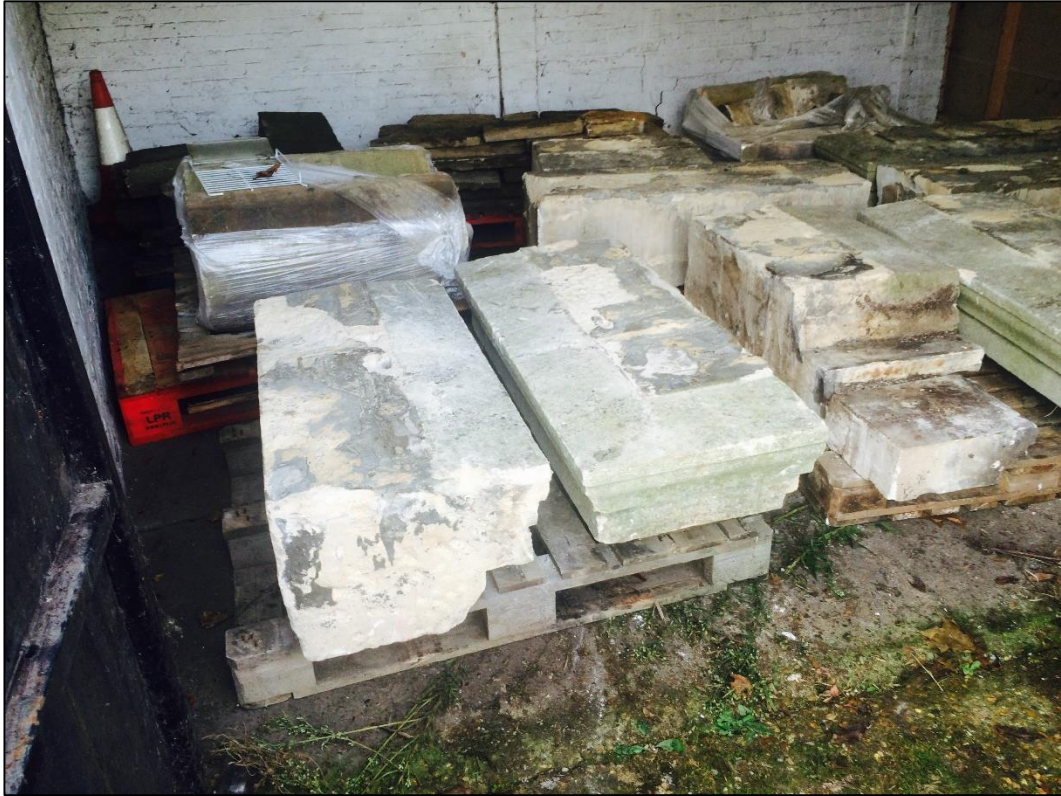
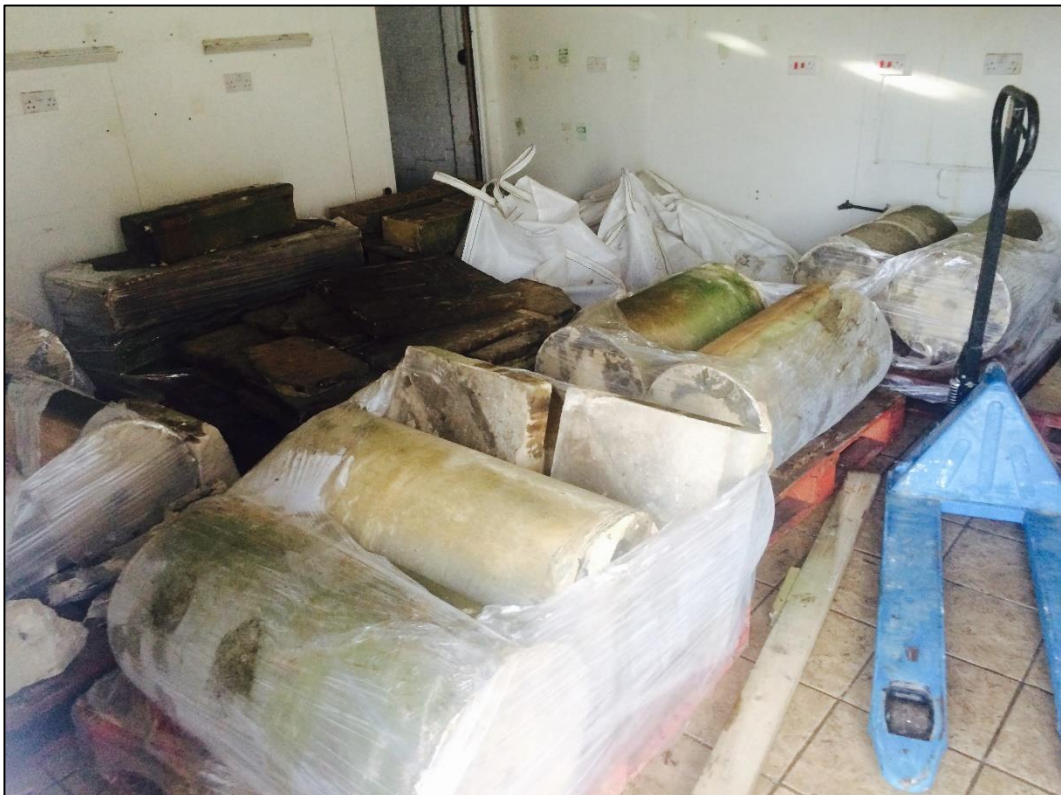
Chapel Portico stored at **Barwin** storage yard,
rear of 61-89, Front Lane, Cranham, Essex, RM14 1XL
Photos as of 7th December 2016

All stones will be wrapped in a geotextile material prior to being wrapped in bubble wrap & finally being palletised for removal from site to Barwins secure storage facility.
