P01	Planning issue	26.01.2017	APa	MLu
Rev	Description	Date	Drn	Chk
Status	5			
PLANNING				
Client				
Build	8			
Dana	0			
Projec	rt -			
	Refurbishmen ercy Street	ıt

AC UNITS as PROPOSED

Project No. Drawing No. 16006 PCY-PL-015 Scale @ A3 Drawn By 1:25 (UNO) APa

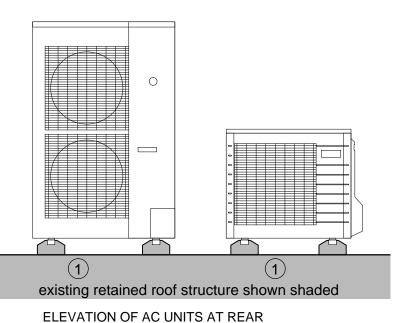
CROSS-SECTION THROUGH AC UNIT AT REAR

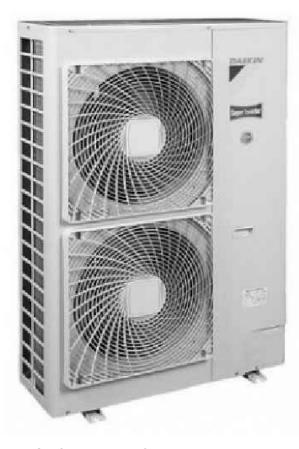
IMAGE OF TALLER AC UNIT AT REAR

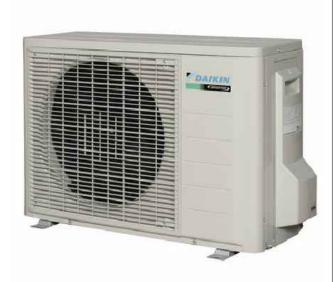
IMAGE OF SMALLER AC UNIT AT REAR
