P03	Planning	27.01.2017	APa	MLu	
P02	Planning	23.12.2016	APa	MLu	
P01	Planning	25.11.2016	APa	MLu	
Rev	Description	Date	Drn	Chk	
Status					
PLANNING					
Client					
Build8					
Project					
Shop Refurbishment 15 Percy Street London W1T 1DS

Drawing GROUND FLOOR PLAN as PROPOSED

Project No. Drawing No. Revision 16006 PCY-PL-008 P03 Scale @ A3 Drawn By 1:100 APa

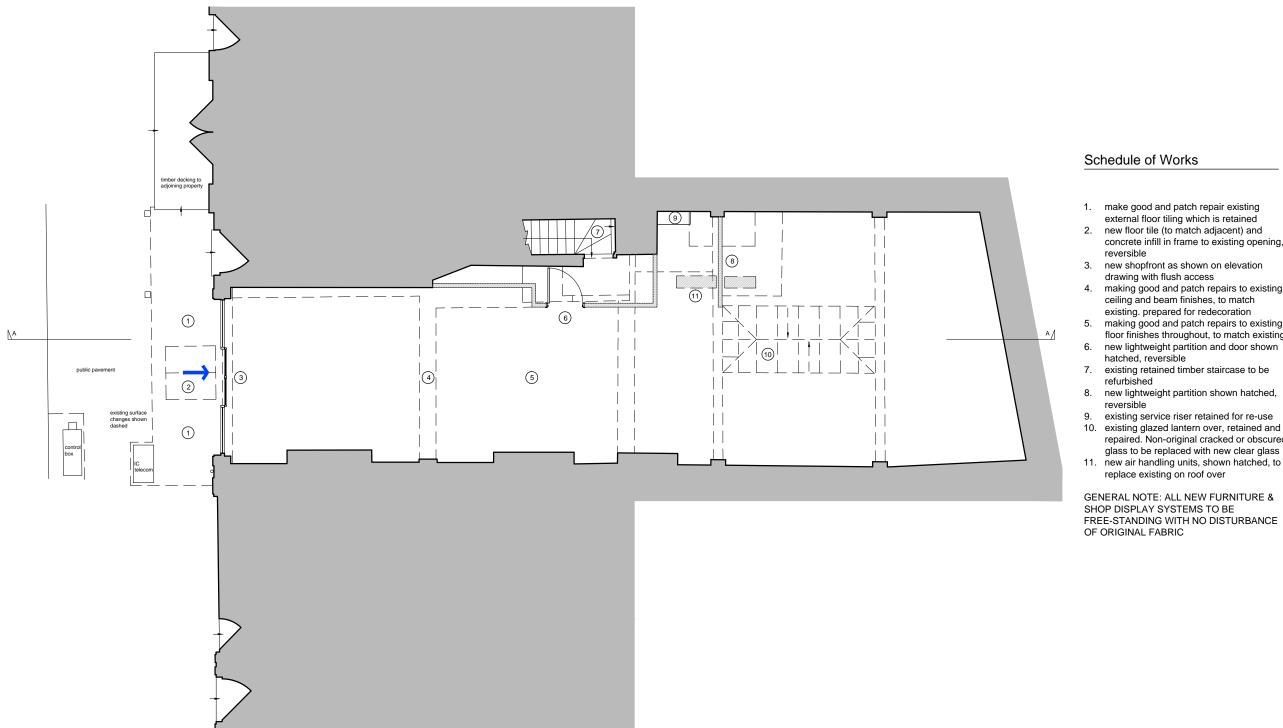
external floor tiling which is retained concrete infill in frame to existing opening,

4. making good and patch repairs to existing ceiling and beam finishes, to match existing. prepared for redecoration 5. making good and patch repairs to existing floor finishes throughout, to match existing

new lightweight partition shown hatched,

existing service riser retained for re-use 10. existing glazed lantern over, retained and repaired. Non-original cracked or obscured glass to be replaced with new clear glass 11. new air handling units, shown hatched, to

FREE-STANDING WITH NO DISTURBANCE
