Title: NUMBERING MARK UP OF WESTERN EXTERNAL STAIRCASE
Drawing number: 2332-24-211-01
Date: Dec 2016

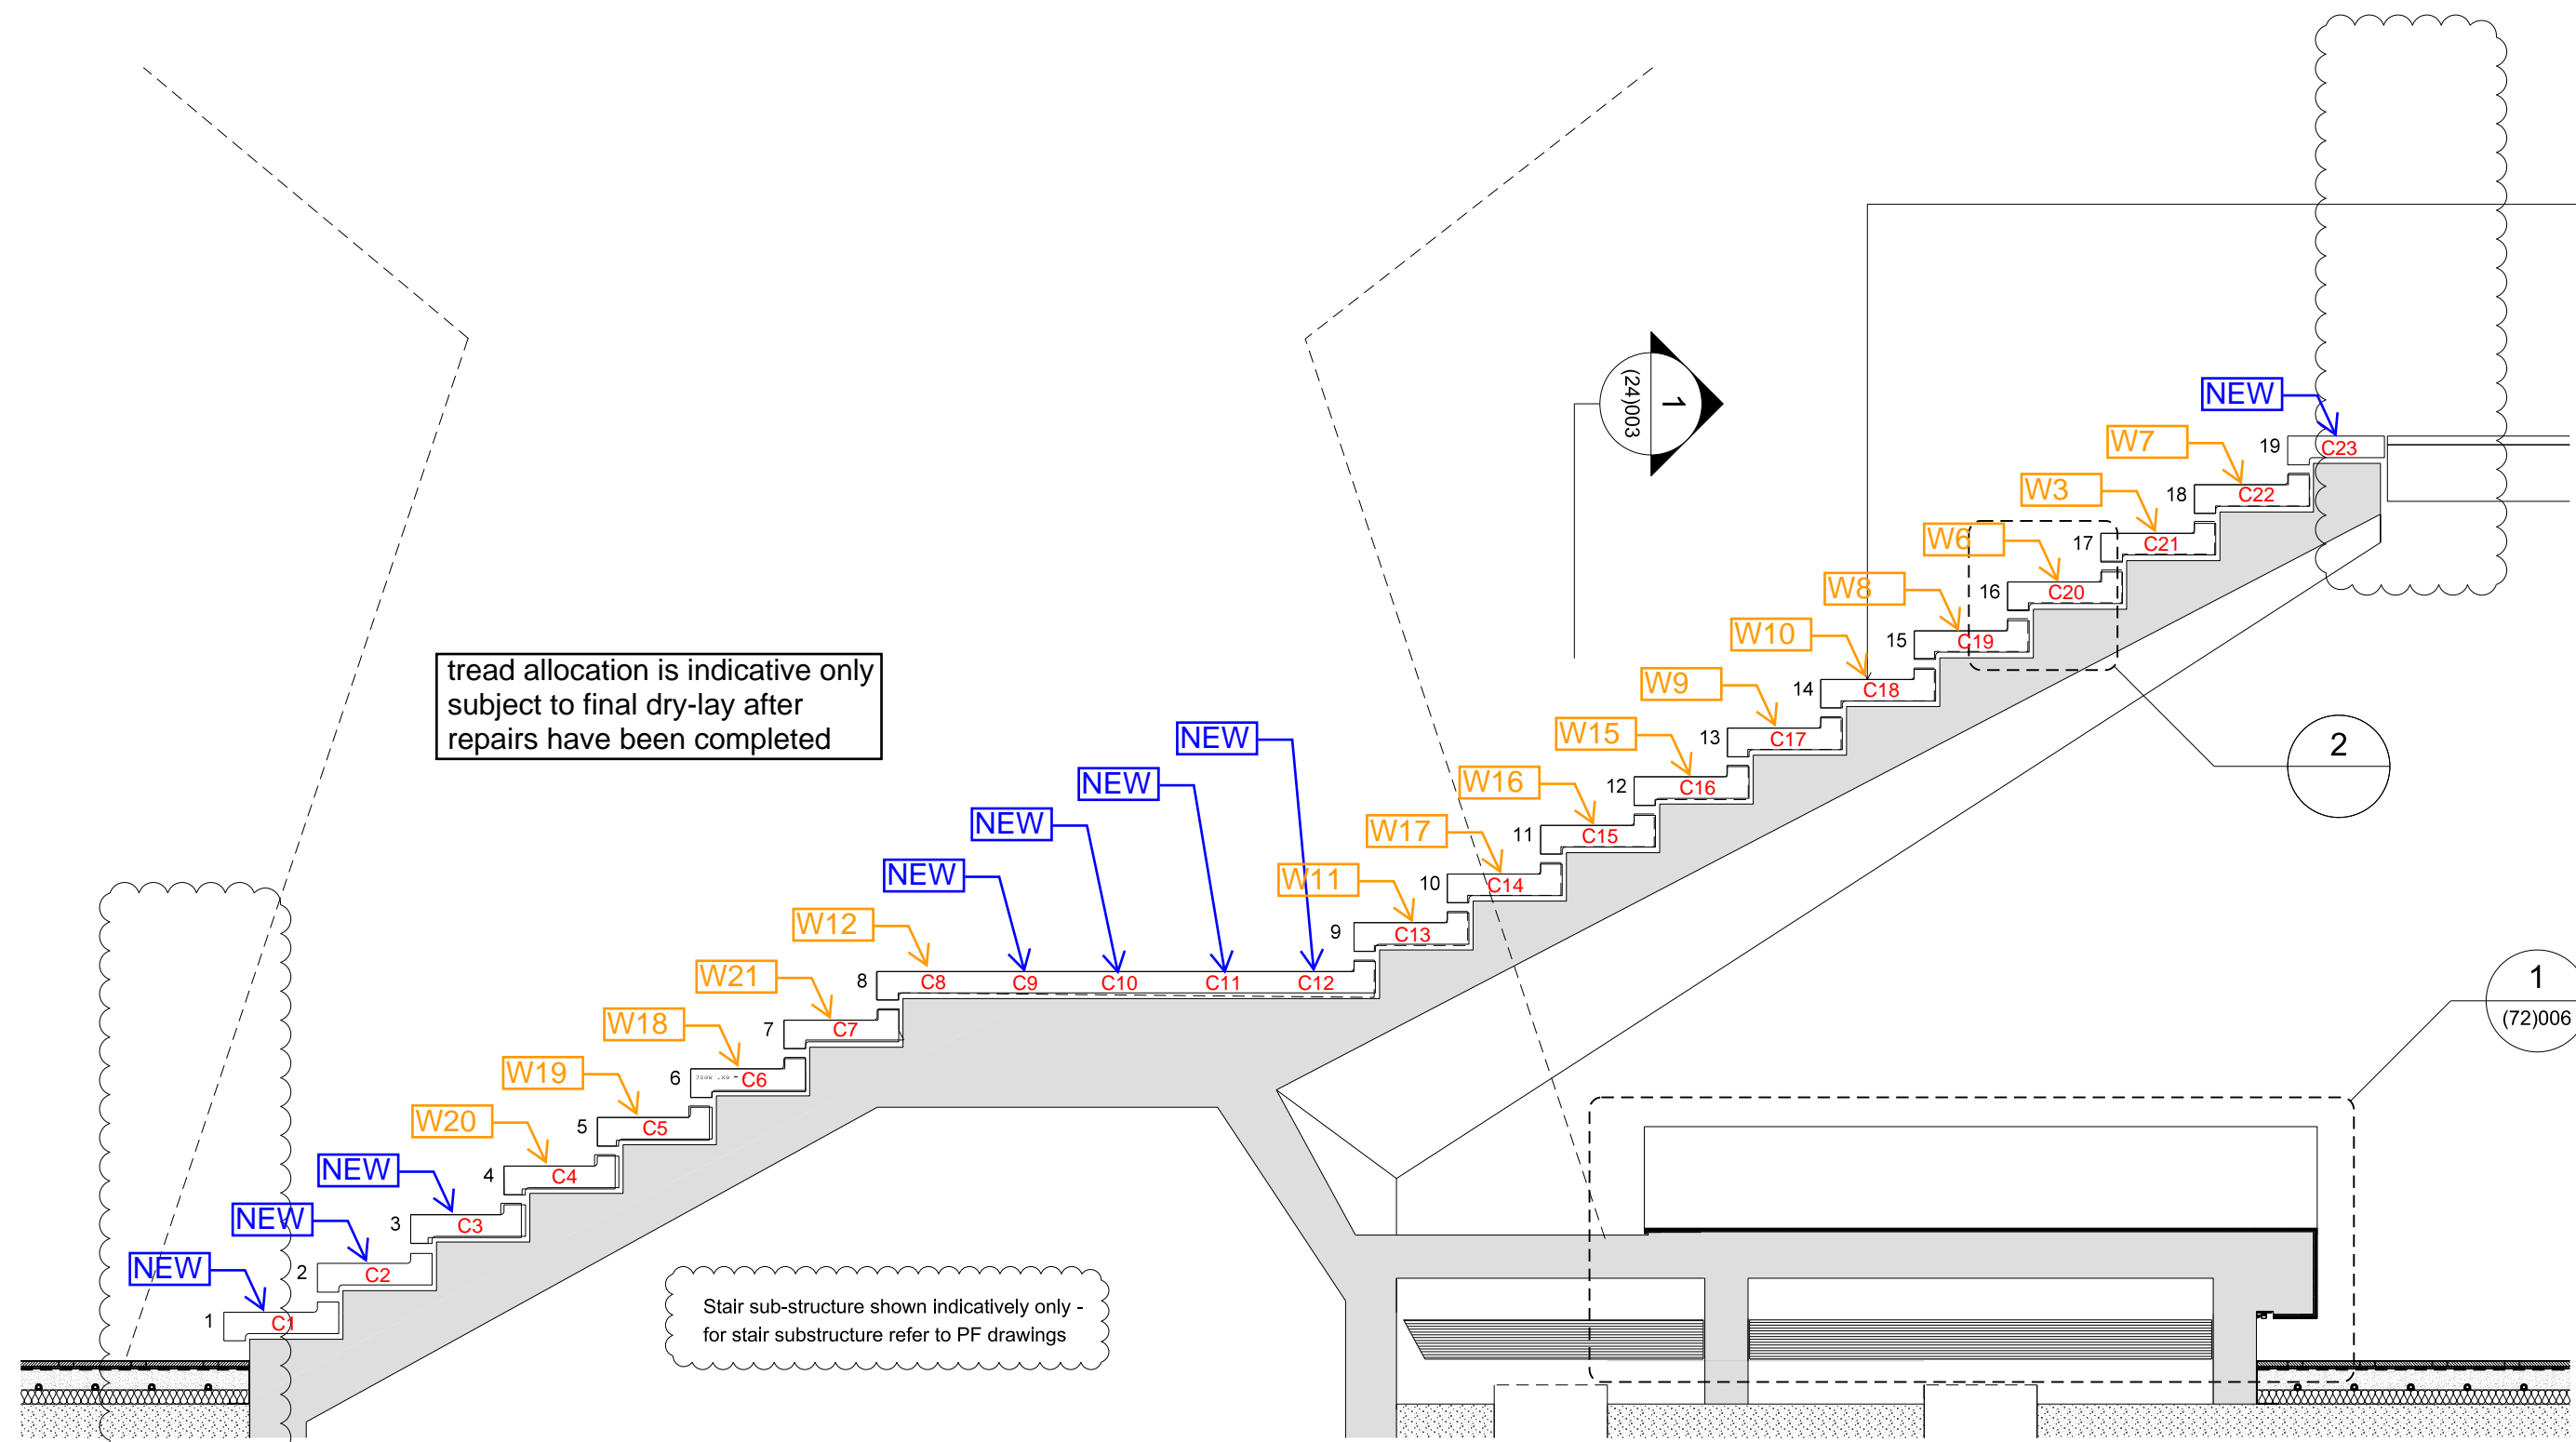
1 WESTERN EXTERNAL STAIRCASE 1:25
SCOPE OF REFURBISHMENT

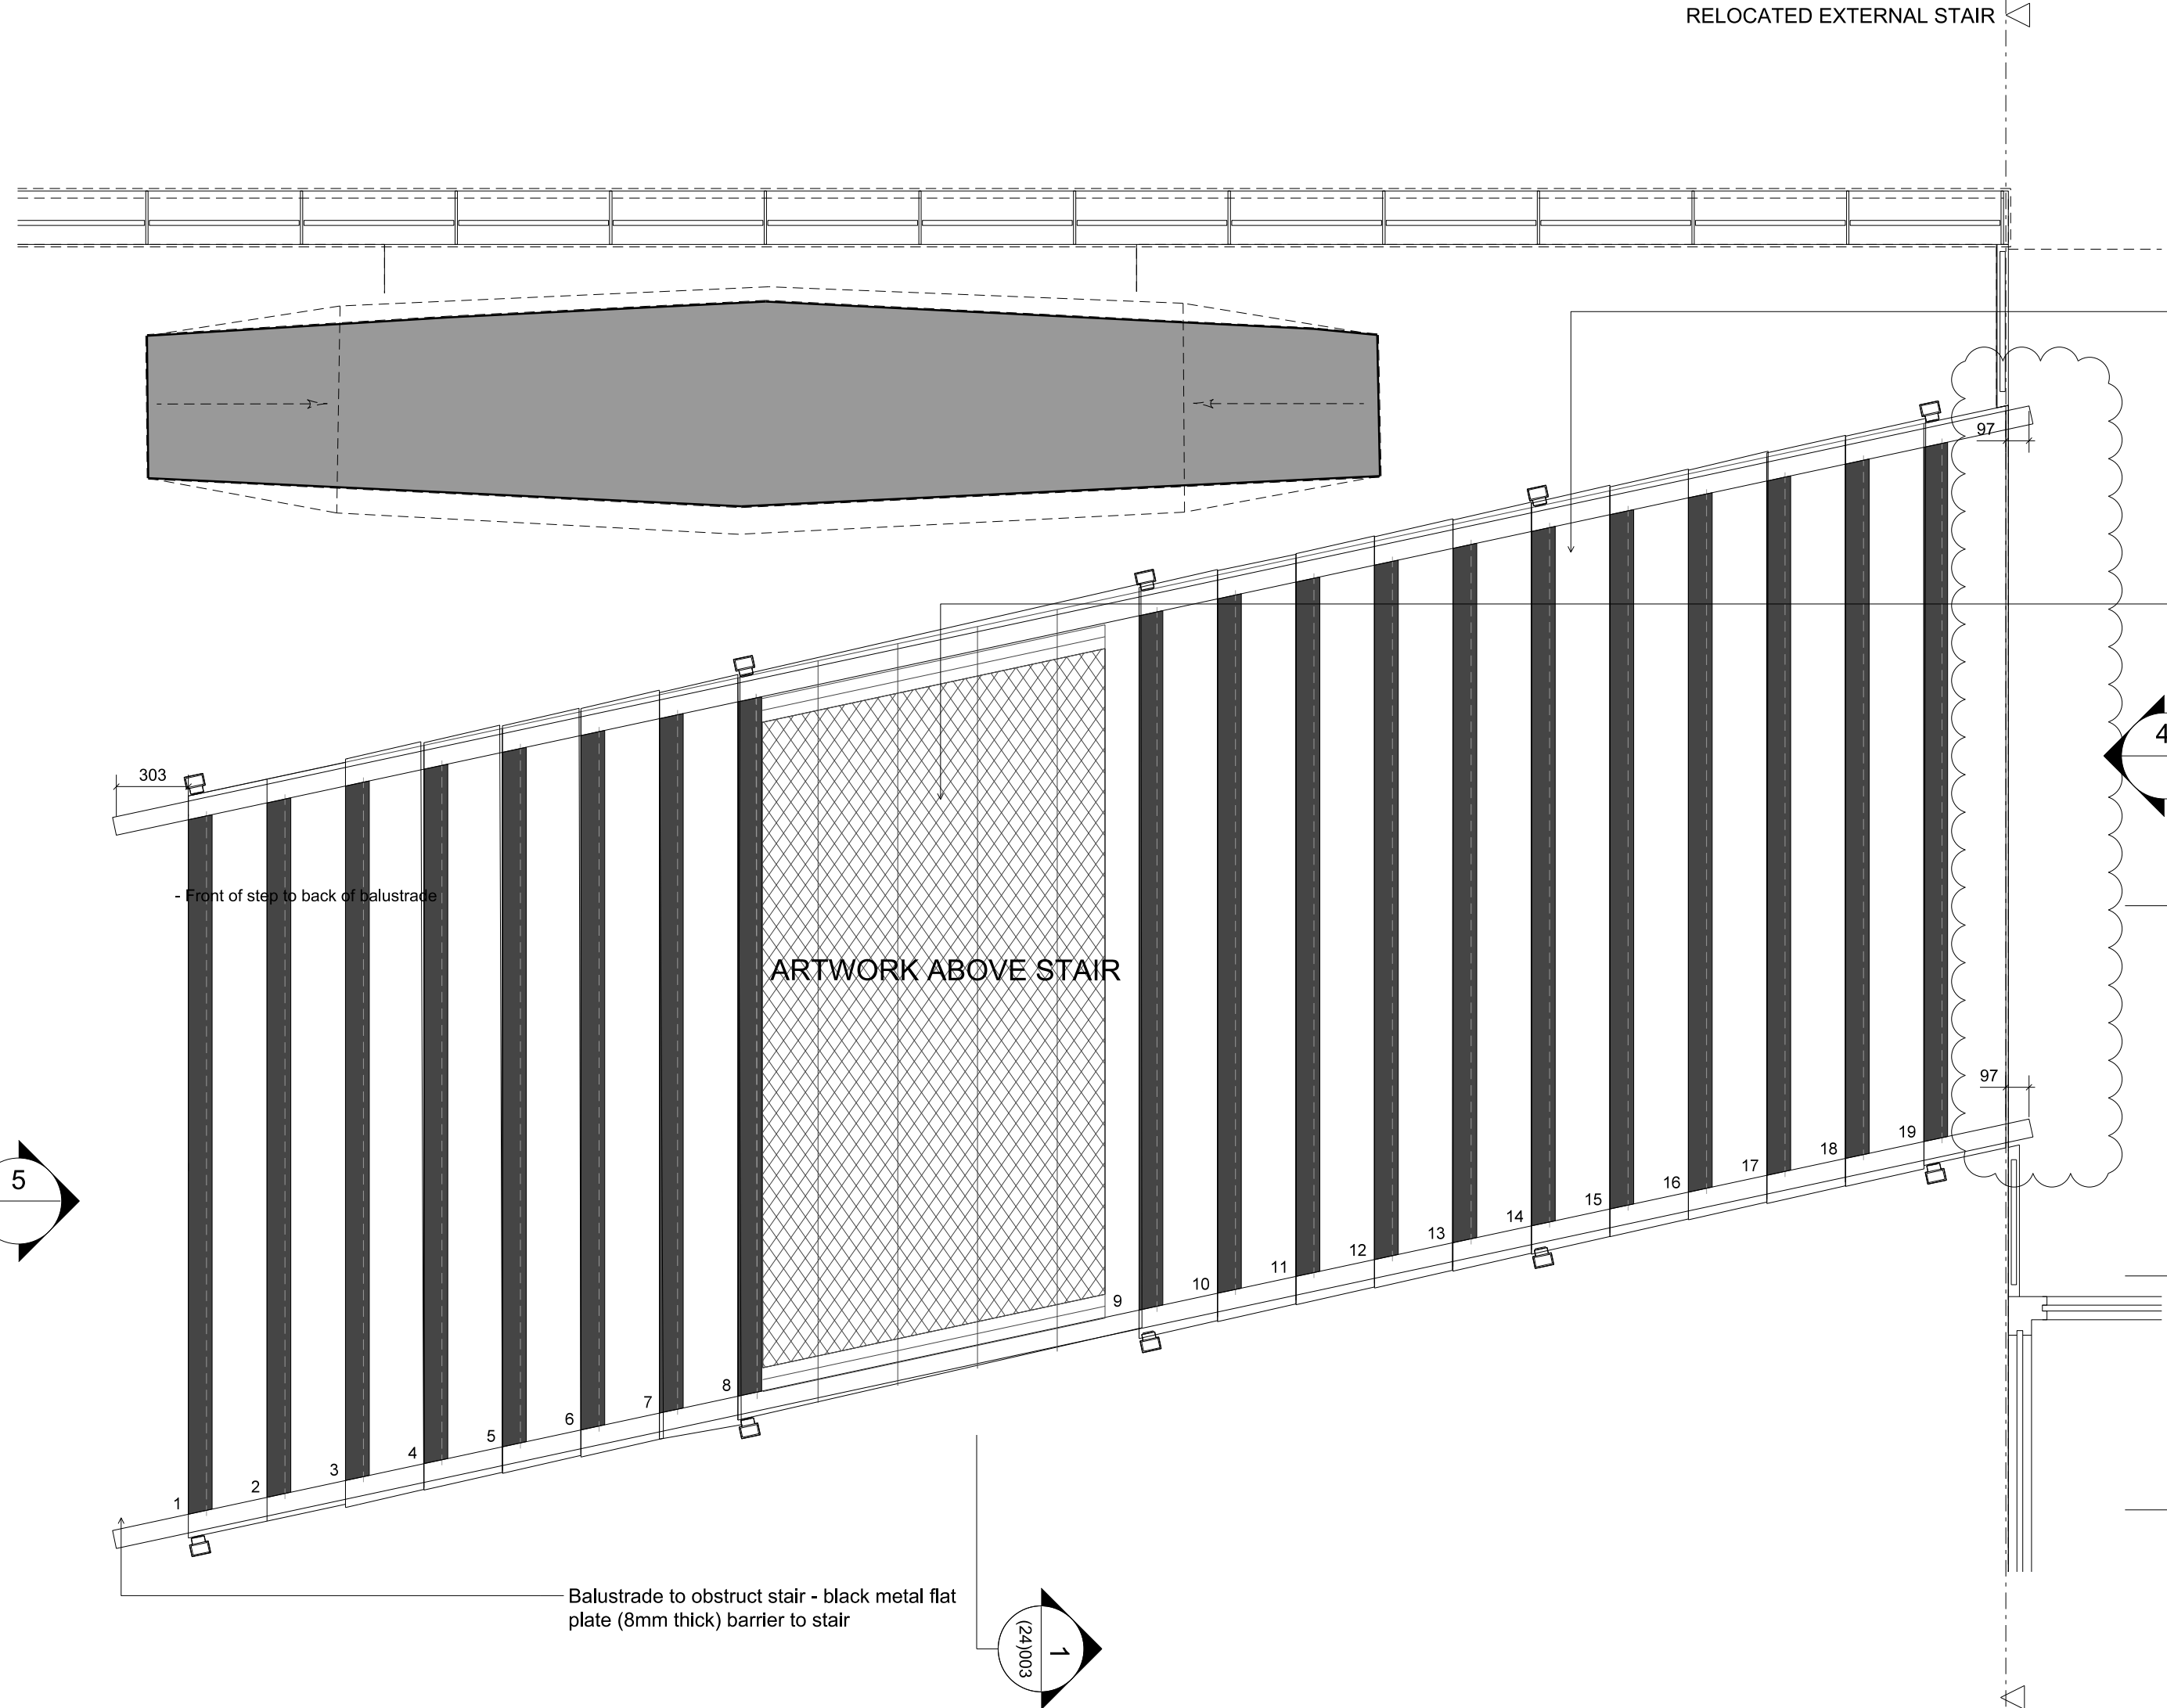
3 WESTERN EXTERNAL STAIRCASE 1:25
PROPOSED PLAN

Existing treads shown are taken from PC 3d survey in the same sequence (as agreed with BMCE 28/4/16) and are shown indicatively only. PAYE to allocate retained treads and propose locations for replacement/new treads

C&P recommend that top treads are new (replaced) to ensure that upper tread is consistent and parallel to slab (at 10mm). C&P recommend that 1st step is new (replaced) tread to maintain offset dim shown in C&P drawings.

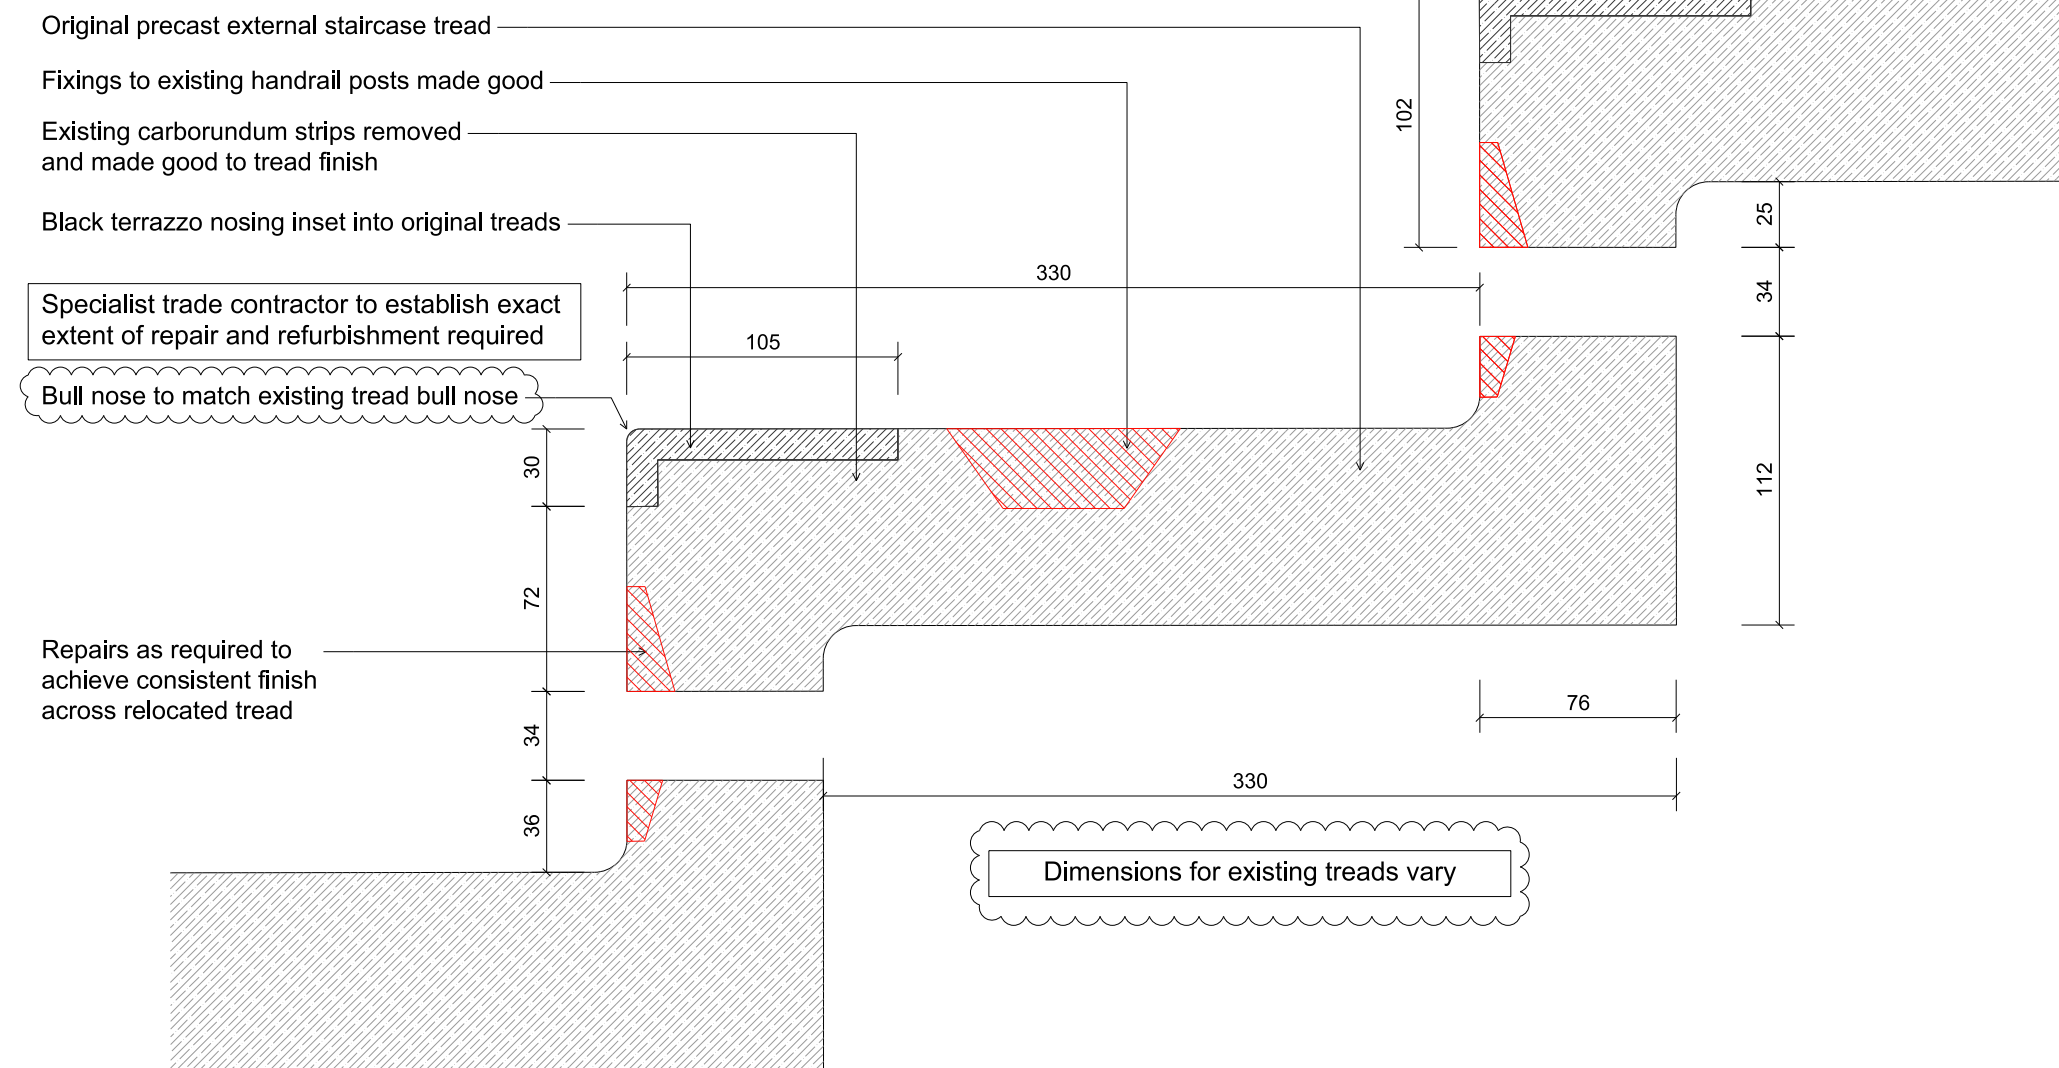
2 WESTERN EXTERNAL STAIRCASE 1:2
SCOPE OF REFURBISHMENT

Existing treads shown are taken from PC 3d survey in the same sequence (as agreed with BMCE 28/4/16) and are shown indicatively only. Treads shown do not reflect the location or quantity to be re-used.

Existing engraved pattern to landing slabs retained and made good to comply with BS 8300, holes to be not greater than 13mm wide
