Basement Impact Assessment

1A St Johns Wood Park
Camden
NW8 6NE

Mike Ofori
Liv International

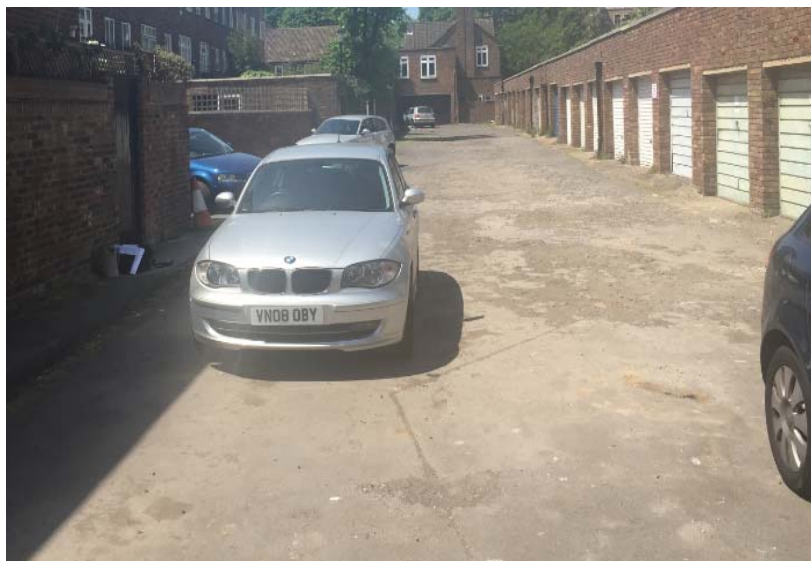
There are rainwater pipes which discharge below ground level.

Figure 6: Hard standing area

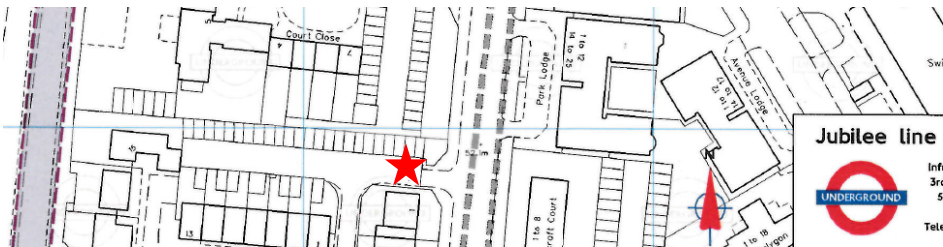
<p><i>Figure 7: Extract from LUL map showing proximity of rail lines</i></p> <p>LUL have been informed of this proposal (e-mails are appended). An initial response from them has confirmed that a correlation survey will be required. The design team should proceed with this at detailed design stage and follow any subsequent procedures (e.g. issue of Record of Commercial Details) considered applicable by LUL.</p>
<p>UK Power Networks</p>	<p>There are no significant items of electrical infrastructure (such as pylons or substations) in the immediate vicinity.</p>

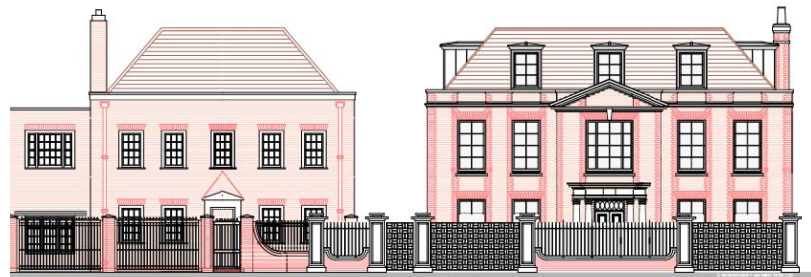
The movement assessment has used empirical means as set out in CIRIA C580 Embedded Retaining Walls: Guidance for Economic Design. An assessment has been done for the closest building; buildings further away will be affected to a lesser extent. The ground movement assessment calculations are appended. These are calculated in relation to 1 St Johns Wood Park, which is the closest habitable building to the development.

Figure 12: Front elevation of 1 St Johns Wood Park and 1a St John's Wood Park (left and right respectively)

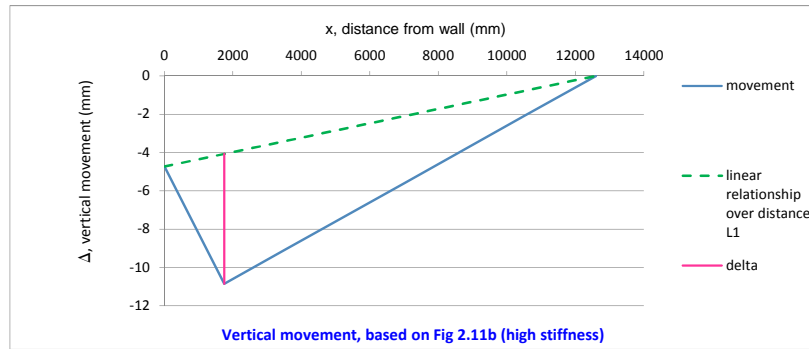
Relative vertical movement as defined by Figure 2.18 (a) in CIRIA C580

Δ = -6.8 mm Δ/L = -0.052%

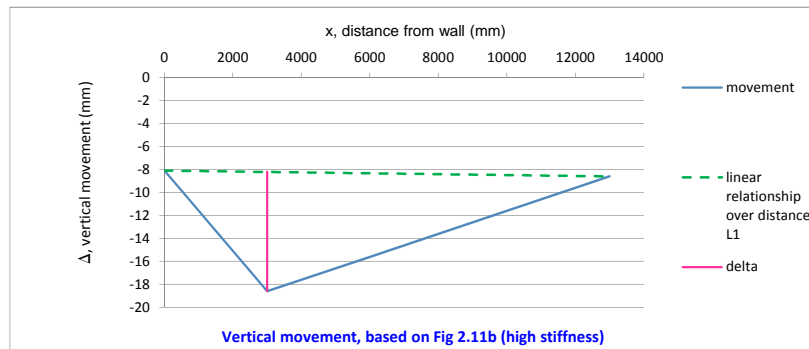
Relative vertical movement as defined by Figure 2.18 (a) in CIRIA C580

$\Delta = -10.4$ mm $\Delta/L = -0.080\%$

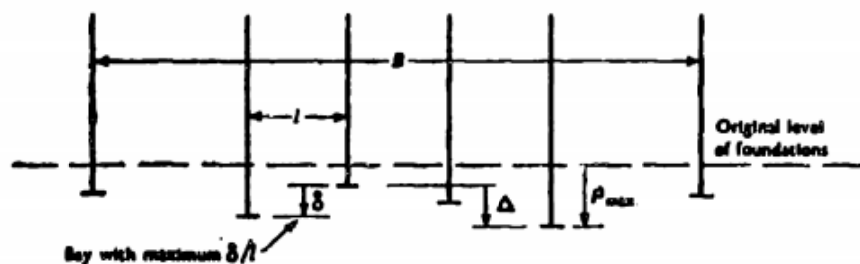
Figure 2.1 – Diagram illustrating the definitions of maximum angular distortion, δ/l , maximum settlement, ρ_{max} , and greatest differential settlement, Δ , for a building with no tilt (Skempton and MacDonald, 1956).

The differential settlement is defined as the greatest vertical distance between two points on the foundation of a structure that has settled, while the angular distortion, is the difference in elevation between two points, divided by the distance between those points.
