Project 32 Percy Street, London W1T 2DE
Project no. 0341
Subject Ground Movement Assessment (GMA)

| Status | Date | Ref | Issued by | Checked by | Approved by |
|---|---|---|---|---|---|
| Ground Movement Assessment (GMA) – supporting design note | 09/12/16 | 0341-TN-01-00 | Silvia Autuori | Alex Nikolic | Tony Suckling |
| Revision 02 – includes SSI review and revised assessment | 26/02/17 | 0341-TN-01-02 | Silvia Autuori | Alex Nikolic | Tony Suckling |

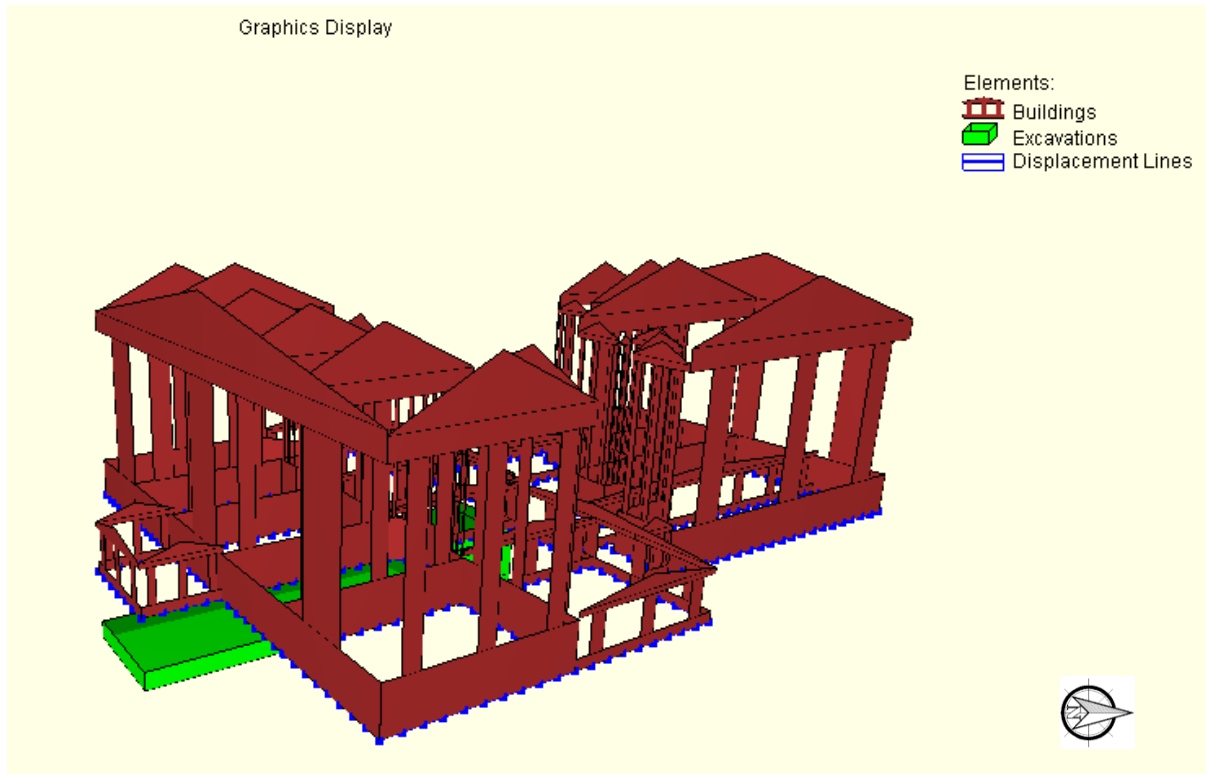
A series of three dimensional models of the proposed scheme have been developed in Pdisp and Xdisp and have been combined by means of superposition, in order to represent the various ground displacement fields related to the key stages of the proposed works. An indicative plot of the analytical model is presented below in Figure 1.

Figure 1 - Indicative plot of the three-dimensional analytical model using the Oasys software suite (soil removed for clarity of presentation).

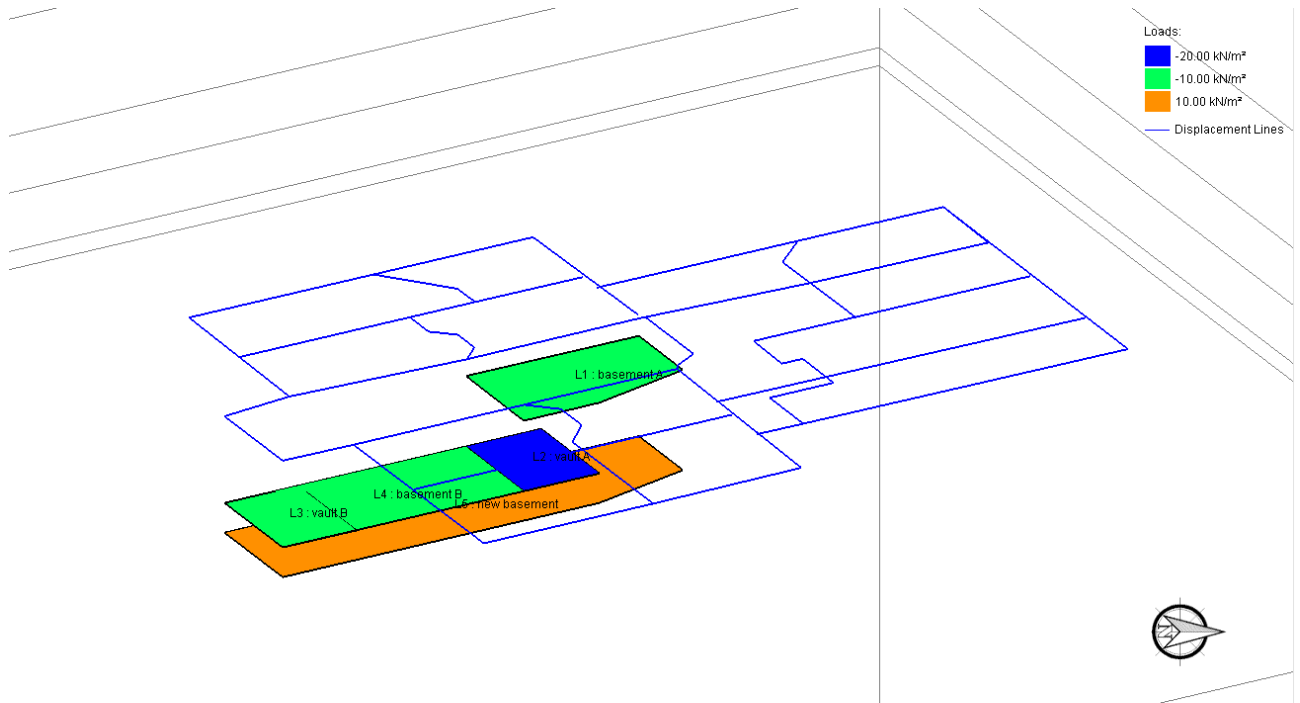
The proposed building loadings are applied upon completion of the development (as presented in Figure 2). This phase of the assessment is undertaken using Pdisp and taking into consideration the previously reported scenario covering both the demolition and excavation phases of the project. The loading applied for ground movement and impact assessment purposes comprises an average representative UDL of 10kPa. This phase of the assessment assumes long-term (drained) conditions.

Figure 2 - Long term phase loading scheme (3D perspective view; green shading represents existing slab unloading based on average UDL; blue shading represents existing vaults unloading based on average UDL; orange shading represents proposed loading due to new basement based on average UDL; blue *displacement lines* correspond to façade lines of interest captured within the analysis).

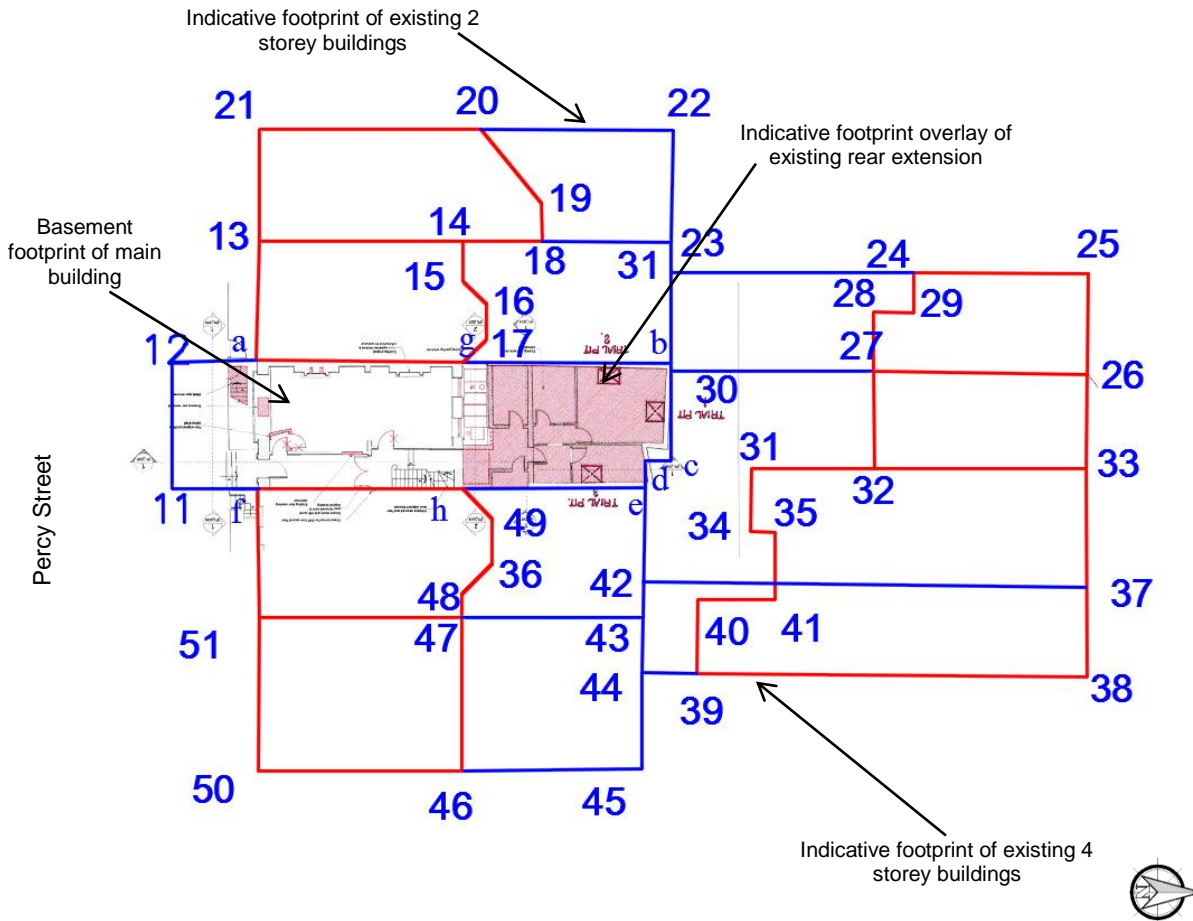
Each wall has been assumed to behave as an equivalent beam subject to a bending and extension/compression deformation mechanism, based on the evaluated *greenfield* ground movement, as outlined previously.

Figure 3 – Simplified scheme and nomenclature for building façade/masonry wall elements (node/intersect reference numbers denoted)

Table 3 – Evaluated damage categories for demolition, excavation and long term condition stages (refer to Figure 3 for wall nomenclature)

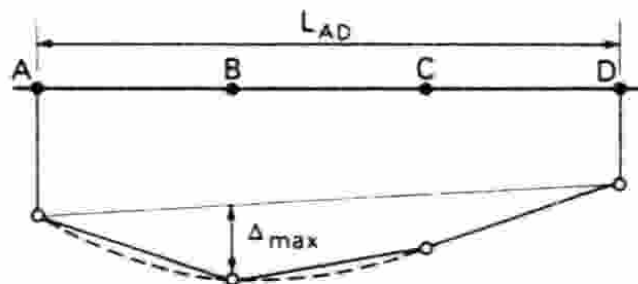
Tensile strains induced within the building masonry walls have been evaluated based on the deflection ratios Δ/L estimated from the analyses. The assessment considers the well-established Burland (1997) damage classification method, as presented and summarised in Figures 4 and 5. This method involves a simple but robust means of assessment, which widely adopted and is considered to comprise an industry standard/best practice basis for impact assessments of this typology.

Figure 5 – Definition of relative deflection Δ and deflection ratio Δ/L

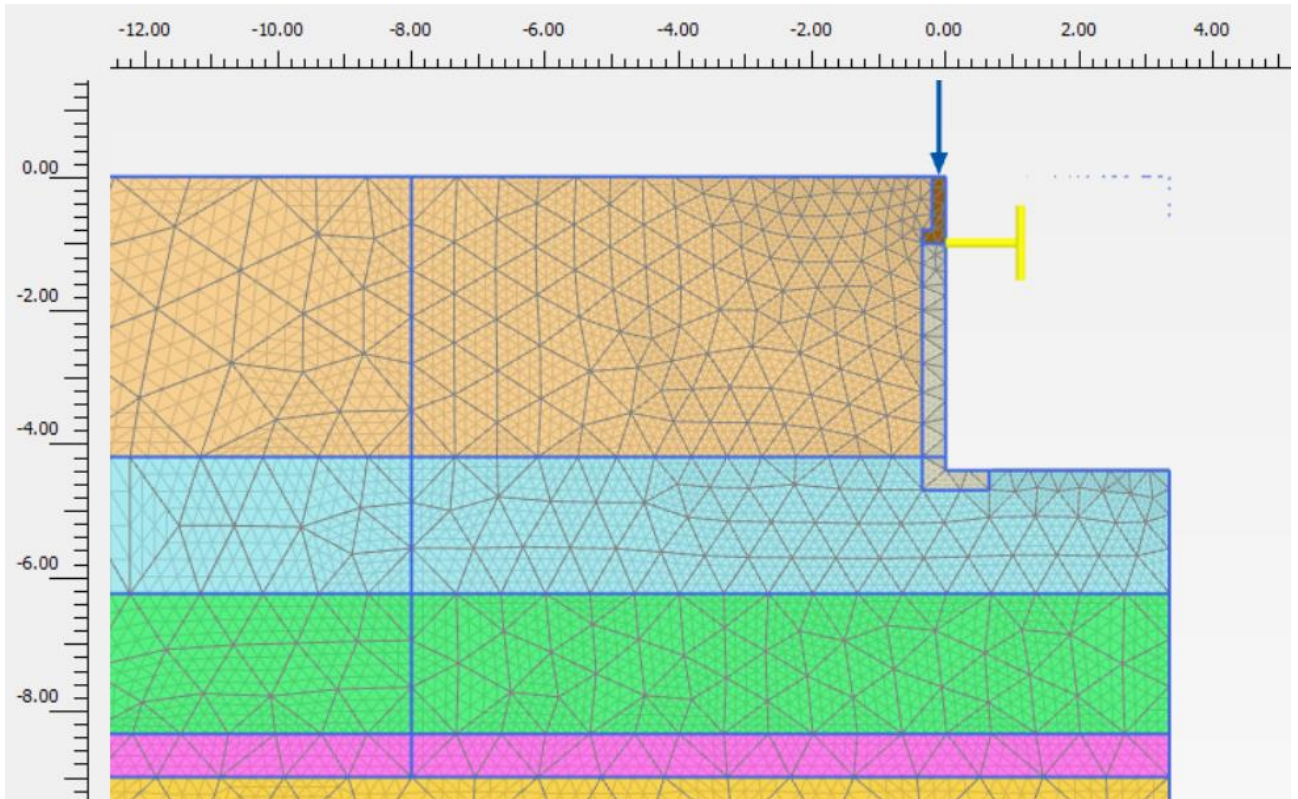
Half of the cross-section has been modelled, in view of the broadly symmetric geometry. A view of the Plaxis 2d model is presented in Figure 6. All strata have been modelled as linear elastic perfectly plastic (Mohr-Coulomb failure criterion) materials, using the strength and stiffness properties summarised in Table 1.

The analysis simulates the proposed excavation works. The mass concrete underpinning is wished-into-place, assuming that means and methods implemented will prevent/minimise ground movements during the underpin construction. A level of temporary props has been modelled at approximately 1m below ground level, with an assumed equivalent axial stiffness of 50,000kN/m/m.

Figure 6 – Indicative view of the Plaxis 2d model

A finite element (FE) soil-structure interaction analysis has been carried out considering a representative cross-section through the northern part of the site area, in which it is proposed to excavate from approximately 0.6m to 4.2m below ground level, for the construction of the proposed basement. The aim of the analysis is to evaluate likely ground movements induced by the proposed excavation means and methods in the area surrounding the site, and in turn indicatively confirm the adequacy of the CIRIA C580 horizontal ground movement profile adopted in the method 1 type of assessment presented in the previous section.

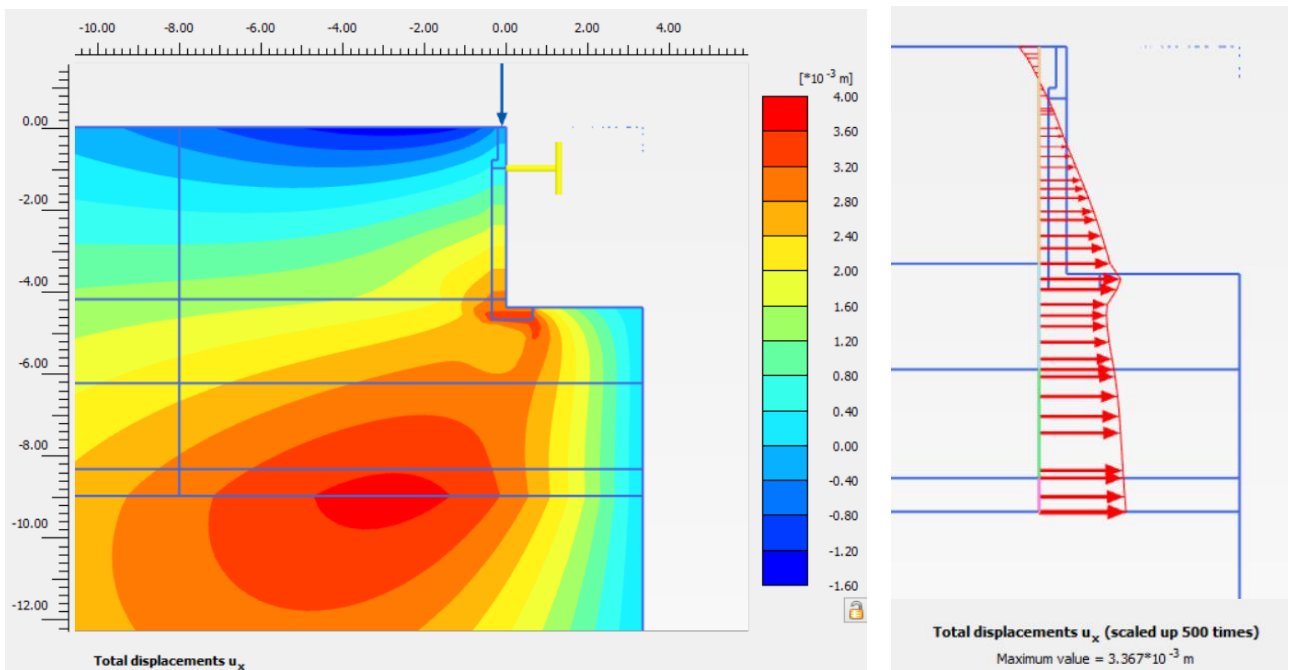
Horizontal ground movements arising as a result of the excavation works are presented in Figure 7. Displacements increasing with depth, up to approximately 4mm, are predicted. The maximum horizontal displacement at ground level, according to the CIRIA C580 diagram adopted, is 0.15% of the excavation depth, resulting in approximately 5mm. The use of the CIRIA C580 profile is deemed appropriate (and conservative), considering that all façades have been modelled at ground level as part of the Pdisp/Xdisp analyses. The vertical movement mechanisms are captured by the two alternative analyses described in section 2.1.

Figure 7 – Horizontal ground movements predicted in Plaxis 2d

A plane strain finite element analysis has been undertaken in order to validate the CIRIA ground movement profiles adopted as part of the method 1 assessment. The results from the analyses are presented in Table 3 (denoting the evaluated damage categorisation in accordance with the Burland criteria presented herein). All façades fall within Categories 0 and 1, representative of *Negligible* and *Very Slight* damage classification respectively.
