Project :	28 Belsize Lane
Title :	Roof Plan
Client :	Vivien & Edmund Bradley
Scale :	1:50 (A1), 1:100 (A3)
Date :	14. 03. 2017
Drawn By :	RM
Drawing :	2214_PL_035
Revision :	1

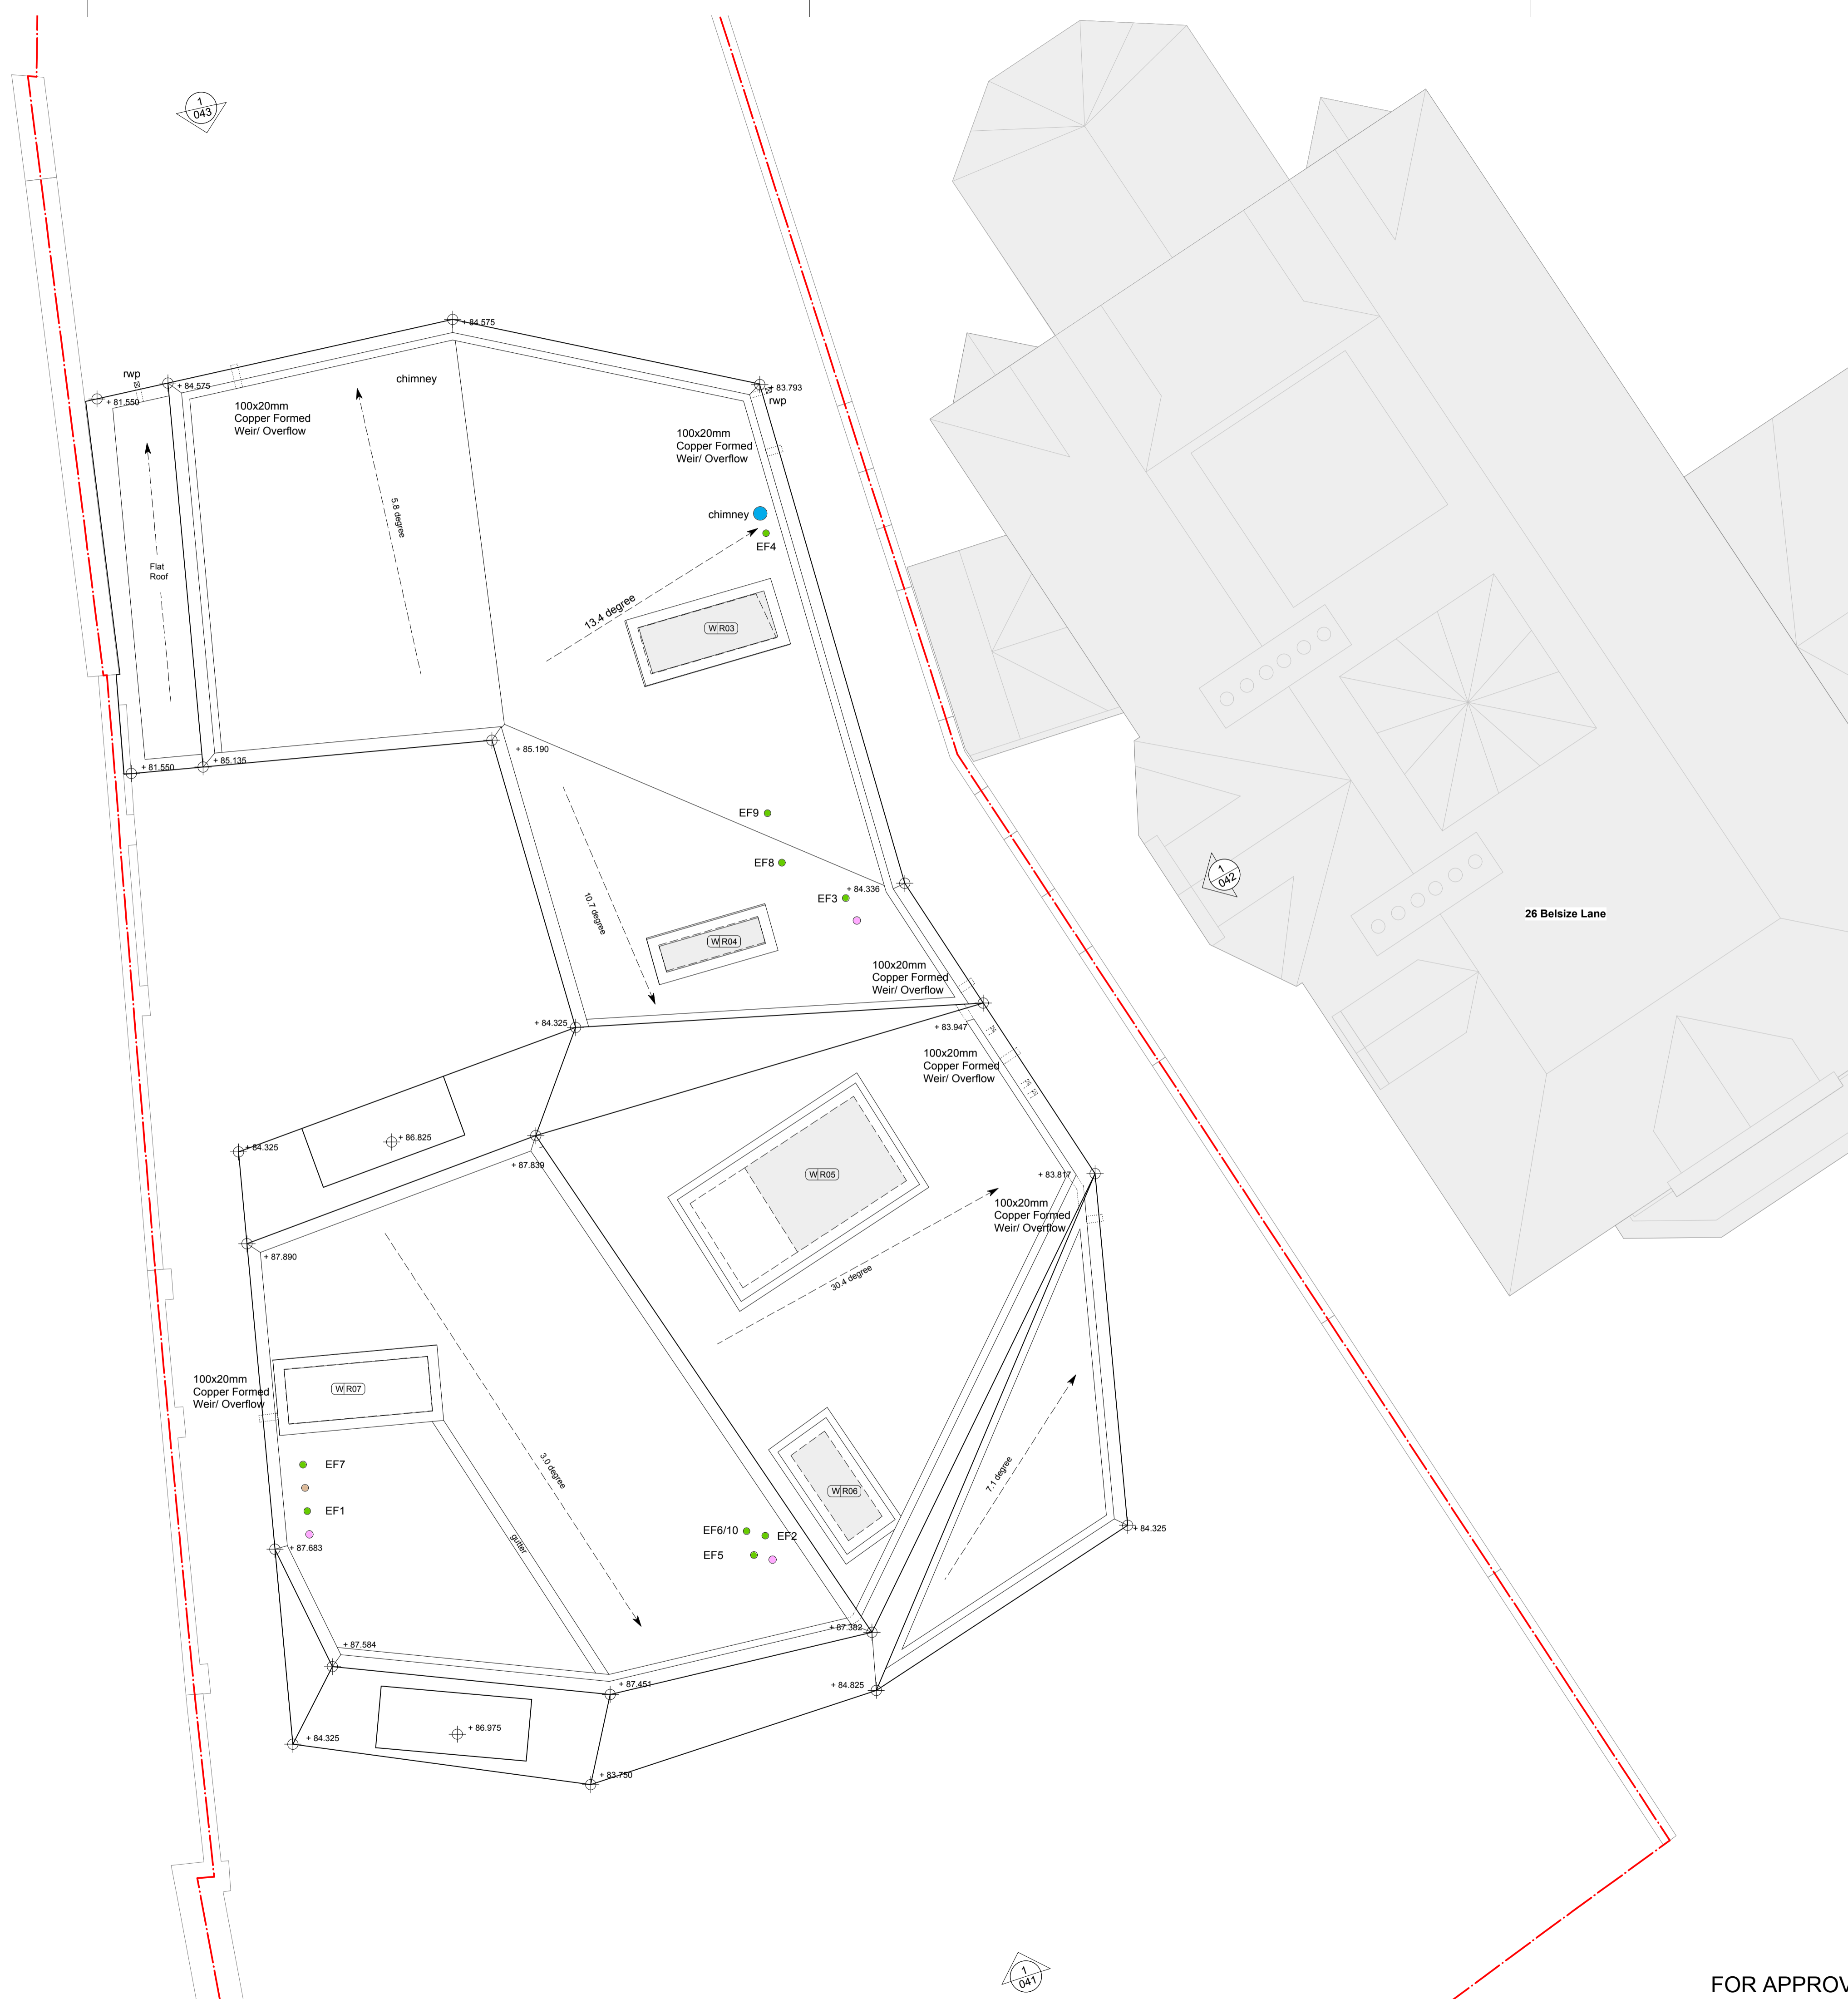
**Notes**  
**Note 1**  
 To be read in conjunction with Acoustic report 11377 PCR 01 & 02.  
 ● Chimney (gas fire) Approved 2014/0246/P  
 ● Concentric Flue Vent  
 ● Extract Vent  
 ● SVP

Revision	Date	Notes
1	15/03/17	Service roof penetrations shown; Gutter from W-R07 shown. Note 1 & 2 added. RWP's shown as square.
