**Uri Friedländer**

20 Belsize Avenue

**1704.PL.06 – Test hole findings**

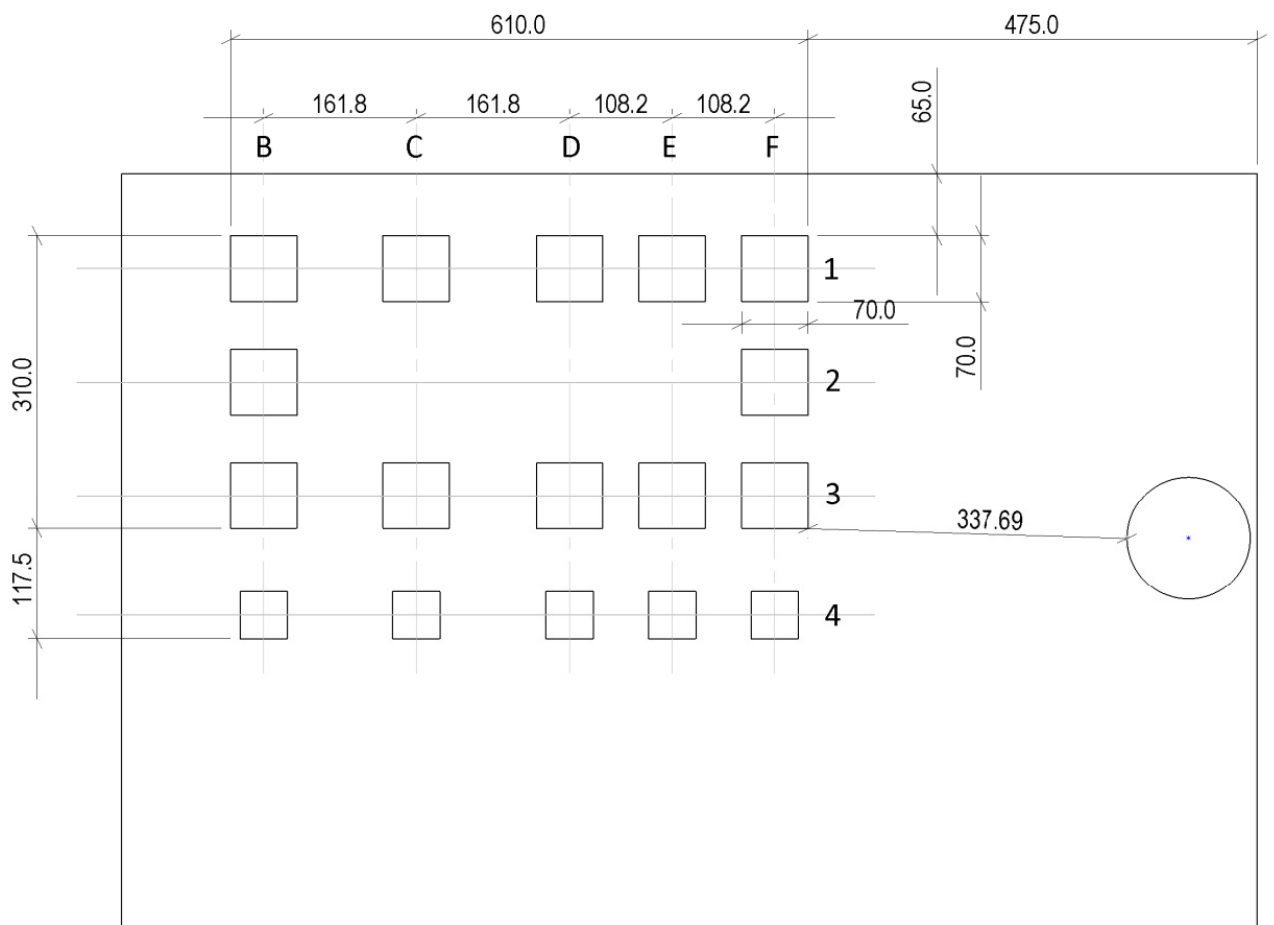
F2 – Test hole dug to 350mm Depth – no roots >25mm found.

F3 – Test hole dug to 350mm Depth – no roots >25mm found.

F4 – Test hole dug to 350mm Depth – no roots >25mm found.

E3 – Test hole dug to 350mm Depth – no roots >25mm found.

All dims in cm
