Drawing Title: Replacement floor covering			Alex Sargeson 07447082328
Project: Flat 3, 34 Museum St. London. WC1A 1LH.			
Scale: 1:20/1:200	Date: 020317	Drawn by: AS	
Drawing Number: 005

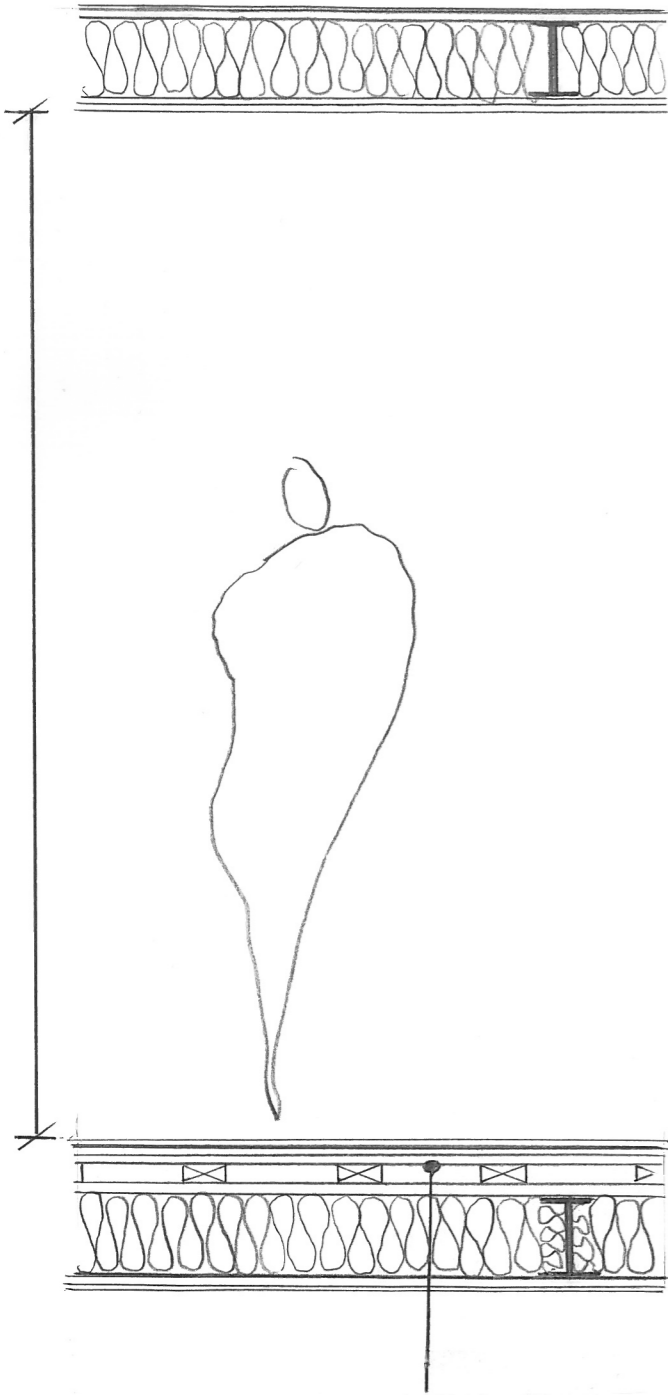
Pre Existing

Vinyl / laminate / carpet / tile Finishes / hardboard layers  
 1993 'floating floor' laid on top of floor boards/steel structure.  
 Floating floor had perished due to extensive water damage  
 Acoustic insulation had aged and failed.  
 Acoustic properties no longer significant.  
**Total depth 90mm**

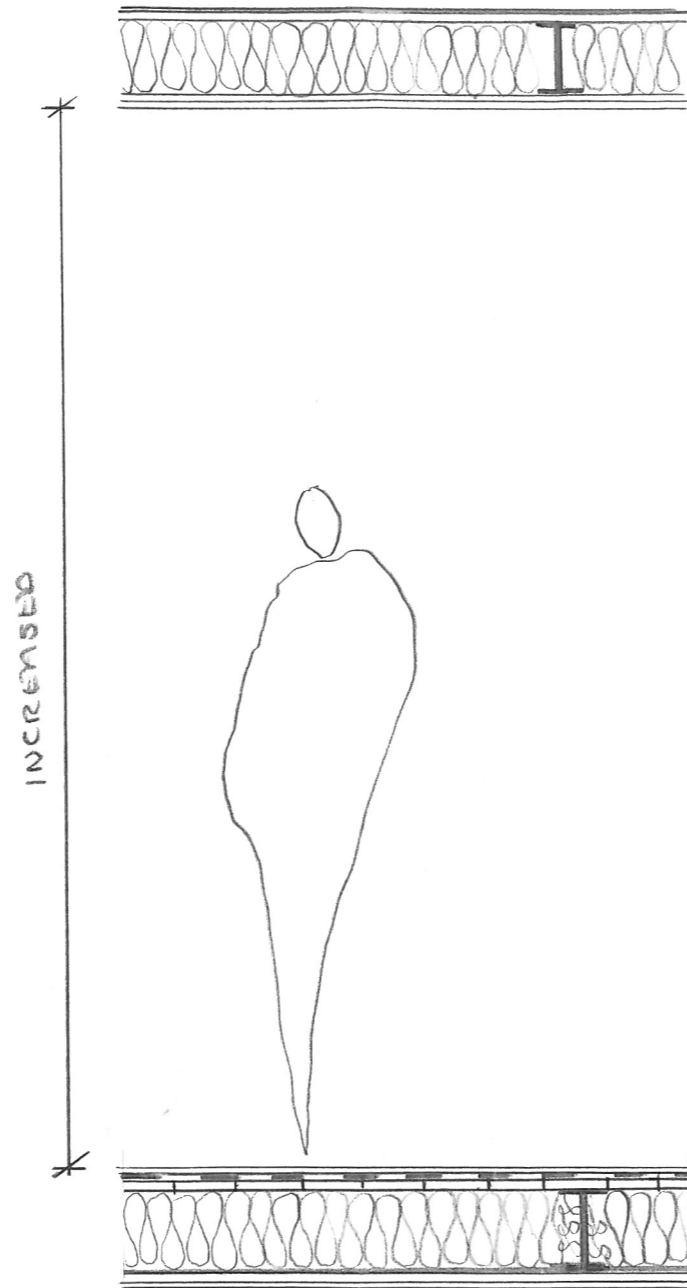
As built

New acoustic floor laid using 'REGUPOL 4.5mm' laid over floor boards  
 Laminate laid throughout  
 Floor to ceiling height increased  
**Total depth 11mm**

**Notes:** Due to damage Floor needed to be replaced  
 New floor achieved better acoustic properties and added 80mm back to room height

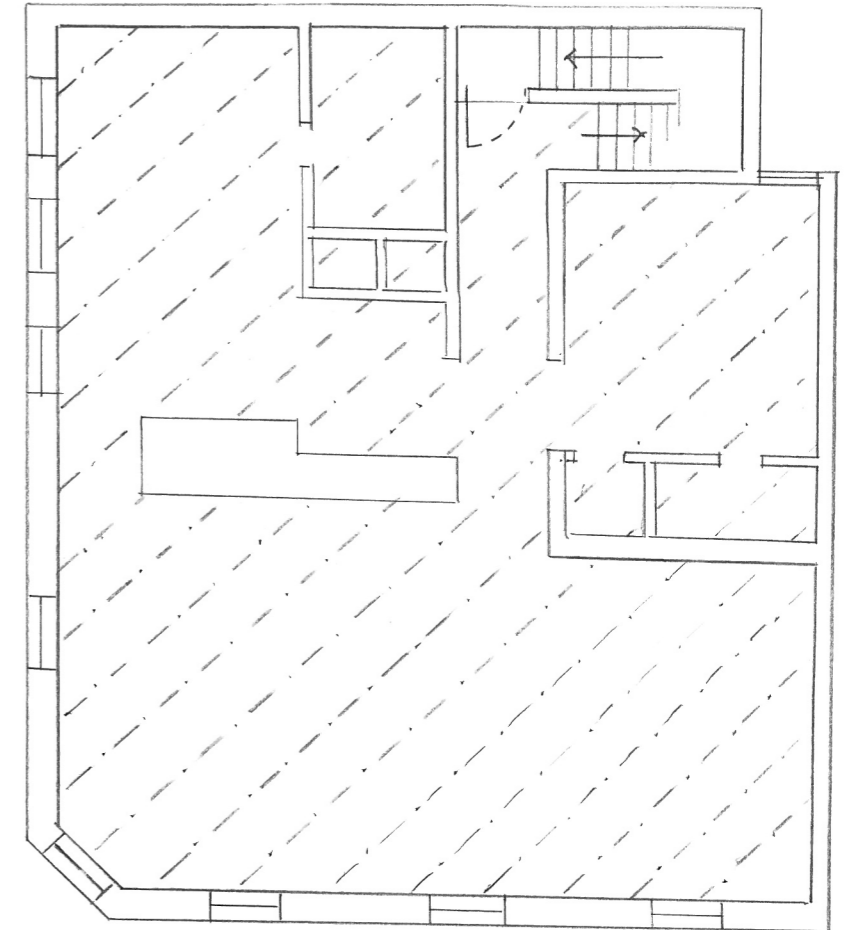
Reference Plan:

Floor: Area of floor replaced due to water damage / perished acoustic floor
