PROJECT
KIDDERPORE AVENUE

DRAWING
Generally Applicable
Door and window details 2 - Heritage

DRAWING No. 15 230
9000-DRG-00GN-DE048
DRAWN BY MRR
REV C1

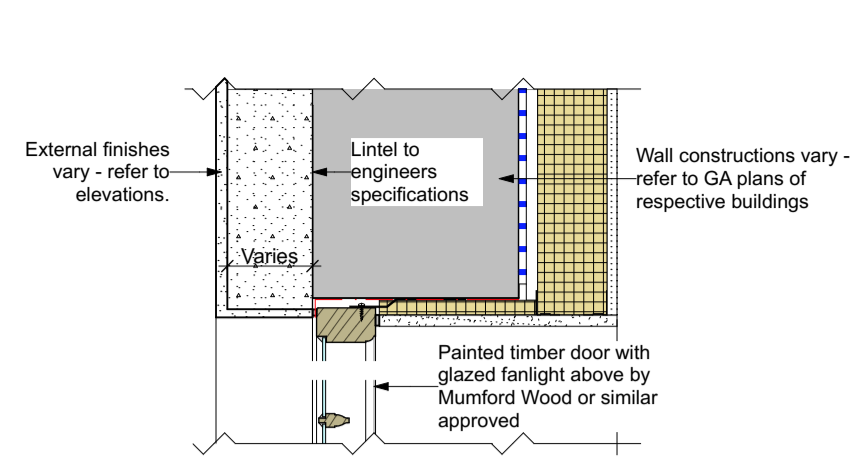
Detail H5 - Typical head detail to fixed fanlight
