Re: Proposed garden building for 95 Canfields Gardens, NW6 3DY

Soil survey

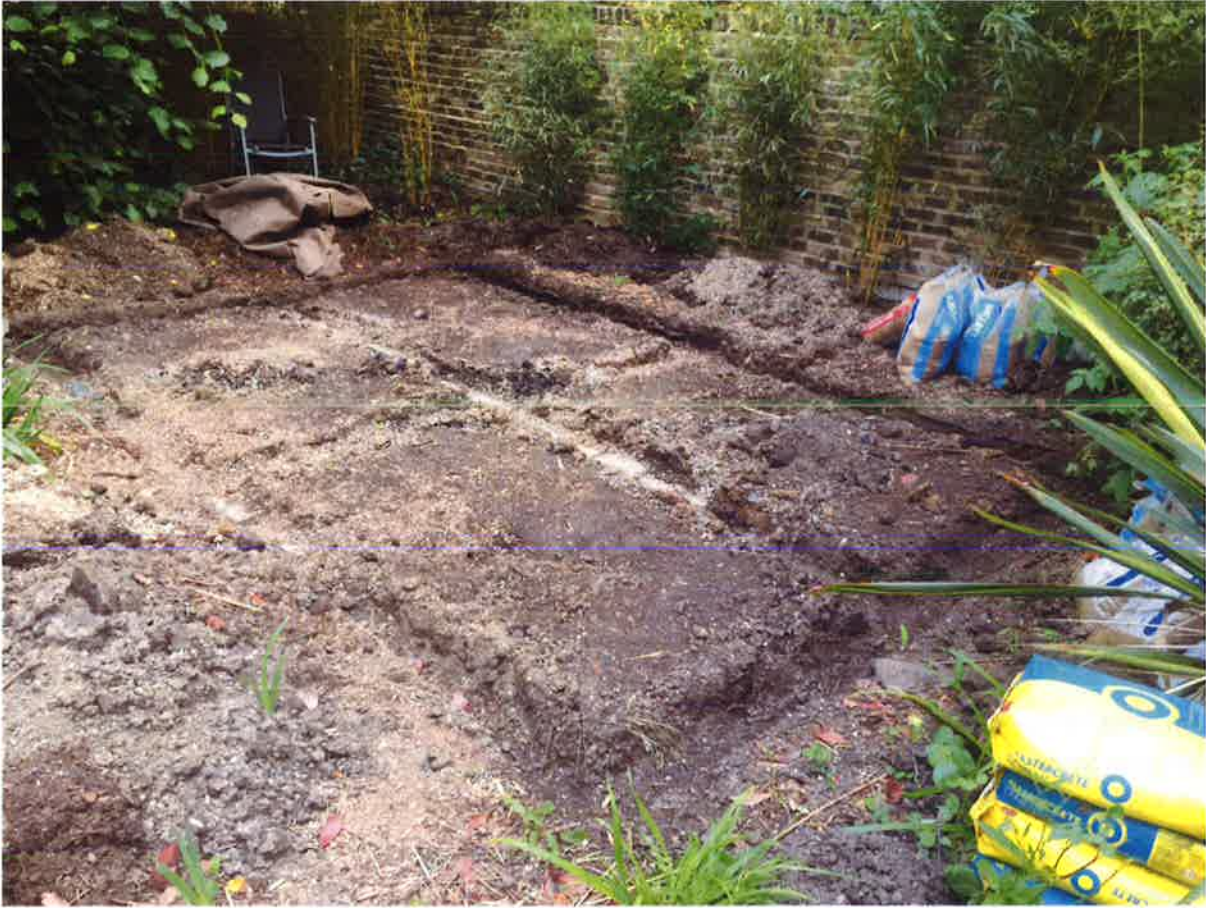
Picture A

We have completed a trench survey of the exact site of the proposed garden building. The area we surveyed was 6m x 4m and we dug to a depth of 150mm (as proposed by the shed designer). You will see the grid system we used in Picture A.

Grid system for 6m x 4m area

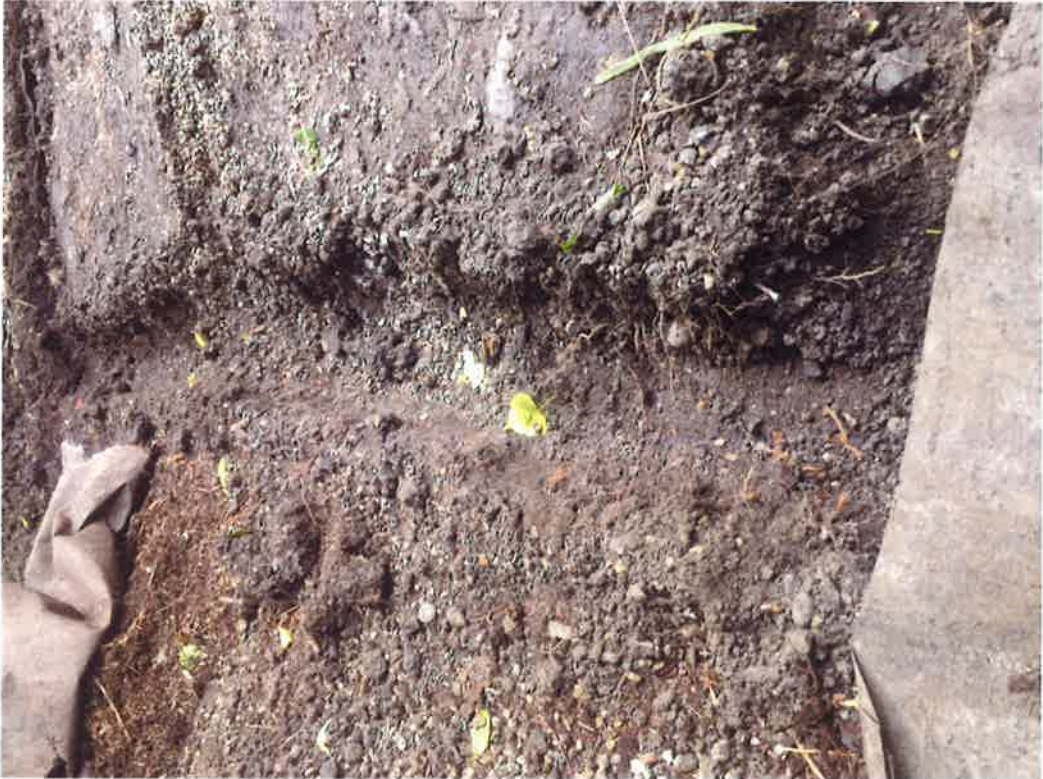
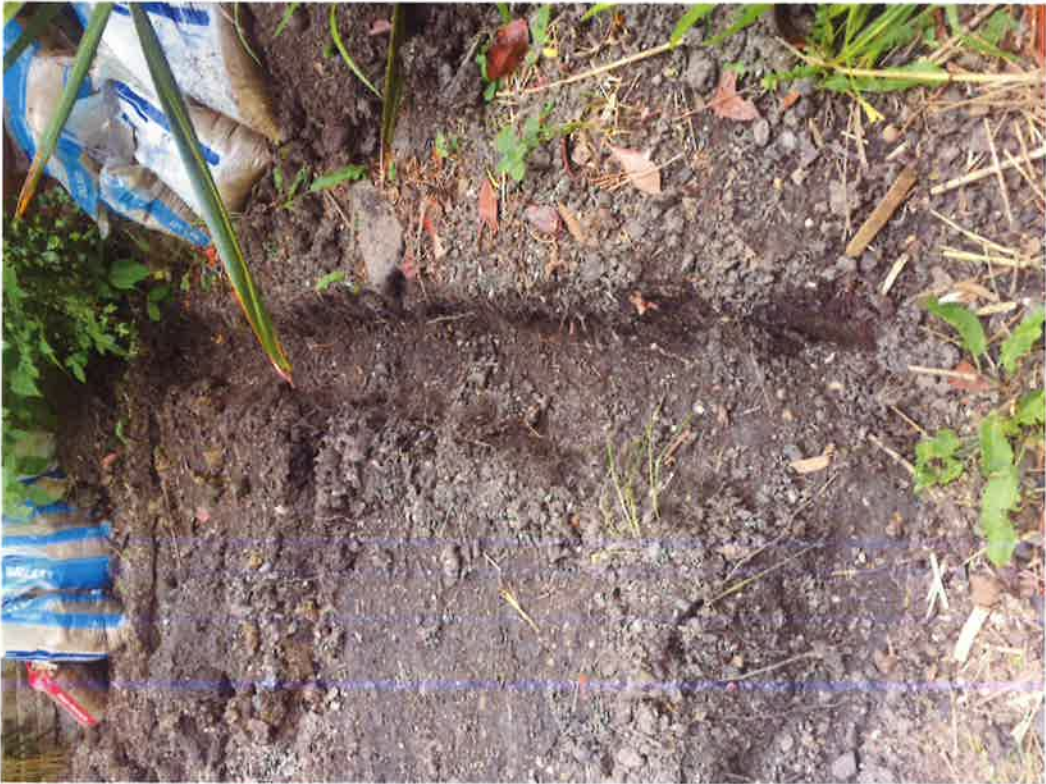
There was no evidence of roots beyond what is expected from grass and small plants. See Pictures B & C

Pictures B & C. Close-ups of channel showing lack of roots

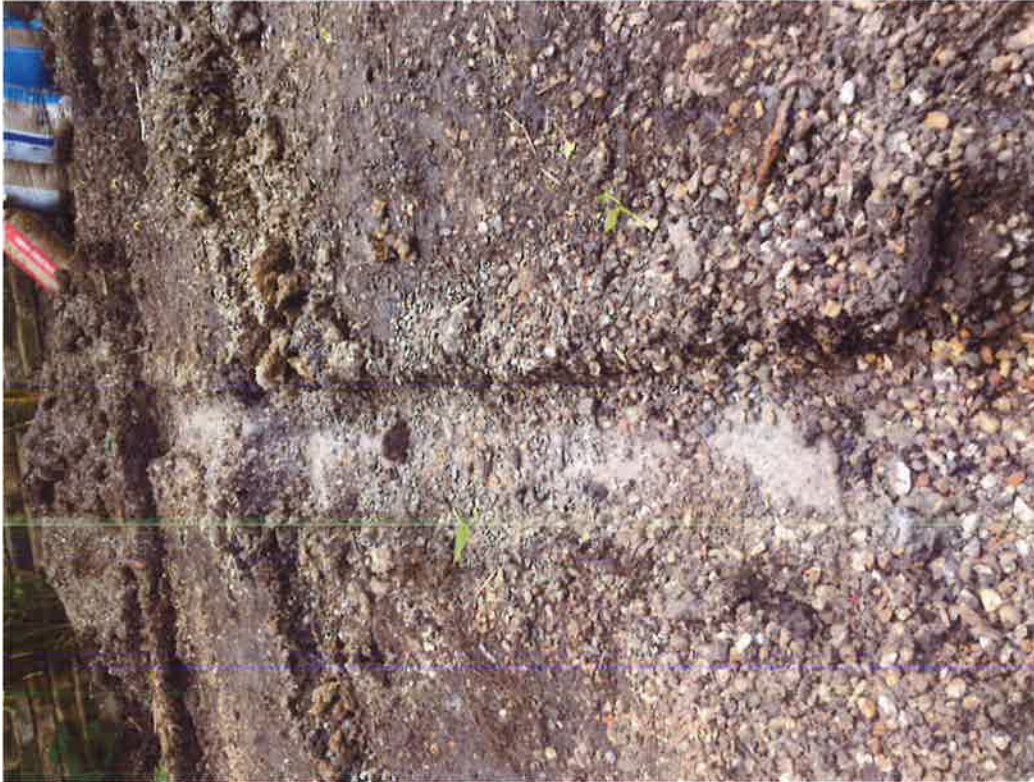
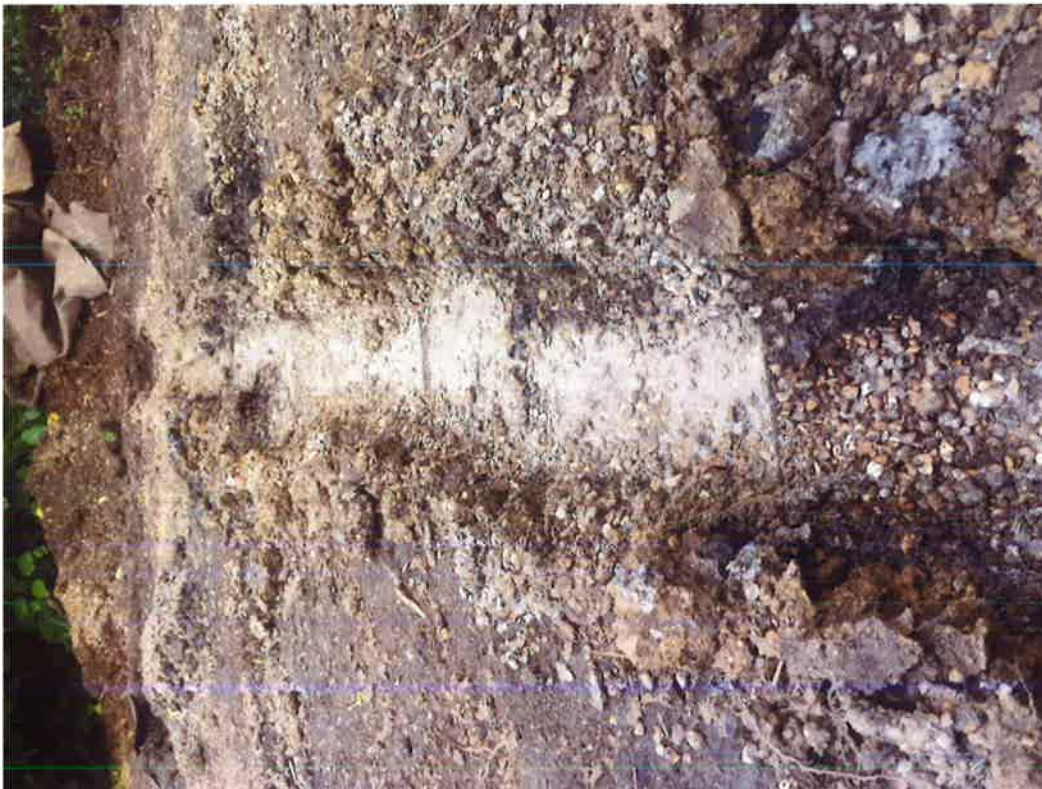
An area comprising approx. 60% is actually a previous foundation. It is concrete and was located approx. 100mm below the soil. We do not know when this was constructed. See Pictures D & E. While we believe there is absolutely no root issue in our plans, this shows a previous building was in fact there and its foundations have not impacted any large nearby trees.

Pictures D & E. Previous foundation
