**Landmark Trees**  
20 Broadwick Street, London, W1F 8HT  
Tel: 0207 851 4544 Mobile: 07812 989928  
e-mail: info@landmarktrees.co.uk Web: www.landmarktrees.co.uk

Site: 11 Prince Albert Road	1:200@ A3
Drawing Title: Tree Protection Plan	December 2016

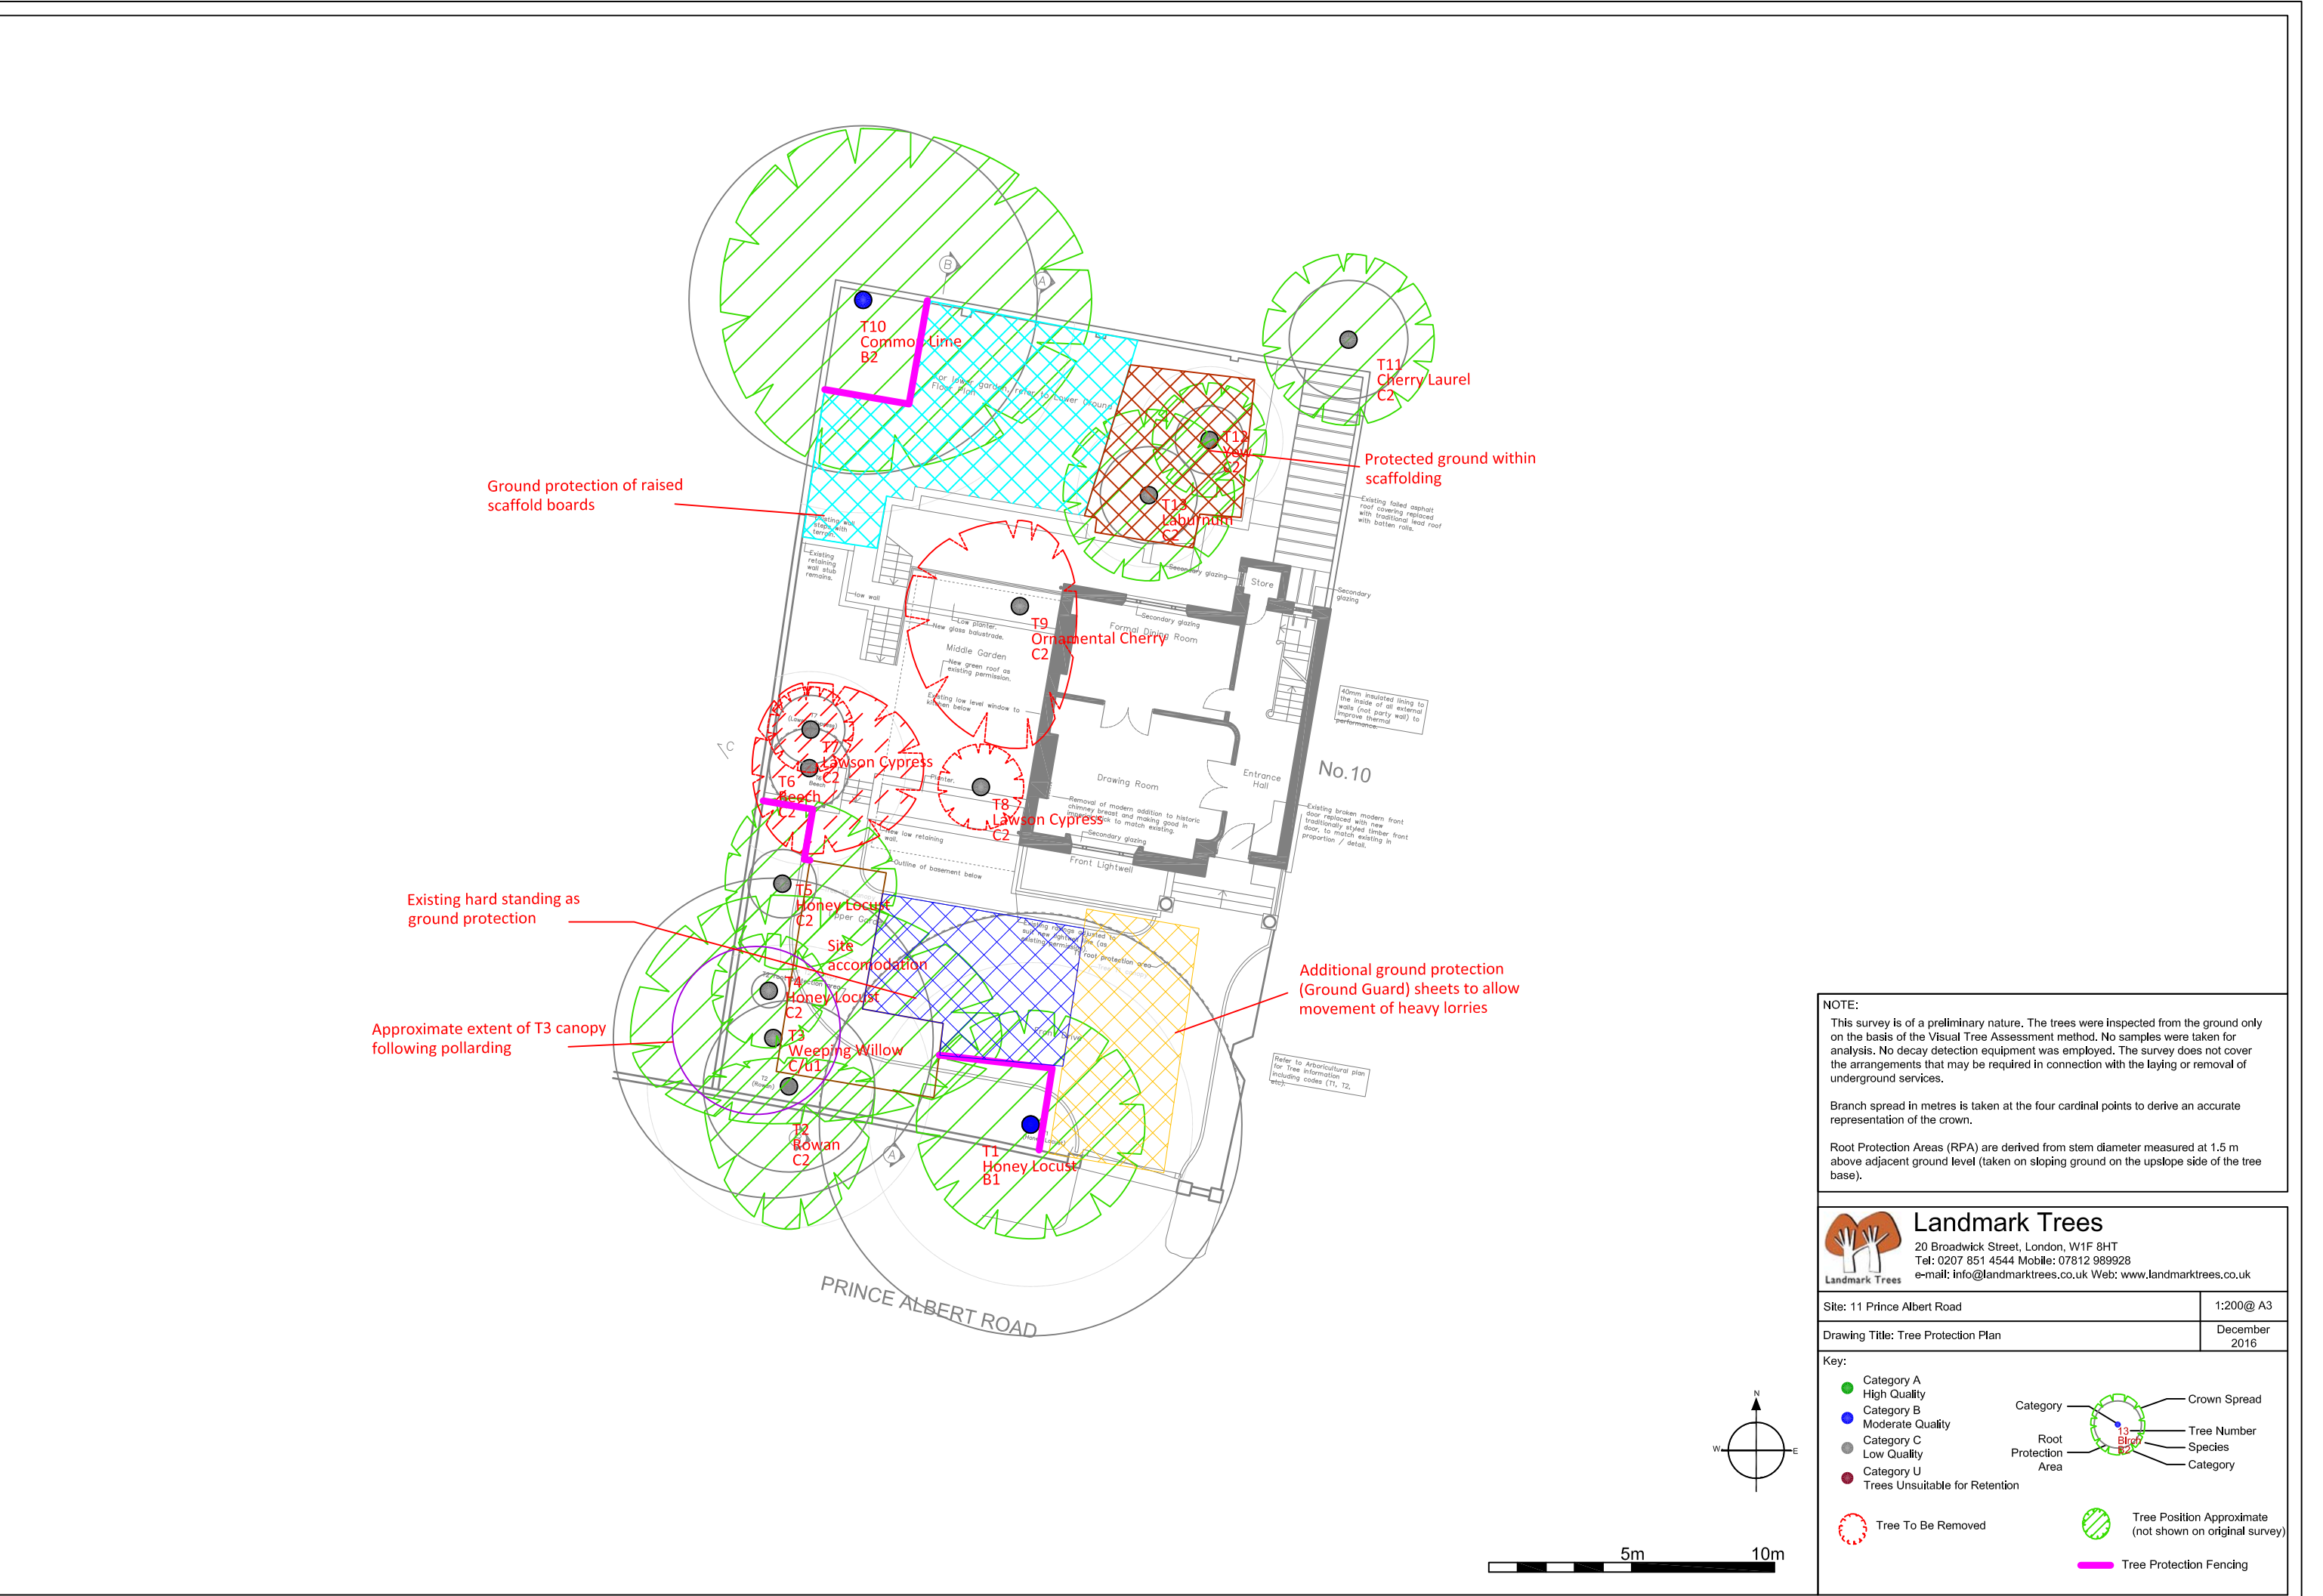
**NOTE:**  
This survey is of a preliminary nature. The trees were inspected from the ground only on the basis of the Visual Tree Assessment method. No samples were taken for analysis. No decay detection equipment was employed. The survey does not cover the arrangements that may be required in connection with the laying or removal of underground services.

Branch spread in metres is taken at the four cardinal points to derive an accurate representation of the crown.

Root Protection Areas (RPA) are derived from stem diameter measured at 1.5 m above adjacent ground level (taken on sloping ground on the upslope side of the tree base).
