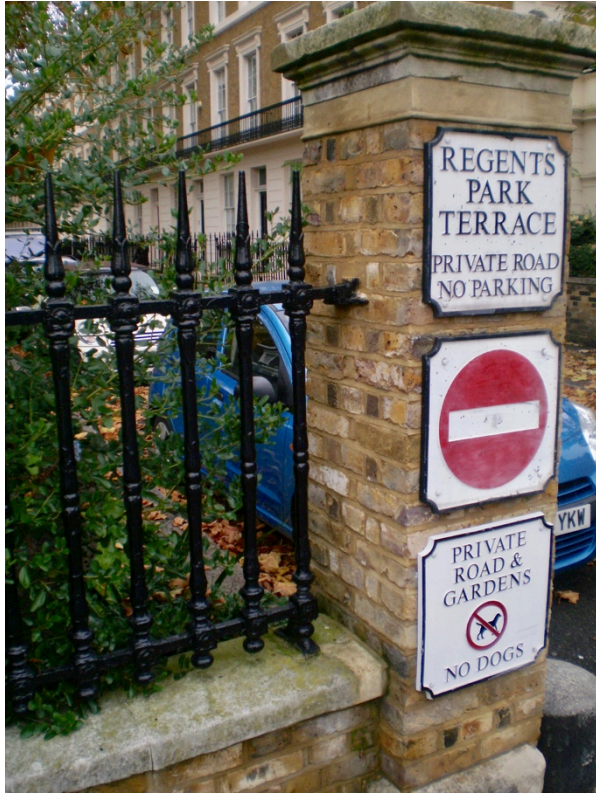
Detail: rebuilt entrance pillar with Portland stone cap & base - Medium Significance. Original decorative cast iron railings - High Significance. Signage clutter.

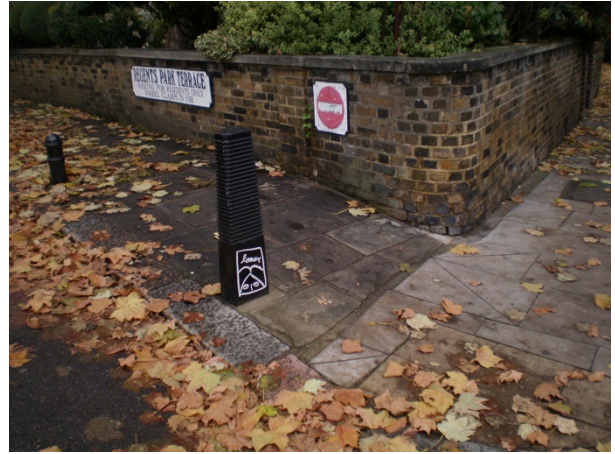
Right-hand side of south entrance: no evidence of a right-hand gate pillar. Original garden wall to No. 1 - High Significance.

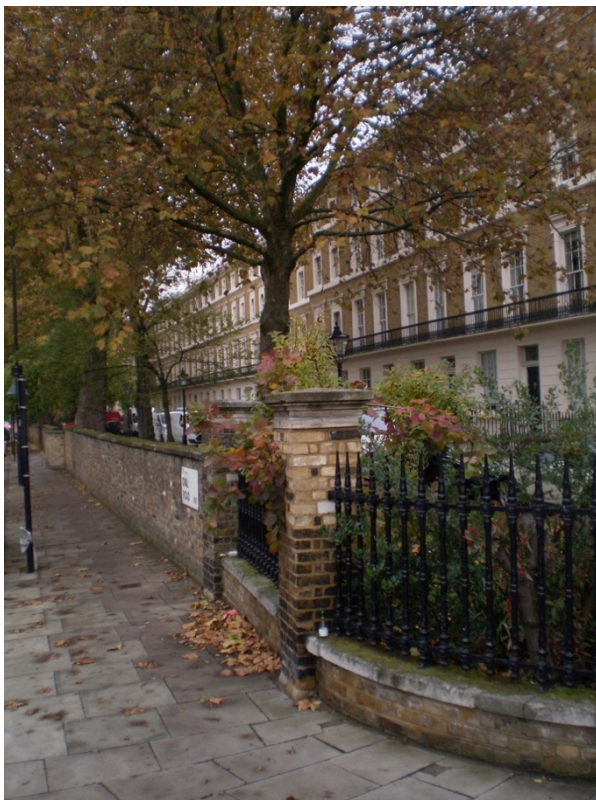
Railings and pillars on the corner of Gloucester Crescent and Oval Road, - High Significance.

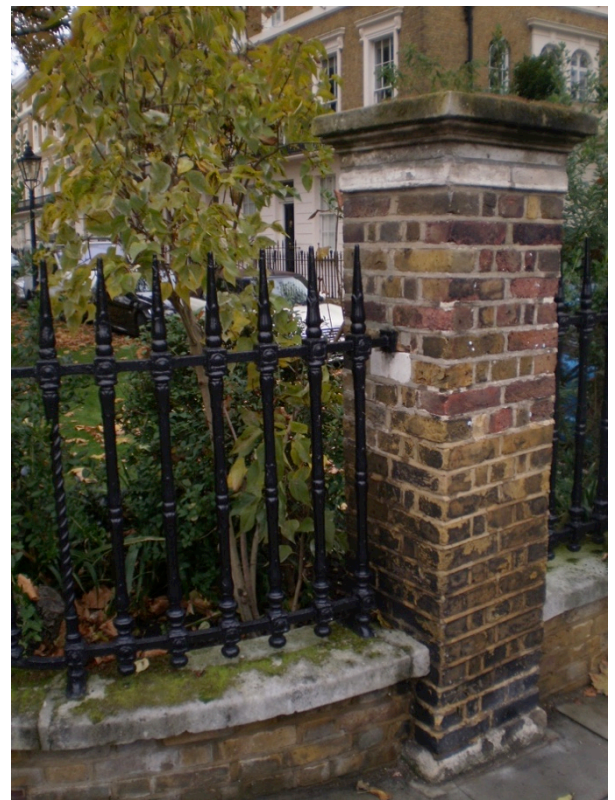
Railings and Pillars on the corner of Gloucester Crescent and Oval Road with Portland stone pillar cap and wall coping - High Significance

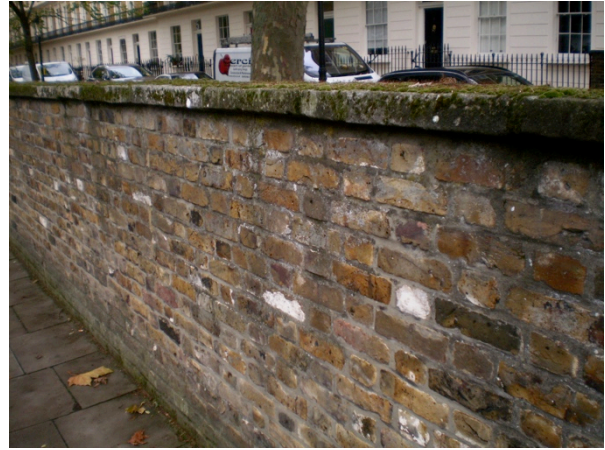
Front boundary wall on Oval Road. Rebuilt using reclaimed bricks and original coping - Medium Significance.

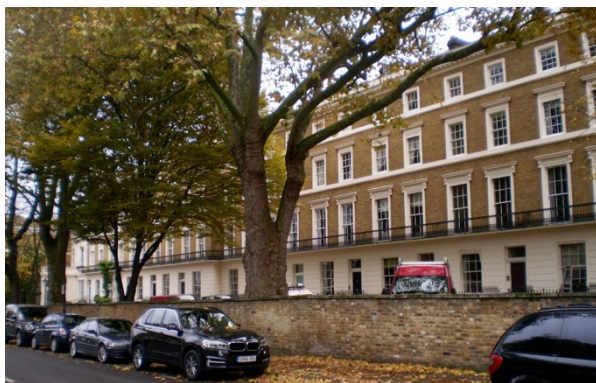
Front boundary wall on Oval Road, middle section. Original parts - High Significance. Rebuilt part Medium Significance.

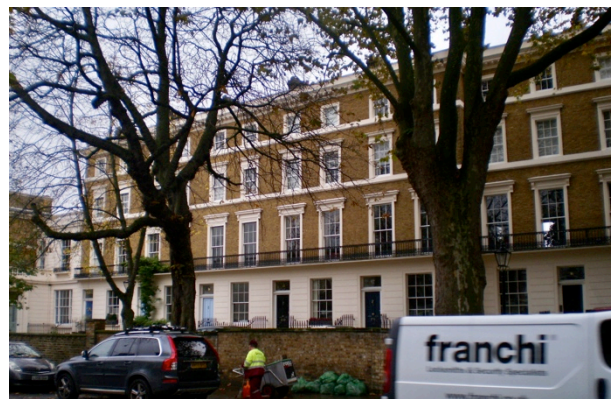
Front boundary wall on Oval Road, north end. Original parts - High Significance. Rebuilt part Medium Significance.

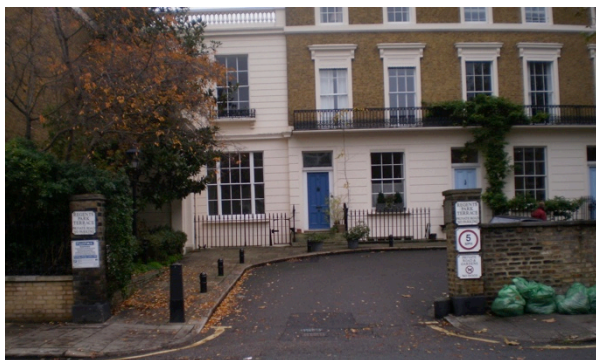
North entrance to Regent's Park Terrace with Original pillars either side - High Significance.

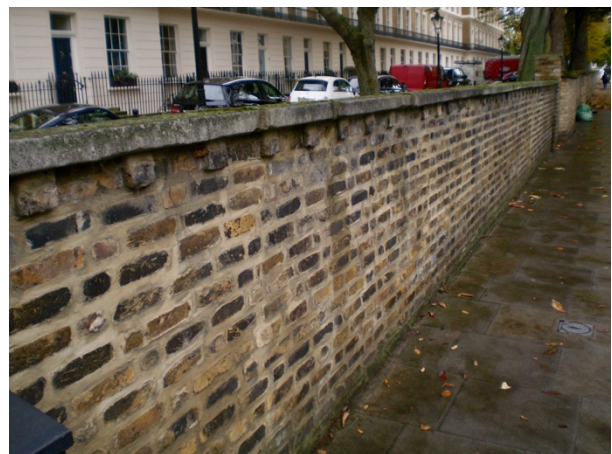
Original section of front boundary wall at north end, with brick dentils and Portland stone coping - High Significance, notwithstanding poor pointing.

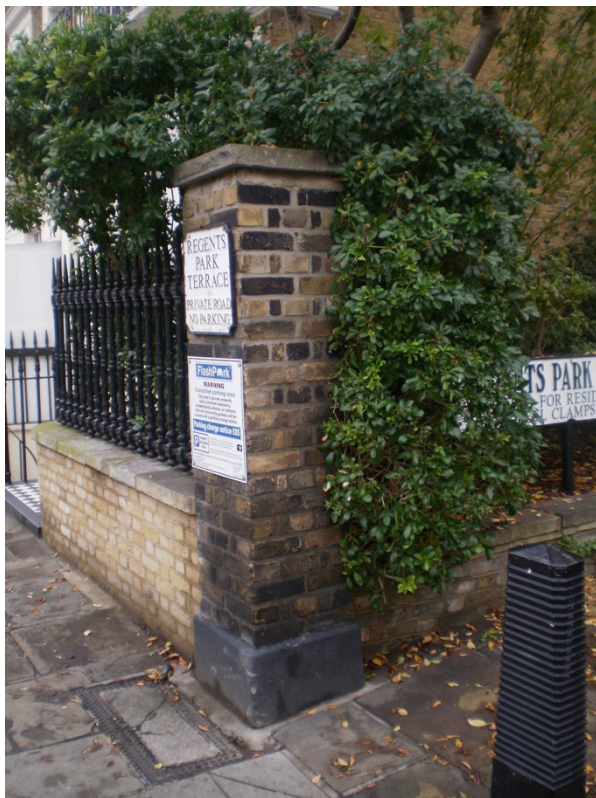
North entrance, original left hand pillar  
Original parts – High Significance. Rebuilt part Medium Significance. Original railings – High Significance. Rebuilt wall – Medium Significance. Signage clutter.

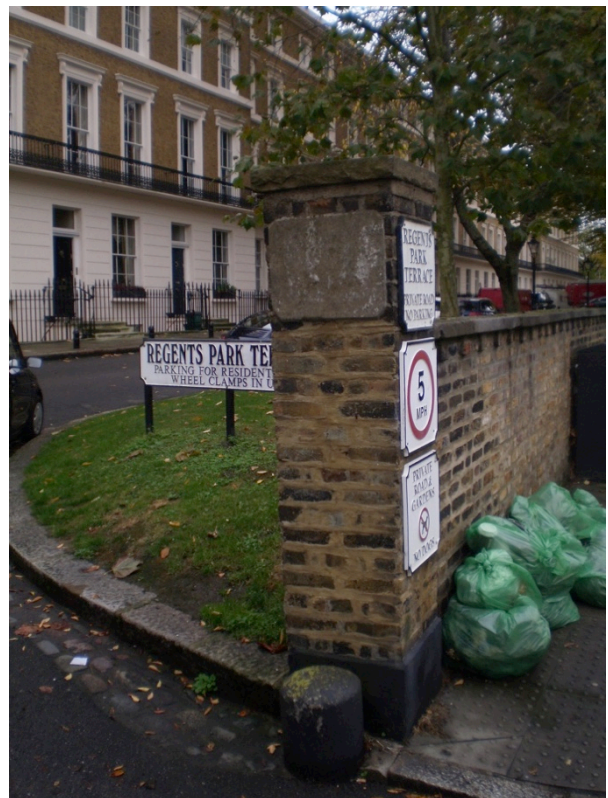
North entrance, original right-hand pillar – High Significance. Signage clutter.

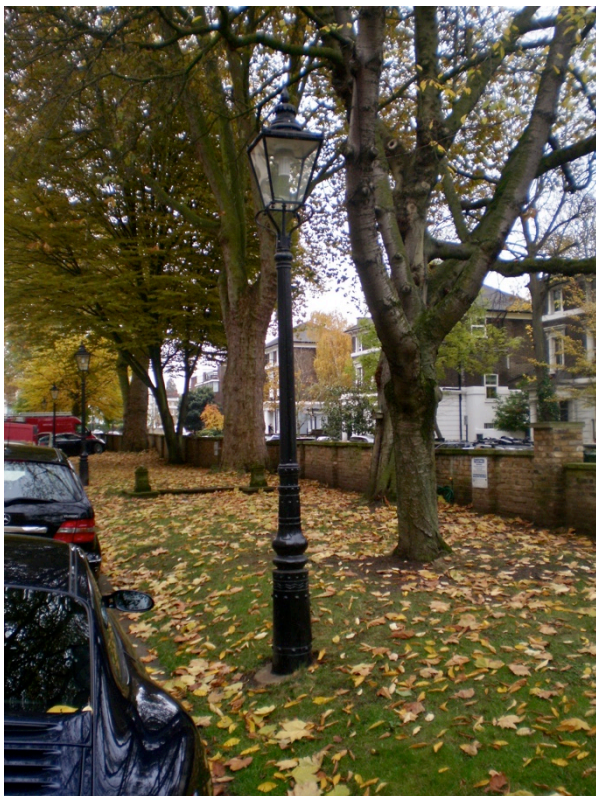
Grass verge & trees within the wall.  
Traditional design cast iron lampposts and lanterns of modern date. No Significance

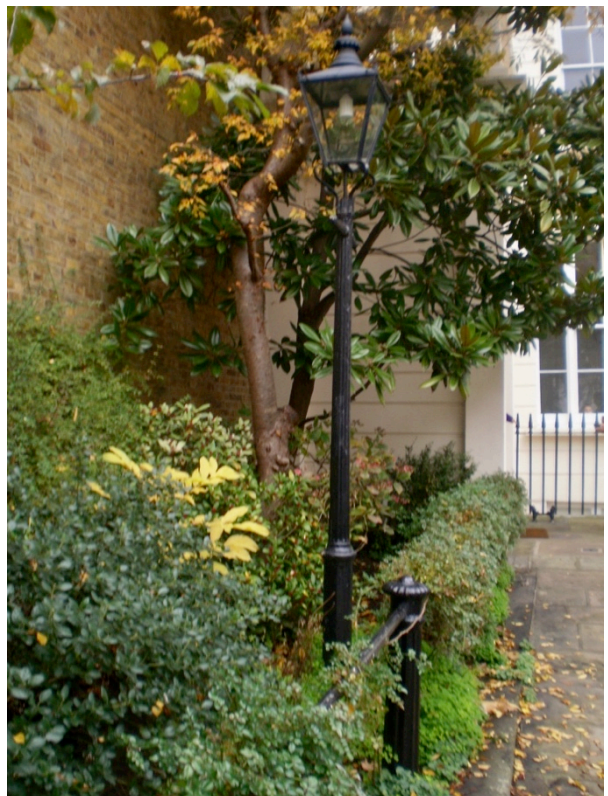
Cast iron lamppost at north end, possibly an original gas lamp adapted to electricity. If original, High Significance.

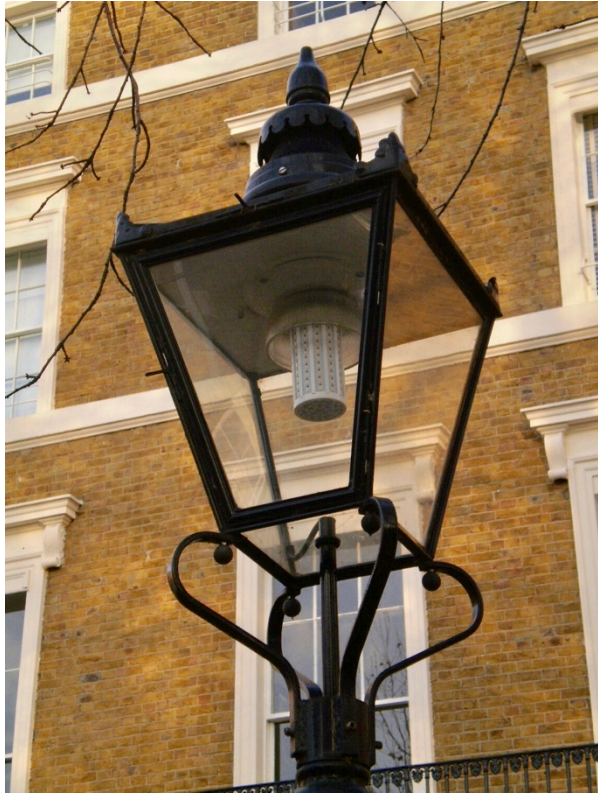
Lamppost on grass verge. Lantern of Modern date - No Heritage Significance, but an attractive and appropriate feature worthy of retention.

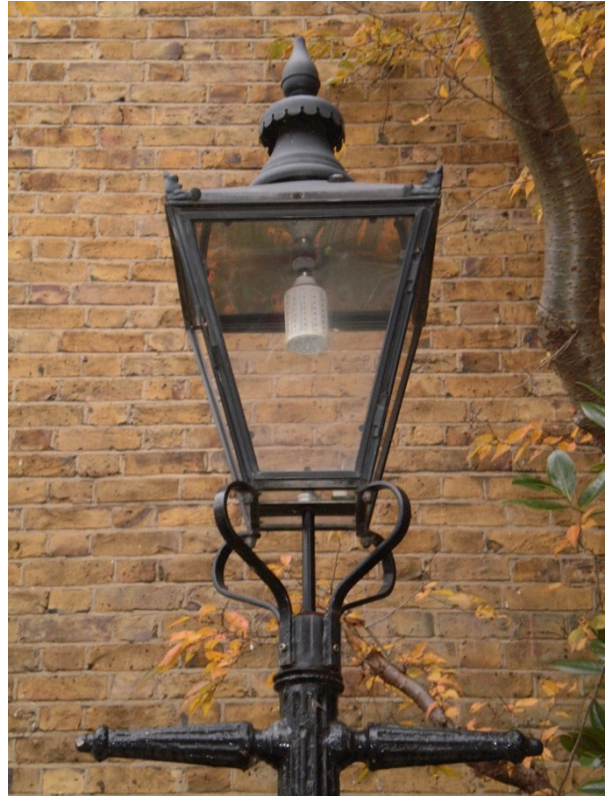
Lamppost at north end. Lantern of modern date - No Heritage Significance, but an attractive and appropriate feature worthy of retention.

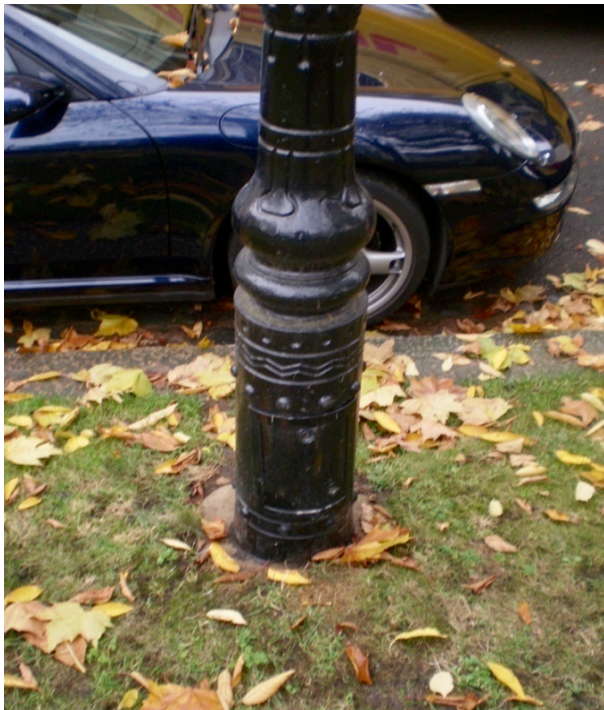
Base of modern date lamppost on grass verge. Door plate to access electric. No Heritage Significance. but an attractive and appropriate feature worthy of retention.

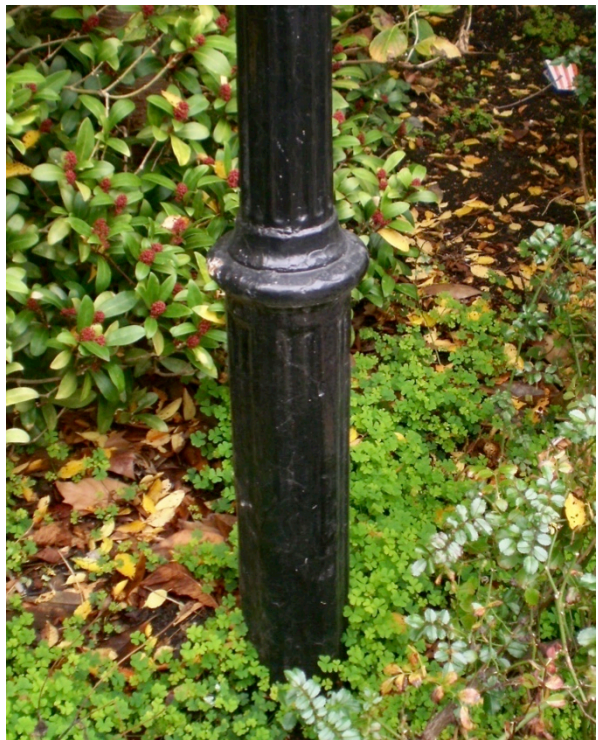
Base of lamppost at north end. No door plate. Lamppost of High Heritage Significance if it is original.
