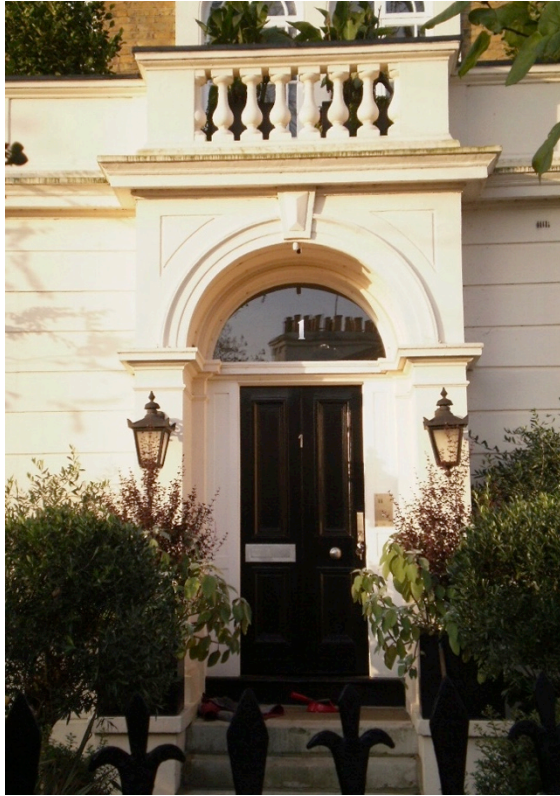
No. 1 Original Portland stone steps, four-panelled door with ogee bolection mouldings -High Significance. Pilasters, arched head & balustrade - High Significance.

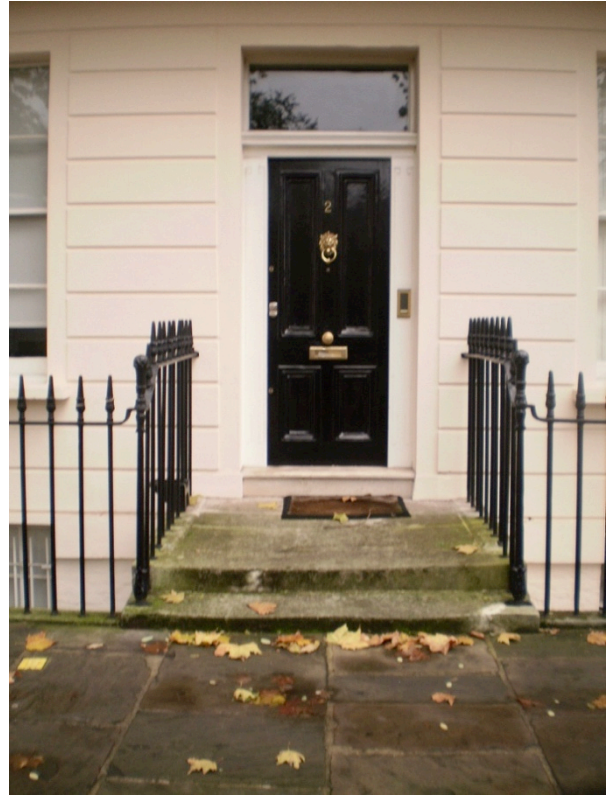
No. 2 Original Portland stone steps, original (?) Portland stone landing, four-panelled door with ogee bolection mouldings - High Significance.

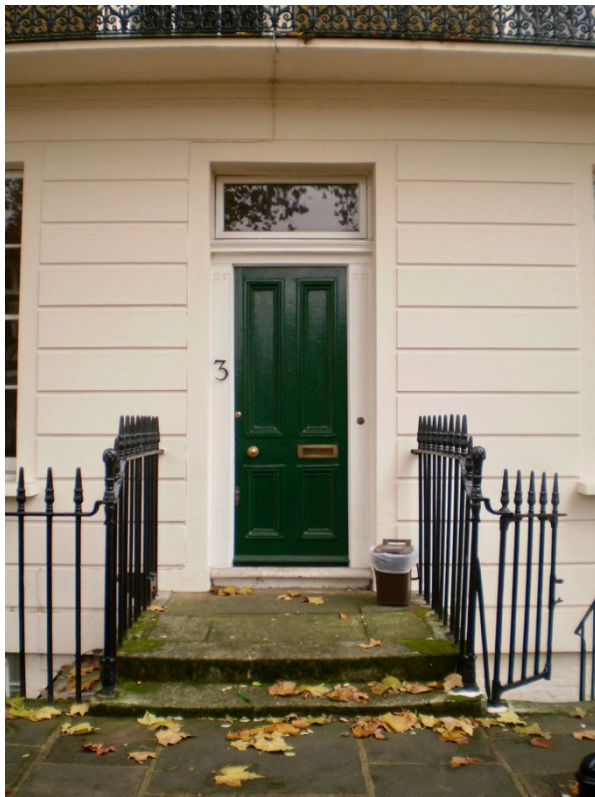
No. 3 Original Portland stone steps, four-panelled door with ogee bolection mouldings - High Significance. Non-original (?) York stone landing - Low Significance.

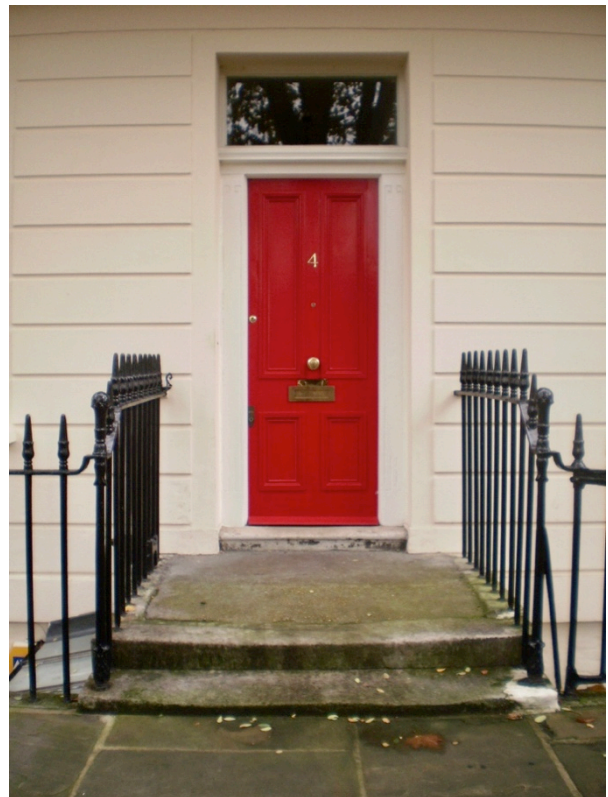
No. 4 Original Portland Stone Steps, four-panelled door with ogee bolection mouldings High Significance. Concrete landing - No Significance.

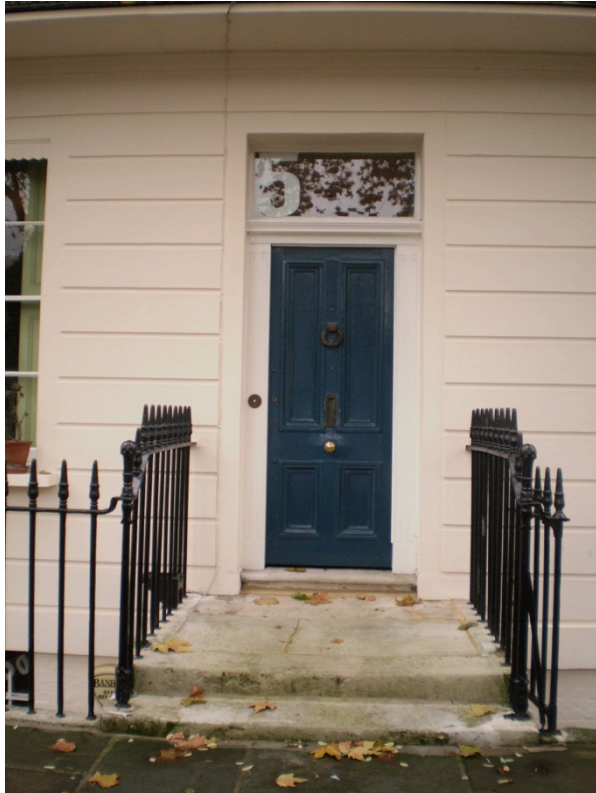
No. 5 Original Portland stone steps & original (?) Portland stone landing, four-panelled door with ogee bolection mouldings - High Significance.

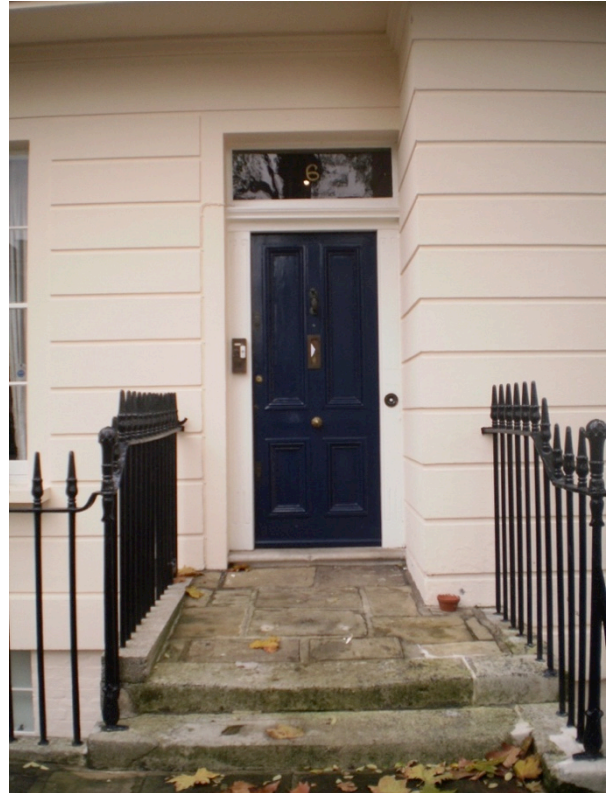
No. 6 Original Portland stone steps, four-panelled door with ogee bolection mouldings - High Significance. Landing reclad in small York stone slabs - Low Significance.

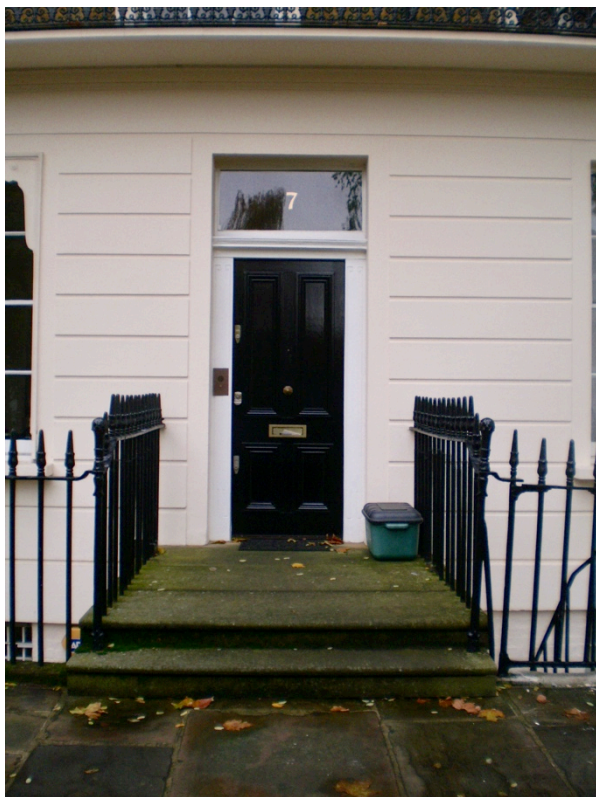
No. 7 Four-panelled door with ogee bolection mouldings - High Significance. Steps and landing reconstructed in Portland (?) stone - Low Significance

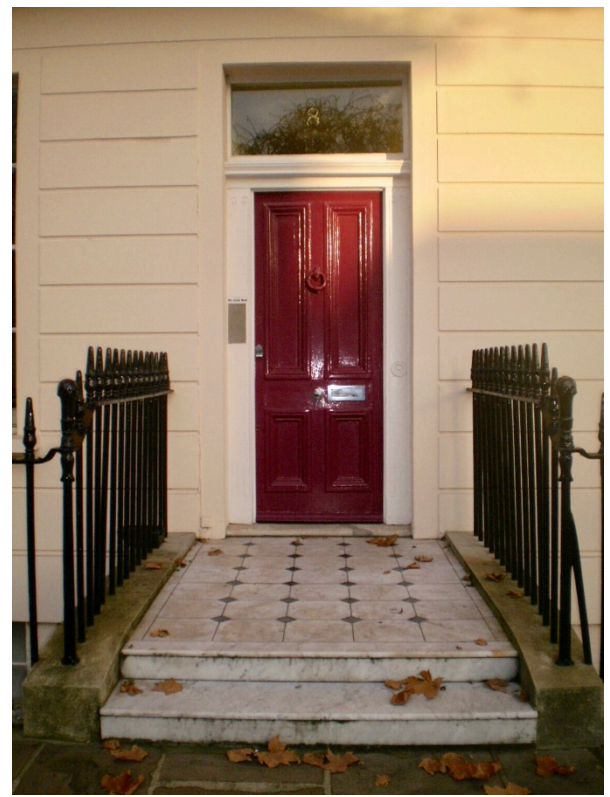
No. 8 Four-panelled door with ogee bolection mouldings - High Significance. Steps and Landing clad in modern tiles - No Significance.

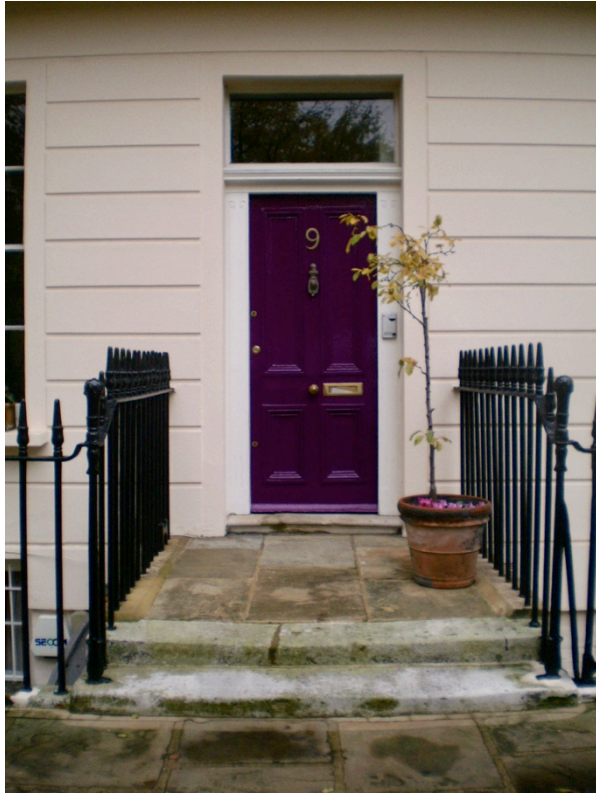
No. 9 Original Portland stone steps, four-panelled door with ogee bolection mouldings - High Significance. Landing reclad in small York stone slabs - Low Significance.

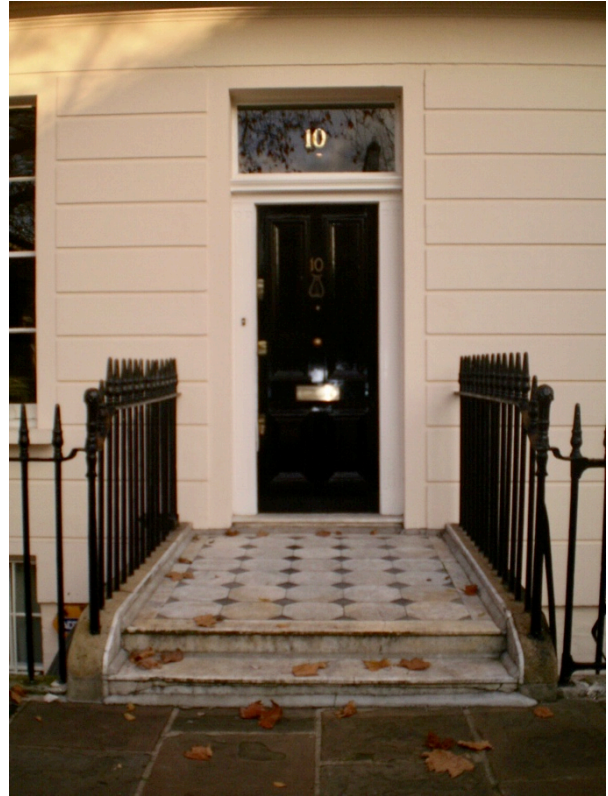
No. 10 Four-panelled door with ogee bolection mouldings - High Significance. Steps and landing clad in marble & marble tiles - No Significance.

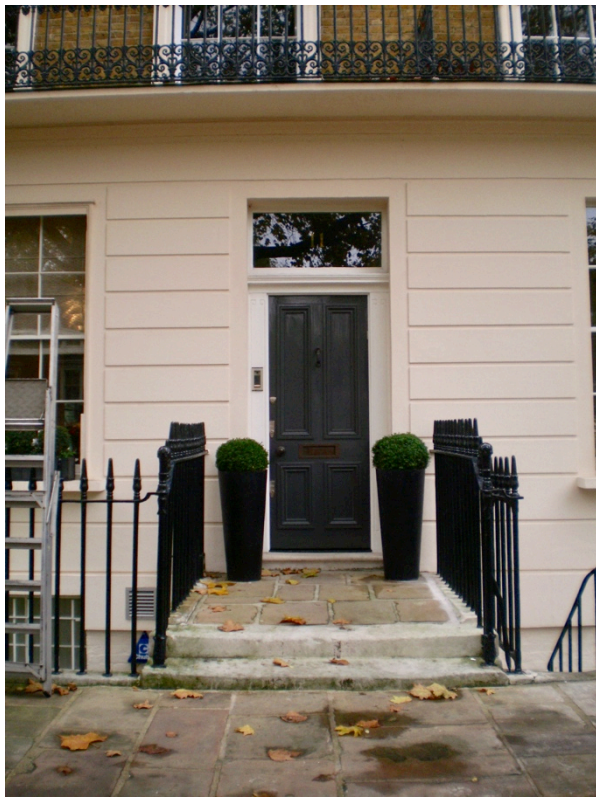
No. 11 Original Portland stone steps, four-panelled door with ogee bolection mouldings - High Significance. Landing reclad in small York stone slabs - Low Significance

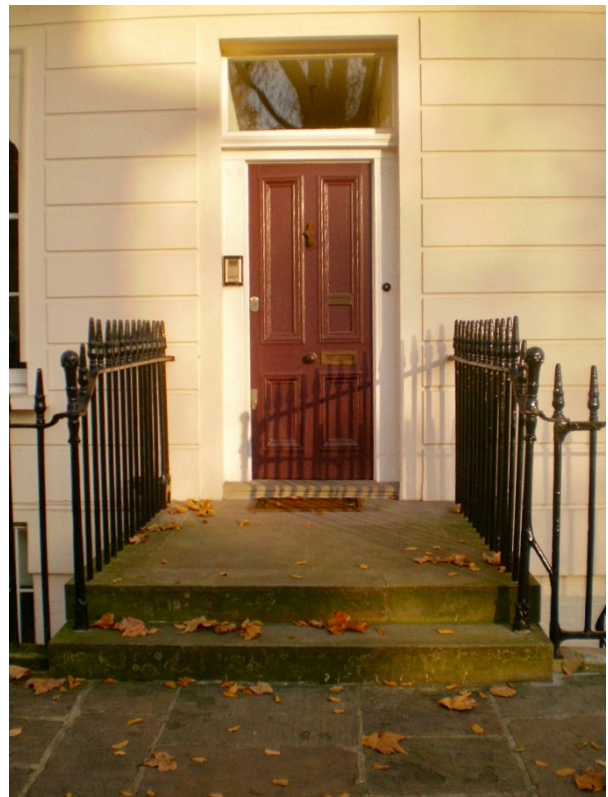
No. 12 Four-panelled door with ogee bolection mouldings - High Significance. Steps & landing rebuilt in York Stone - Low Significance.

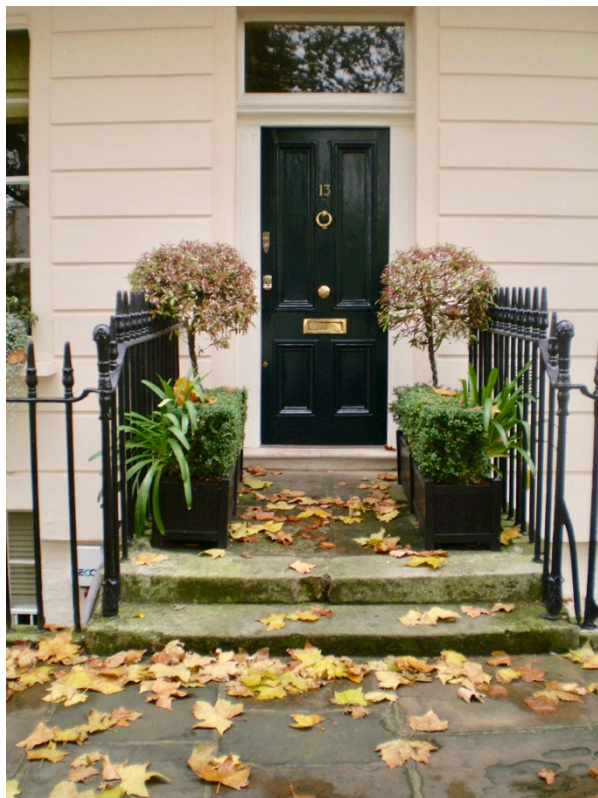
No. 13 Original Portland stone steps, four-panelled door with ogee bolection mouldings - High Significance. Landing reclad in small York stone slabs - Low Significance.

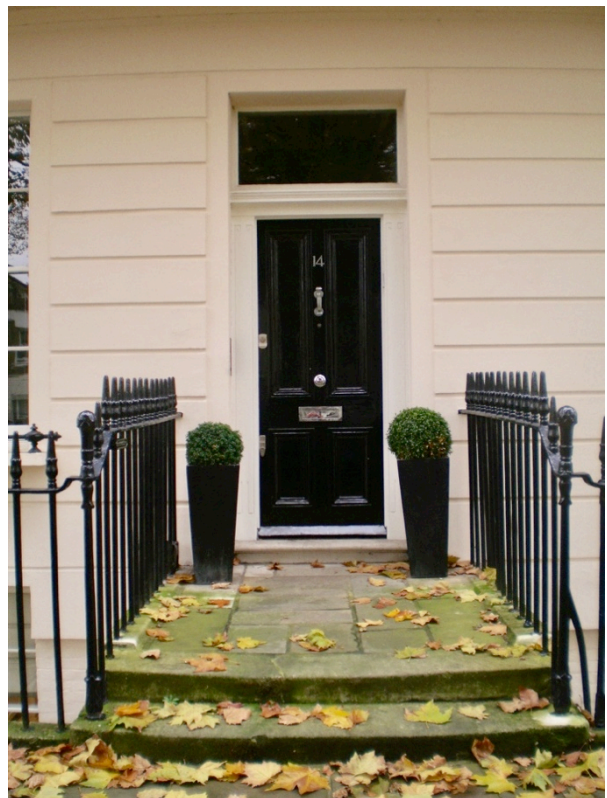
No. 14 Original Portland stone steps, four-panelled door with ogee bolection mouldings - High Significance. Landing reclad in small York stone slabs - Low Significance.

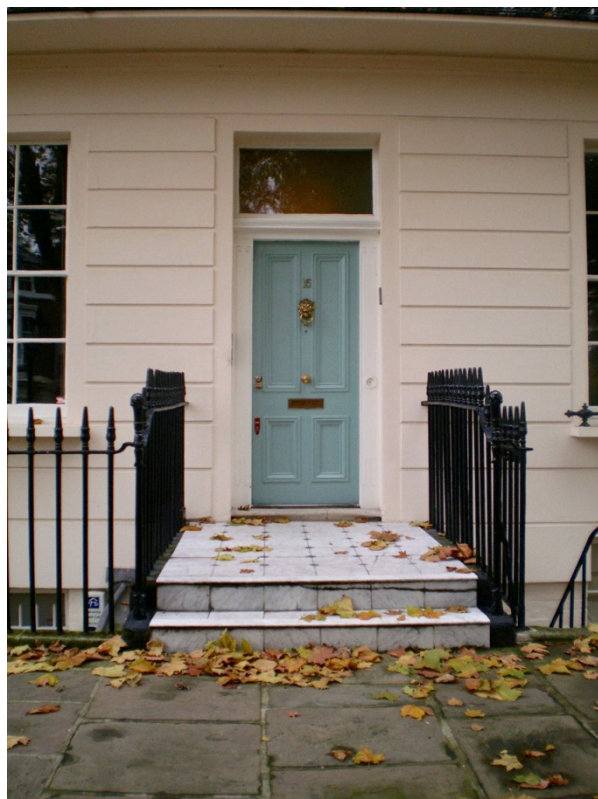
No. 15 Four-panelled door with ogee bolection mouldings - High Significance. Modern white marble tiles with black diamond tiles at corners - No Significance.

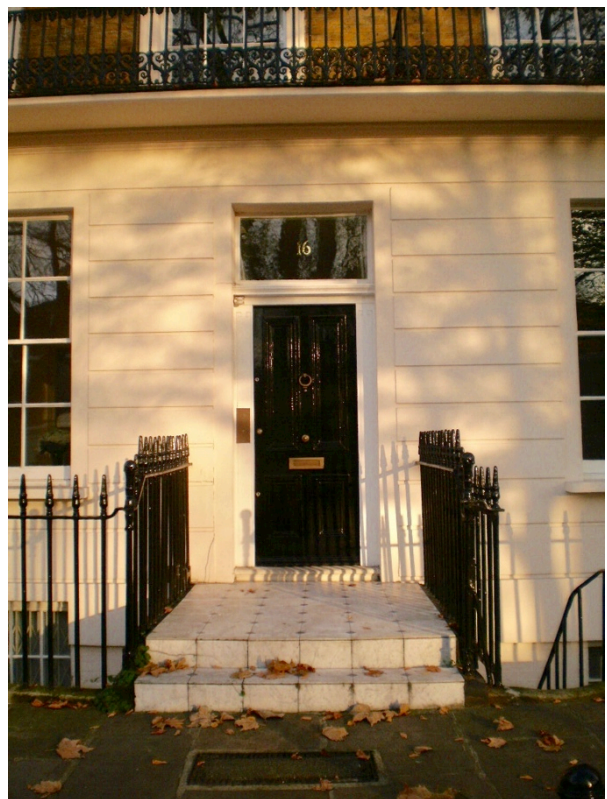
No. 16 Four-panelled door with ogee bolection mouldings - High Significance. Steps & landing clad in modern tiles - No Significance.

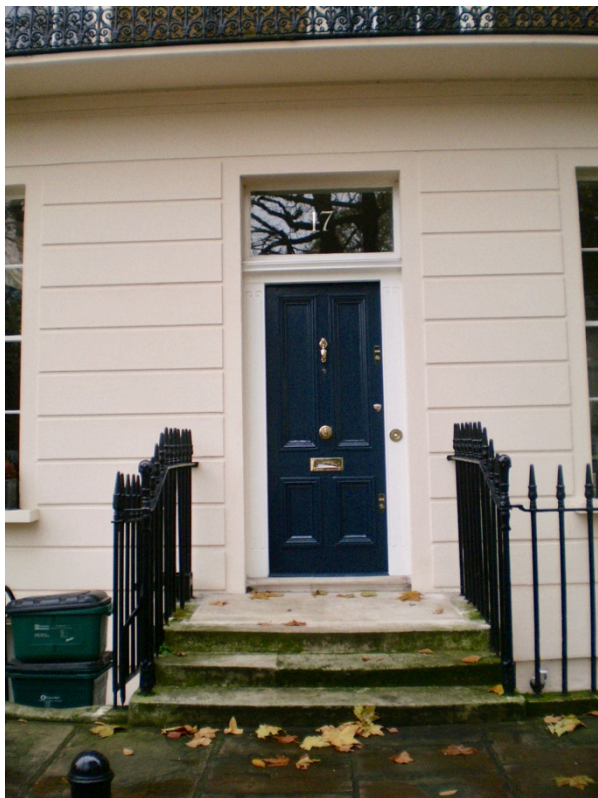
No. 17 Original Portland stone steps, four-panelled door with ogee bolection mouldings - High Significance. Landing reclad in Portland stone slabs - Low Significance.

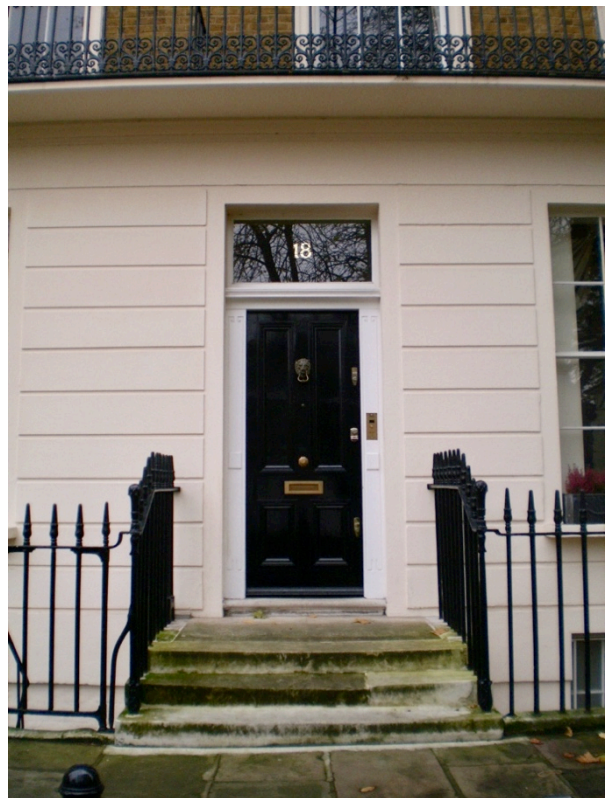
No. 18 Original Portland stone steps, four-panelled door with ogee bolection mouldings - High Significance. Landing reclad in Portland stone slabs - Low Significance.

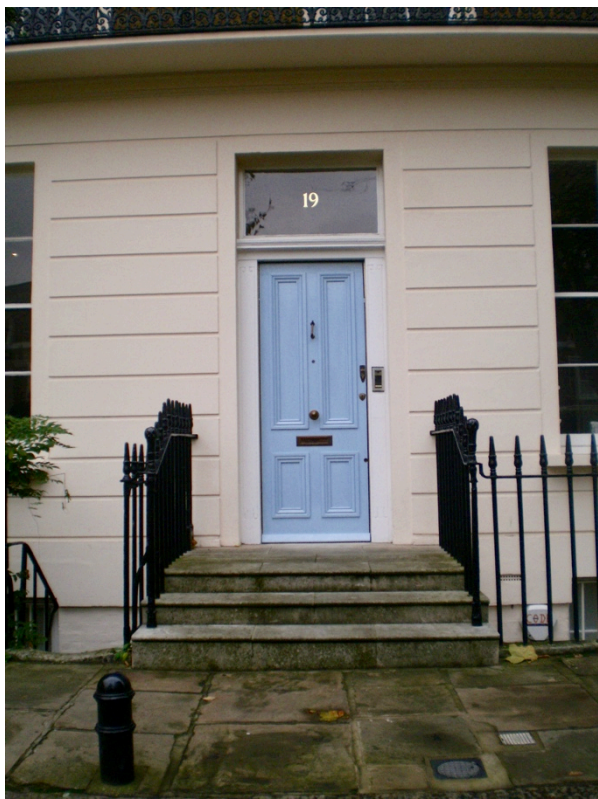
No. 19 Four-panelled door with ogee bolection mouldings - High Significance. Steps and landing reconstructed or clad in Portland stone - Low Significance.

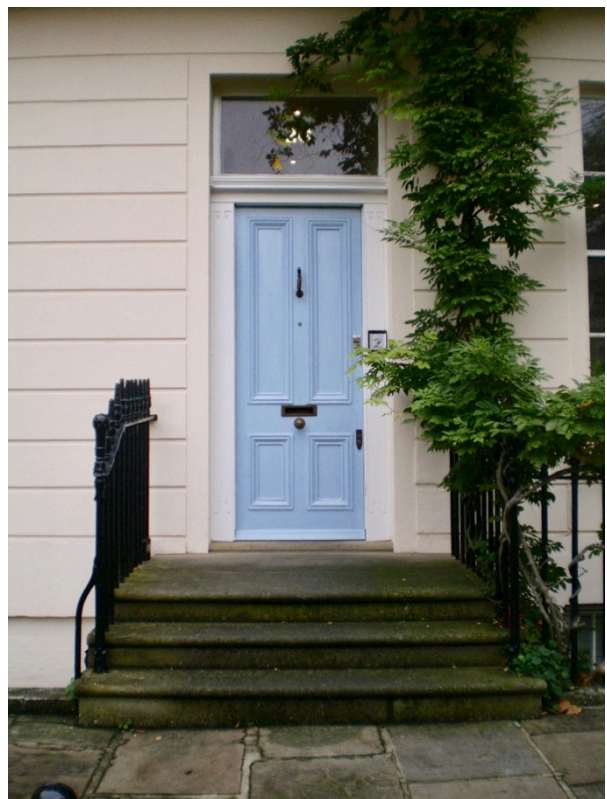
No.20 Four-panelled door with ogee bolection mouldings - High Significance. Steps and landing reconstructed in Portland stone - Low Significance
