SEDUM ROOF DETAILS

THE COTTAGE
LISSENDEN GARDENS
LONDON NW5 1ND

Drawing No: EXT INS 1-2

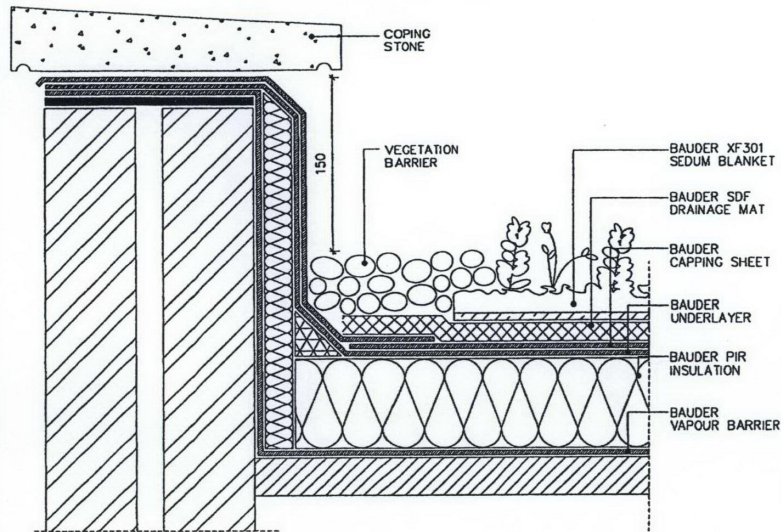
Upstand Detail Under Coping To
Brickwork (Cavity Wall)

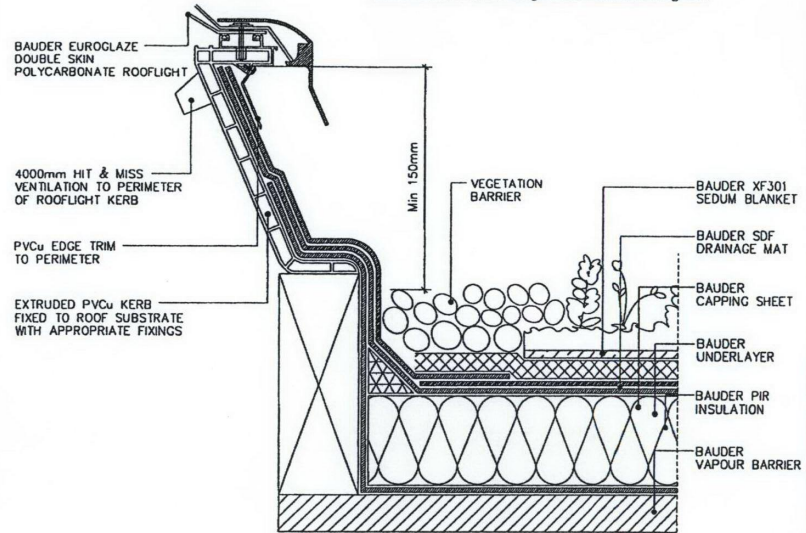
Bauder Euroglaze Rooflight

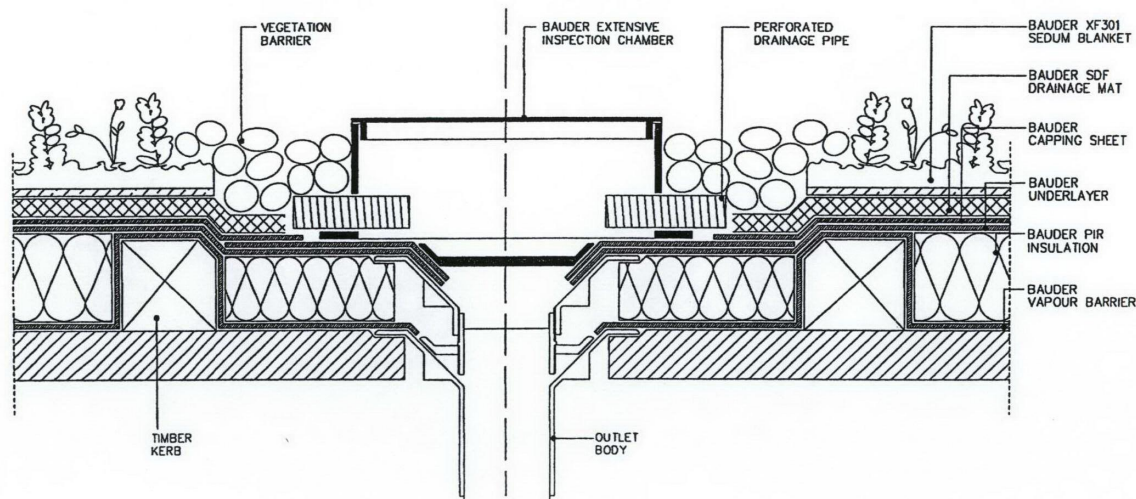
Section Through New Waste Outlet
