Concise Report leading to the replacement of the original 'Split' Ducted Air Conditioning System serving the Reception

VillageVet

Highgate Branch

Report Ref: Village Vet / Highgate / E7032 / JR

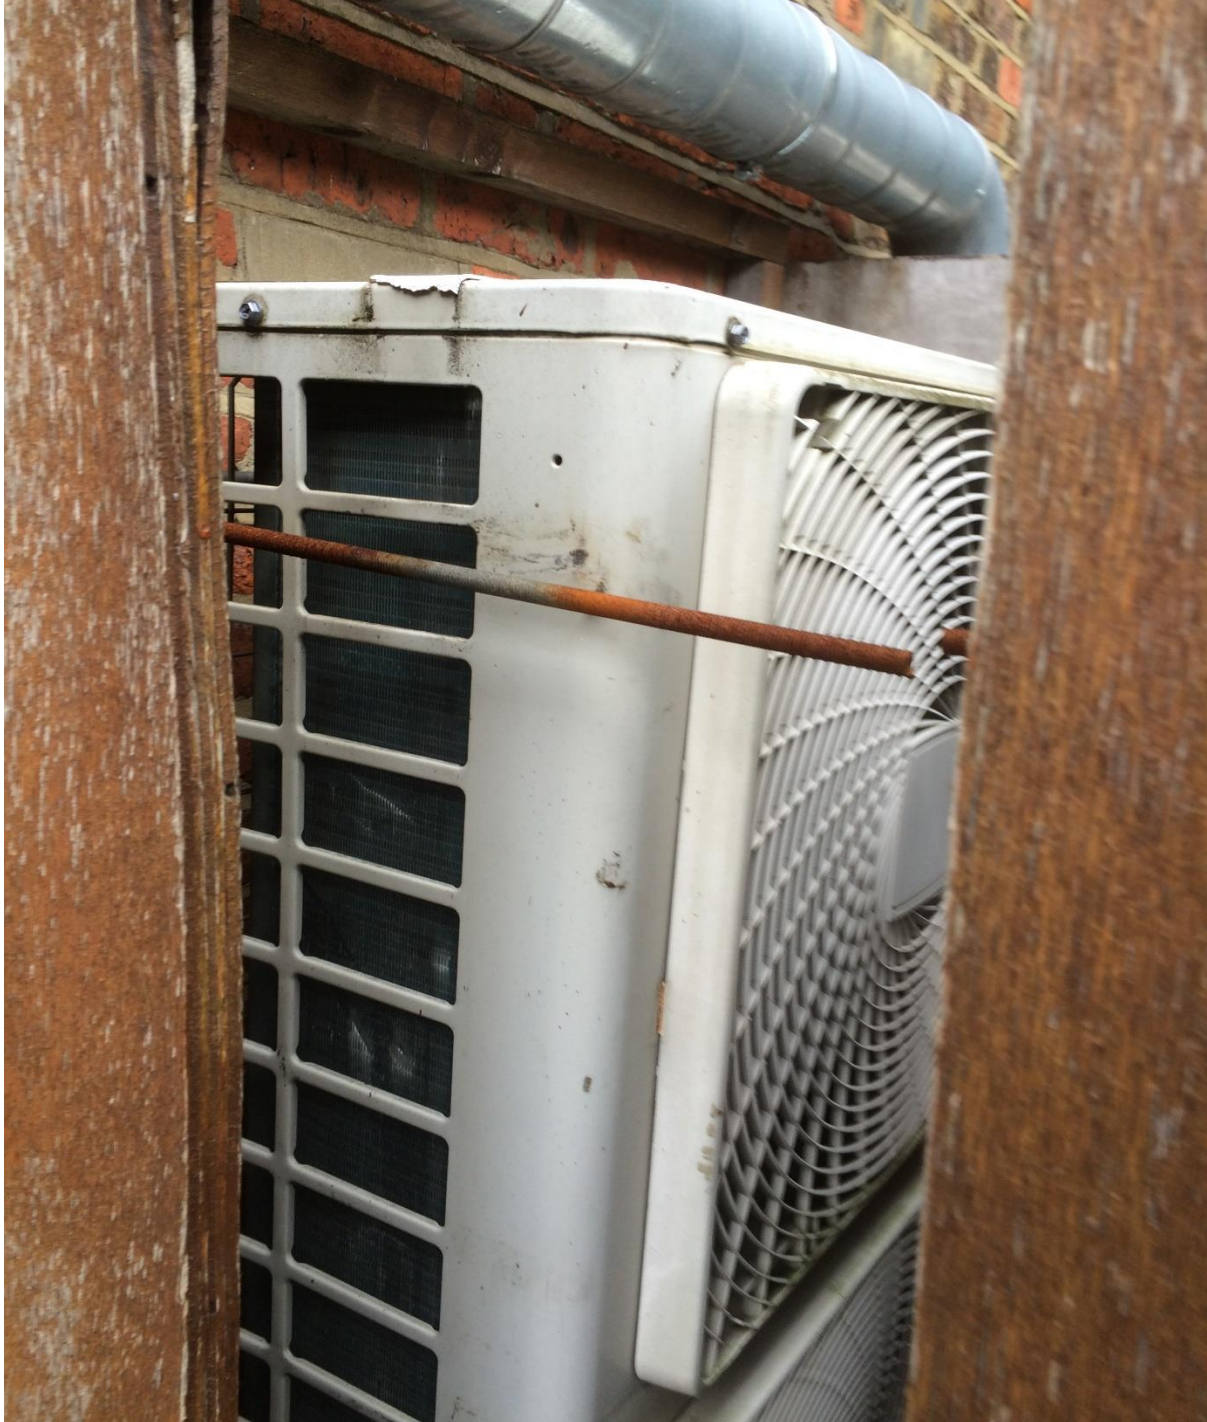
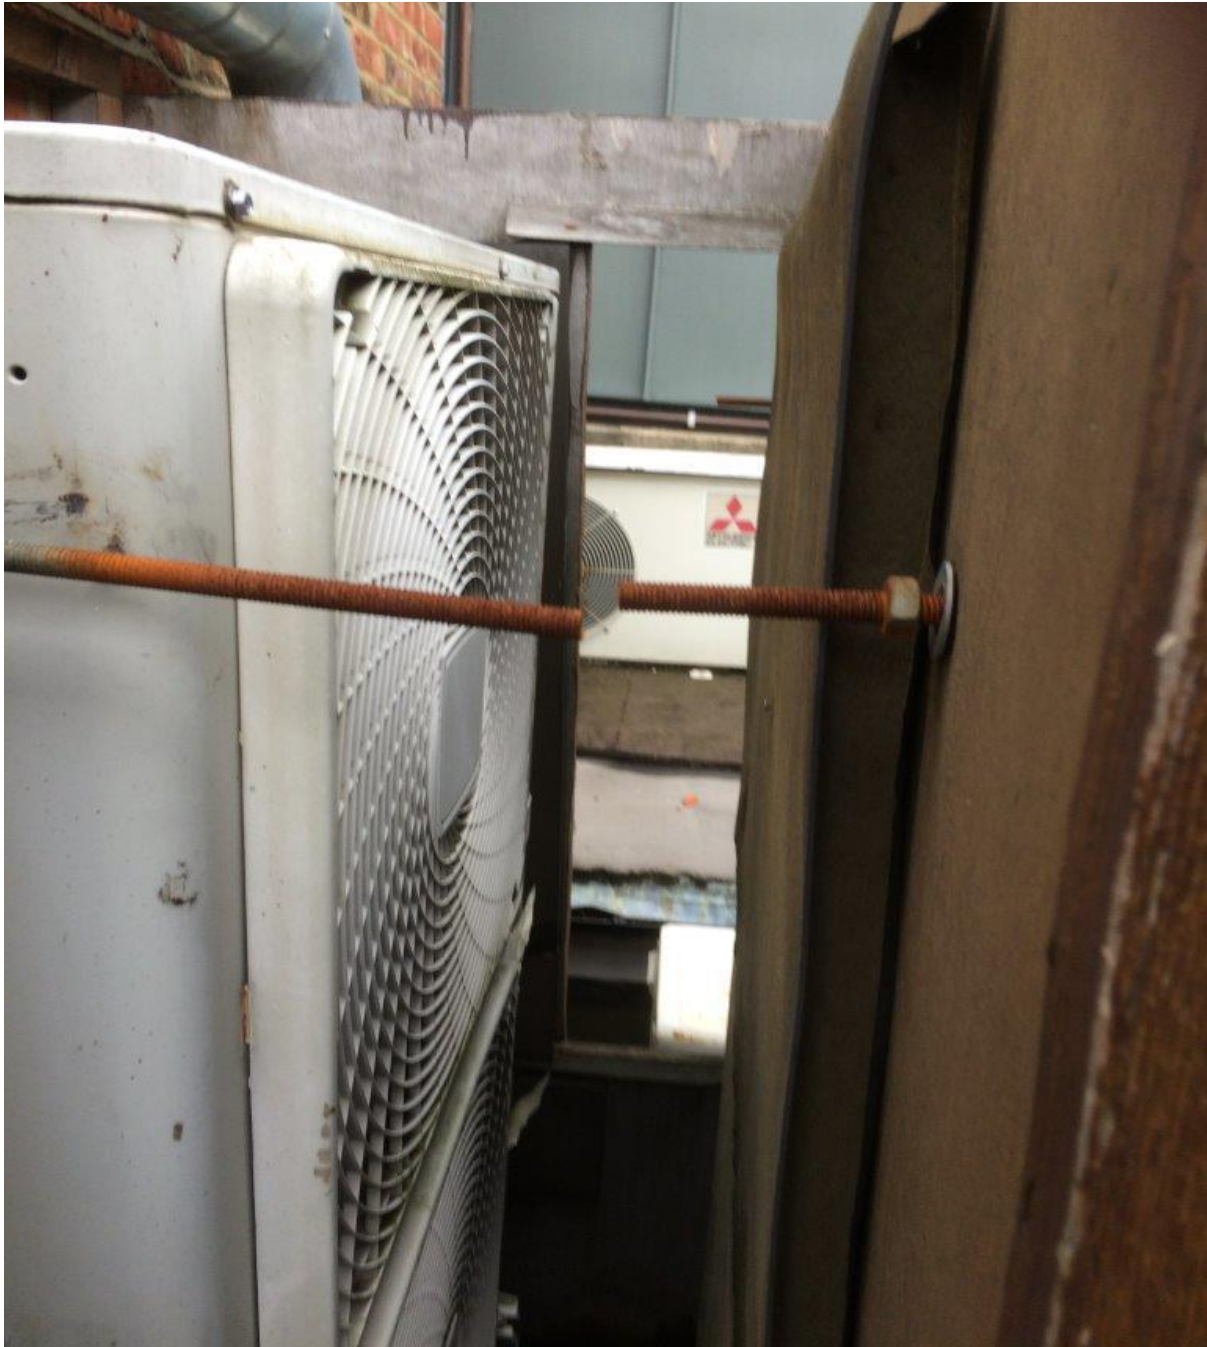
The original outdoor Condenser had a Plywood 'Acoustic' Barrier installed around it at some point and we would believe that this was done in an attempt to reduce the noise emanating from the original Condenser. The Plywood 'Acoustic' Barrier was installed too close to the outdoor Condenser therefore causing all types of problems for the dissipating air discharge and causing the gradual and eventually the final breakdown (Simplified sequence of events) of internal parts within the Condenser. It is recommended by Daikin, the manufacturer, that any Barrier and in this instance a Plywood 'Acoustic' Barrier should have been installed a minimum of 1,000mm away from the discharge fans of the

Condenser. We have attached two (2) pictures of the original Plywood 'Acoustic' Barrier as well as the Daikin RYP100B7V1 outdoor Condenser to illustrate the closeness of the barrier to the Condenser.

We replaced the original Daikin RYP100B7V1 outdoor Condenser and corresponding indoor Fan Coil unit with a new Daikin RZQSG100L9V1B outdoor Condenser and corresponding new indoor Fan Coil

unit. The new indoor Fan Coil unit was again installed onto the Anti-vibration mounts. I have attached the technical brochure of the new RZQSG100L9V1B. You will immediately notice that the new Daikin RZQSG100L9V1B has only one (1) discharge Fan in comparison to the two (2) discharge fans of the original outdoor Condenser, therefore, making the new Condenser quieter.
