ALLUM HOUSE
8 SLADE LANE
ELSTREE, HERTFORDSHIRE
WD6 3PL
Camden Chinese Community Centre
9 Tavistock Place
London WC1H 9SN

PROPOSED DETAIL PLANS

DATE: 12.05.17 SCALE: 1:50@A1
DRAWN: RT CHECKED: SM
DRAWING NUMBER: 1704/P/2201/B

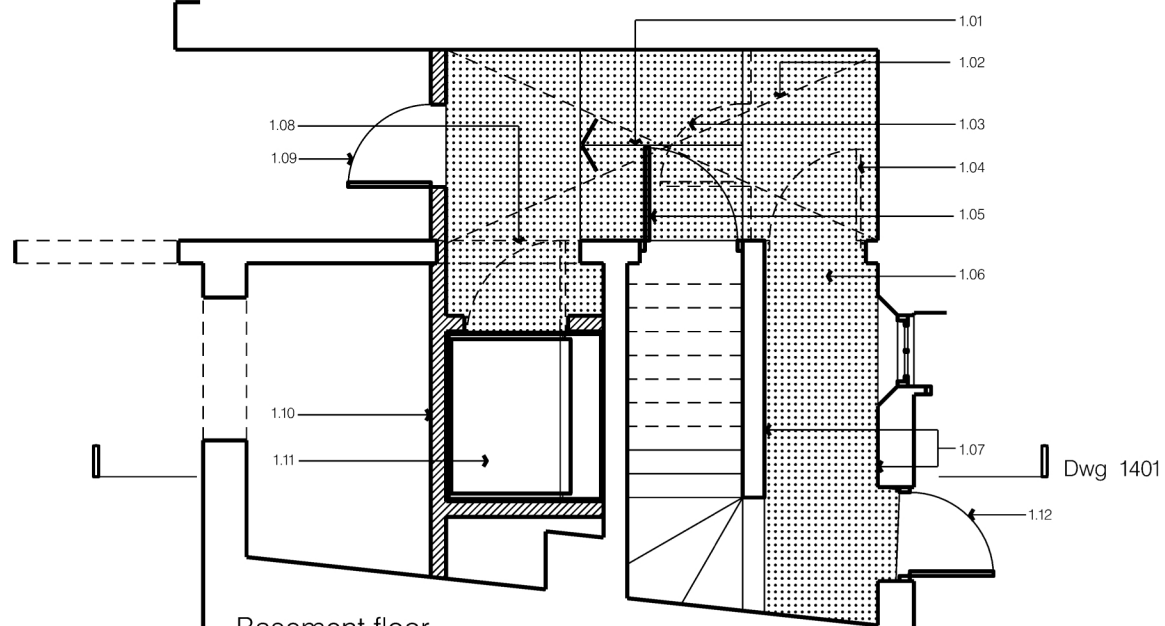
Basement floor

- 1.01 Construct 1:20 ramp to raise lift landing 50mm above existing FFL
- 1.02 High level piped services and soffit over this area to be painted out
- 1.03 Existing door and frame removed and walls made good

- 1.04 Existing door and frame removed and walls made good
- 1.05 New 12hr painted solid core fire door and frame to replace existing
- 1.06 New rubber floor covering (Dalsouple or similar) on levelling screed over hatched area

- 1.07 Existing fair-faced brick work to be painted with emulsion paint within hatched area
- 1.08 Remove existing concrete kerb across threshold
- 1.09 New 1hr painted solid core fire door and frame

- 1.10 New non-load bearing lightweight full height partition forming one side of lift shaft with 1 hr fire resistance (hatched)
- 1.11 New DDA compliant platform lift and lift enclosure by lift supplier

- 1.12 New 1hr painted solid core fire door and frame with vision panel to replace existing
- 1.13 12hr dry-lined partition

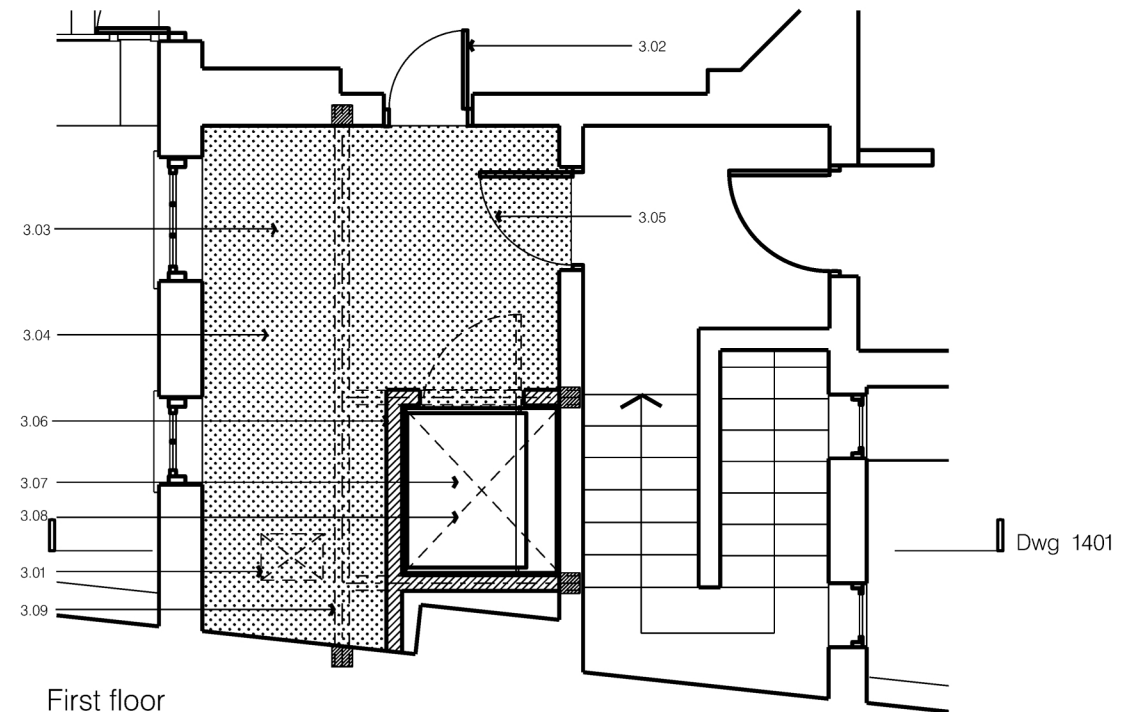
First floor

- 3.01 Relocate existing ceiling access hatch to this position
- 3.02 Replace with new 12hr painted solid core fire door and frame with vision panel
- 3.03 New carpet tiles (Heuga or similar) over hatched area
- 3.04 Make good and redecorate walls and ceiling with emulsion paint within hatched area
- 3.05 Replace with 12hr painted solid core fire door and frame
- 3.06 Non-load bearing lightweight full height partition forming one side of lift shaft with 1 hr fire resistance (hatched)
- 3.07 New DDA compliant platform lift and lift enclosure by Lift supplier
- 3.08 Form new opening approx 1650 x 1500mm through existing concrete floor slab
- 3.09 Steel trimmer beams for new opening in first floor slab to structural engineer's details with 1hr fire protection

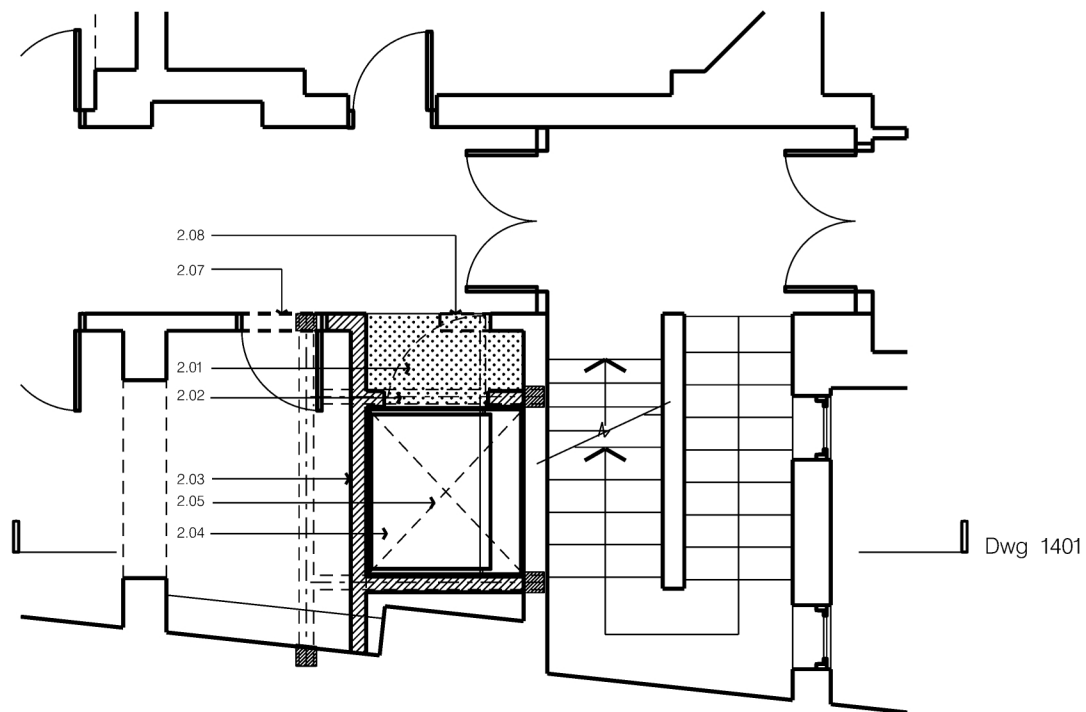
Ground floor

- 2.01 Make good and redecorate existing walls and ceiling with emulsion paint within hatched area
- 2.02 Make good existing timber boarded floor in this area
- 2.03 Non-load bearing lightweight full height partition forming one side of lift shaft with 1 hr fire resistance (hatched)
- 2.04 New DDA compliant platform lift and lift enclosure by Lift supplier
- 2.05 Form new opening approx 1650 x 1500mm through existing concrete floor slab
- 2.06 Steel trimmer beams for new opening in ground floor slab to structural engineer's details with 1hr fire protection
- 2.07 New doorway through existing drylining
- 2.08 Enlarge existing wall opening for disabled access to lift. Make good finishes to match existing.
