PROJECT
KIDDERPORE AVENUE

DRAWING
Kidderpore Hall
Typical Roof Details

9000-DRG-00KH-DE003 REVISION N C2

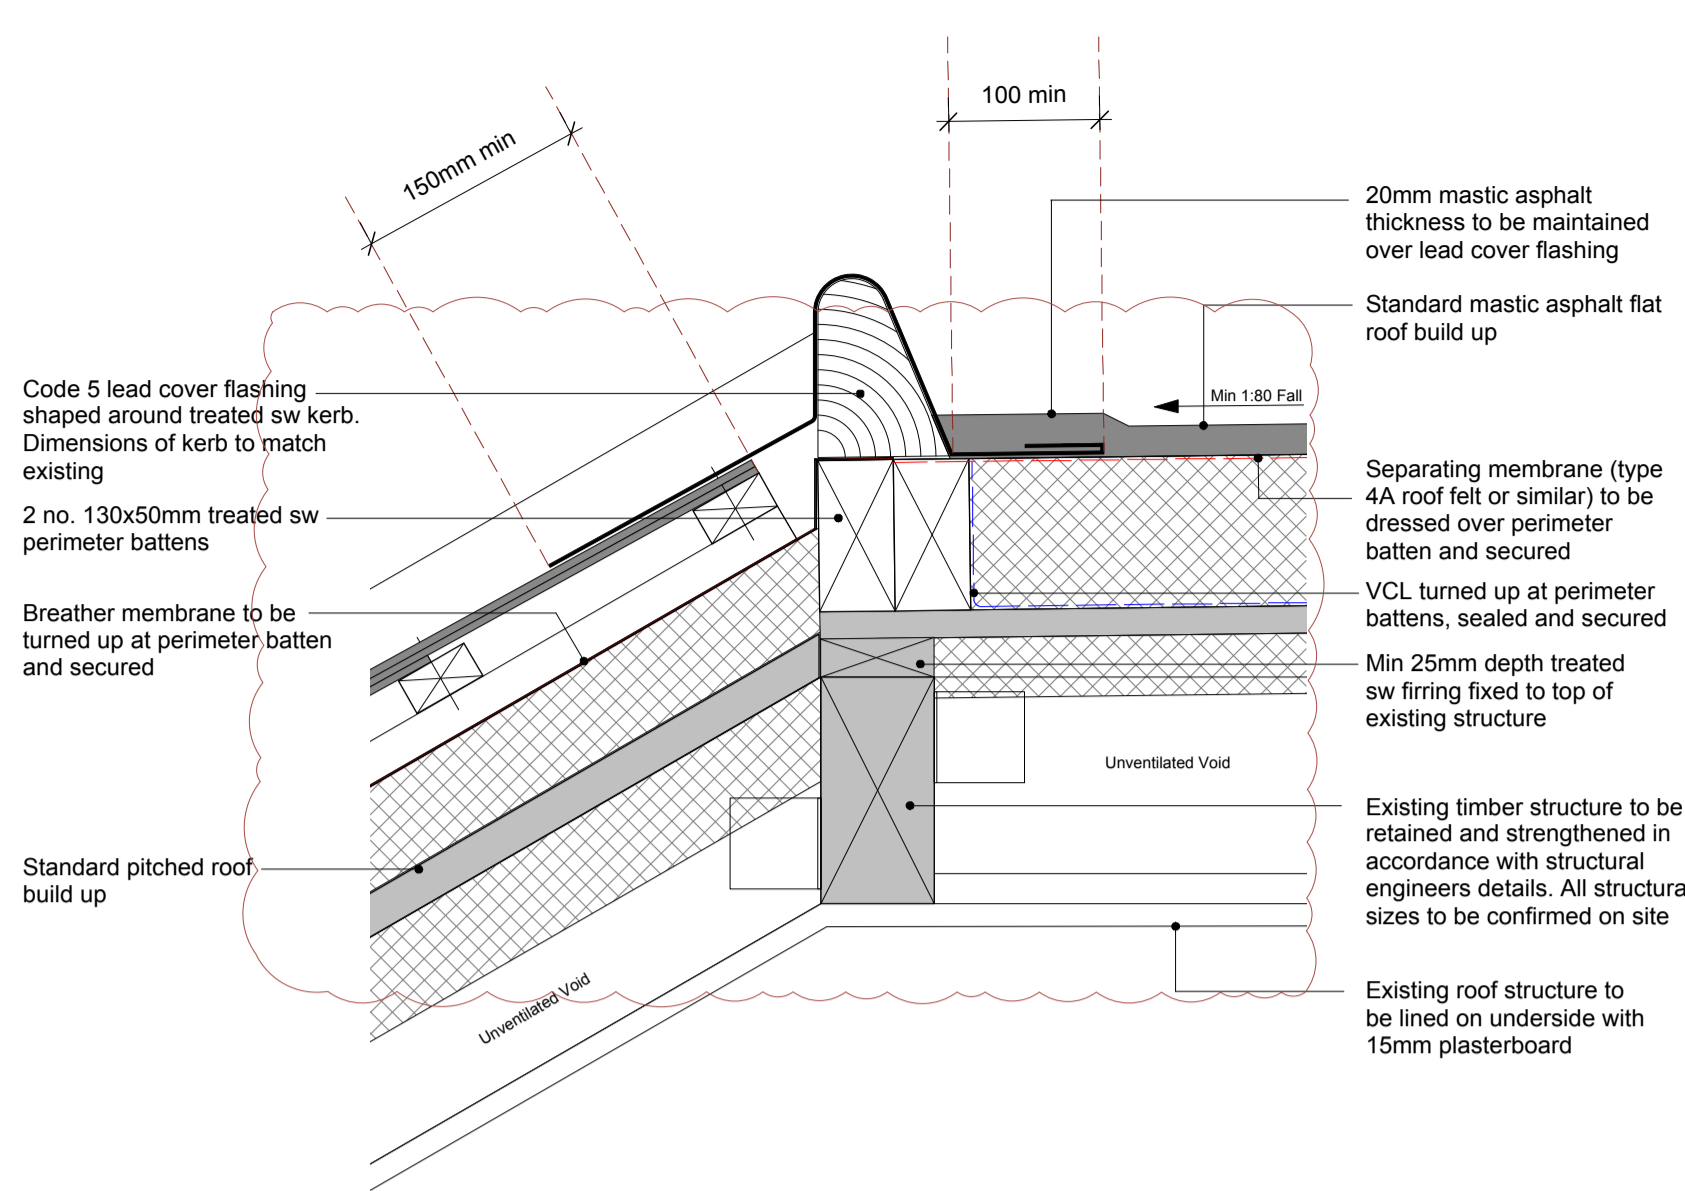
Detail 1: Typical Tile Pitched Roof / Mastic Asphalt Flat Roof Junction (1:5 @ A1)

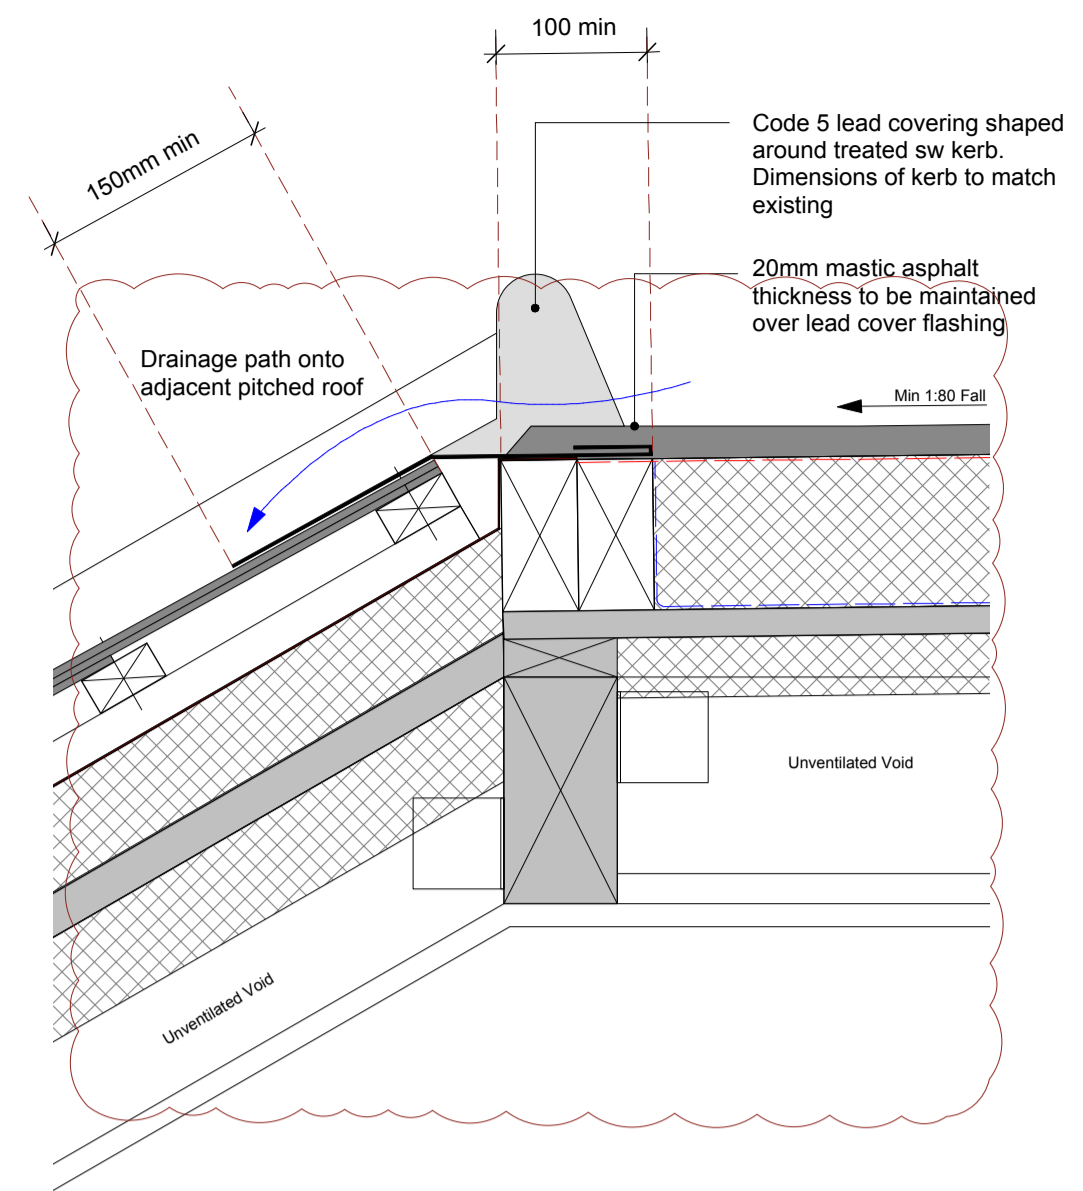
Detail 2: Drainage Detail at Perimeter Kerb (1:5 @ A1)

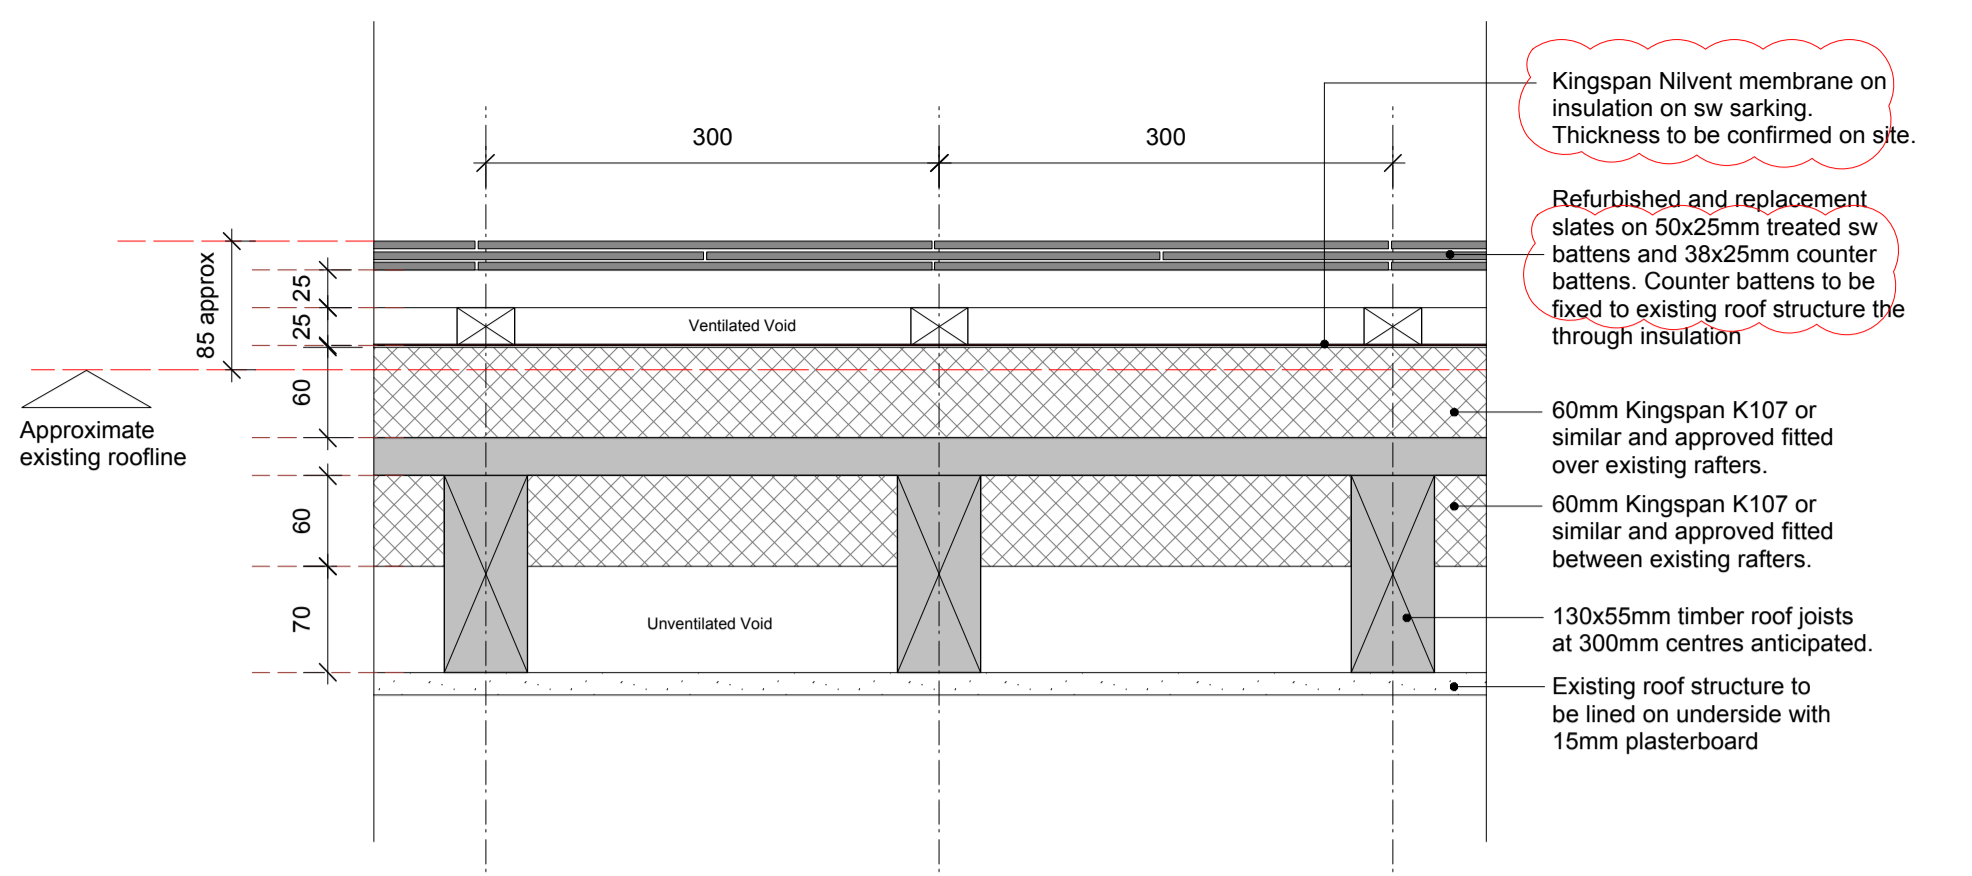
Typical Pitched Roof Build Up (1:5 @ A1)

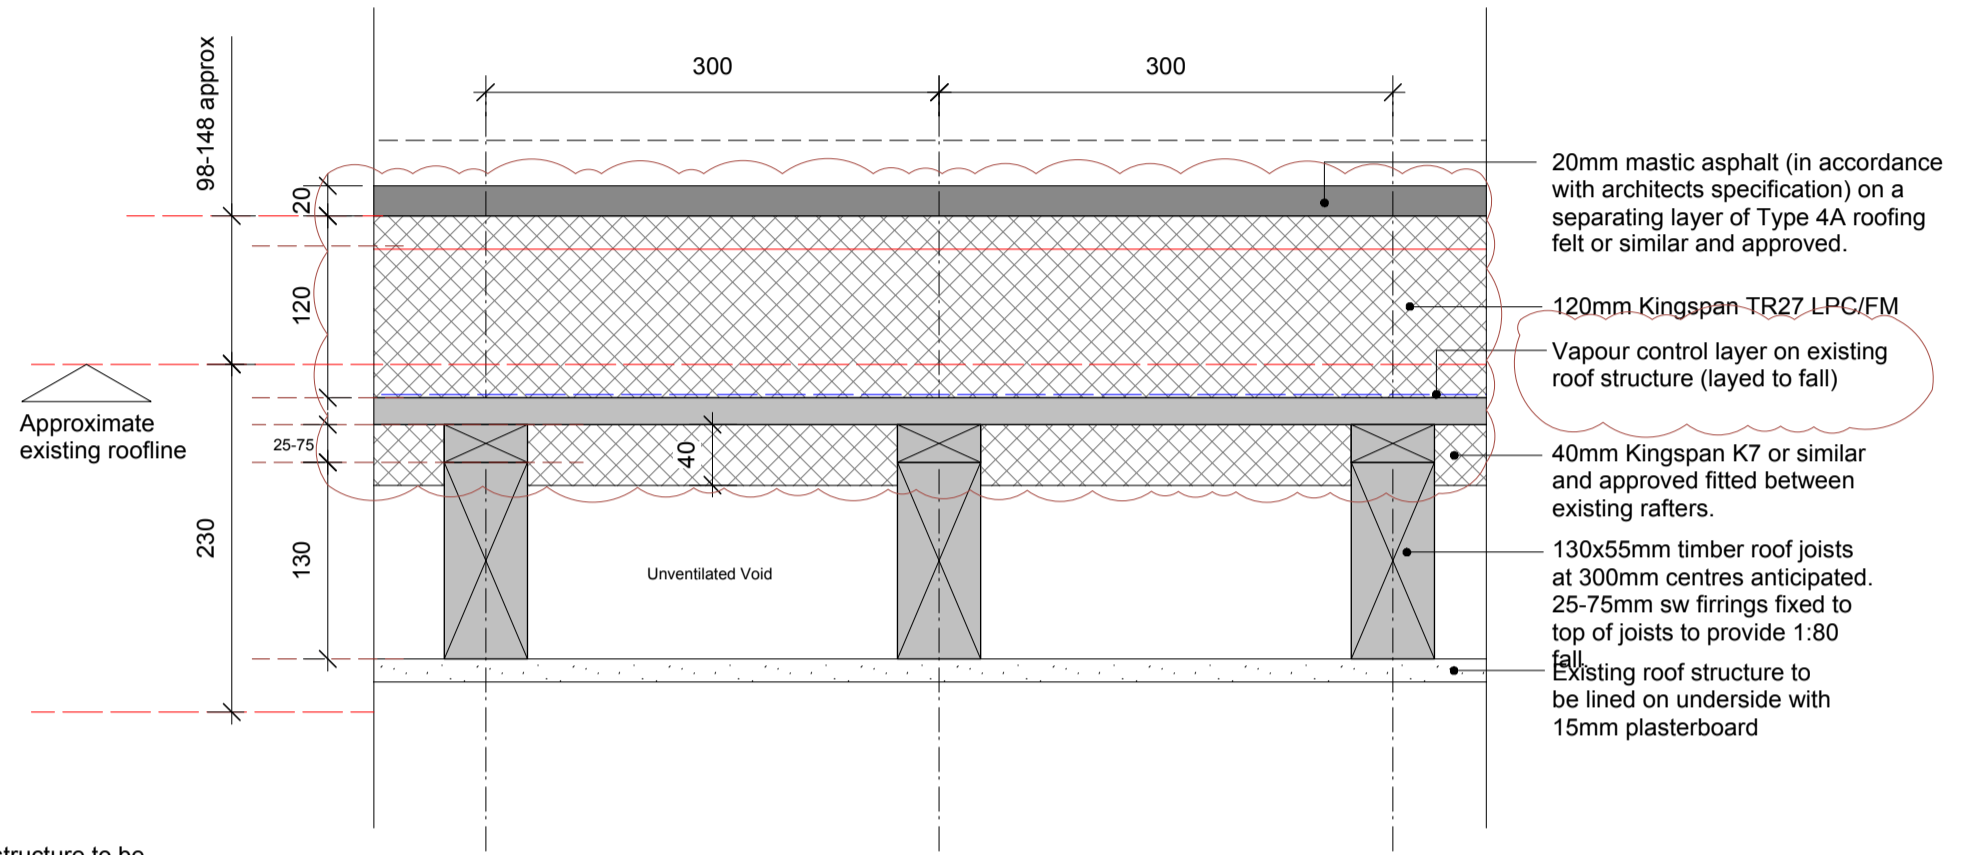
Typical Mastic Asphalt Flat Roof Build Up (1:5 @ A1)

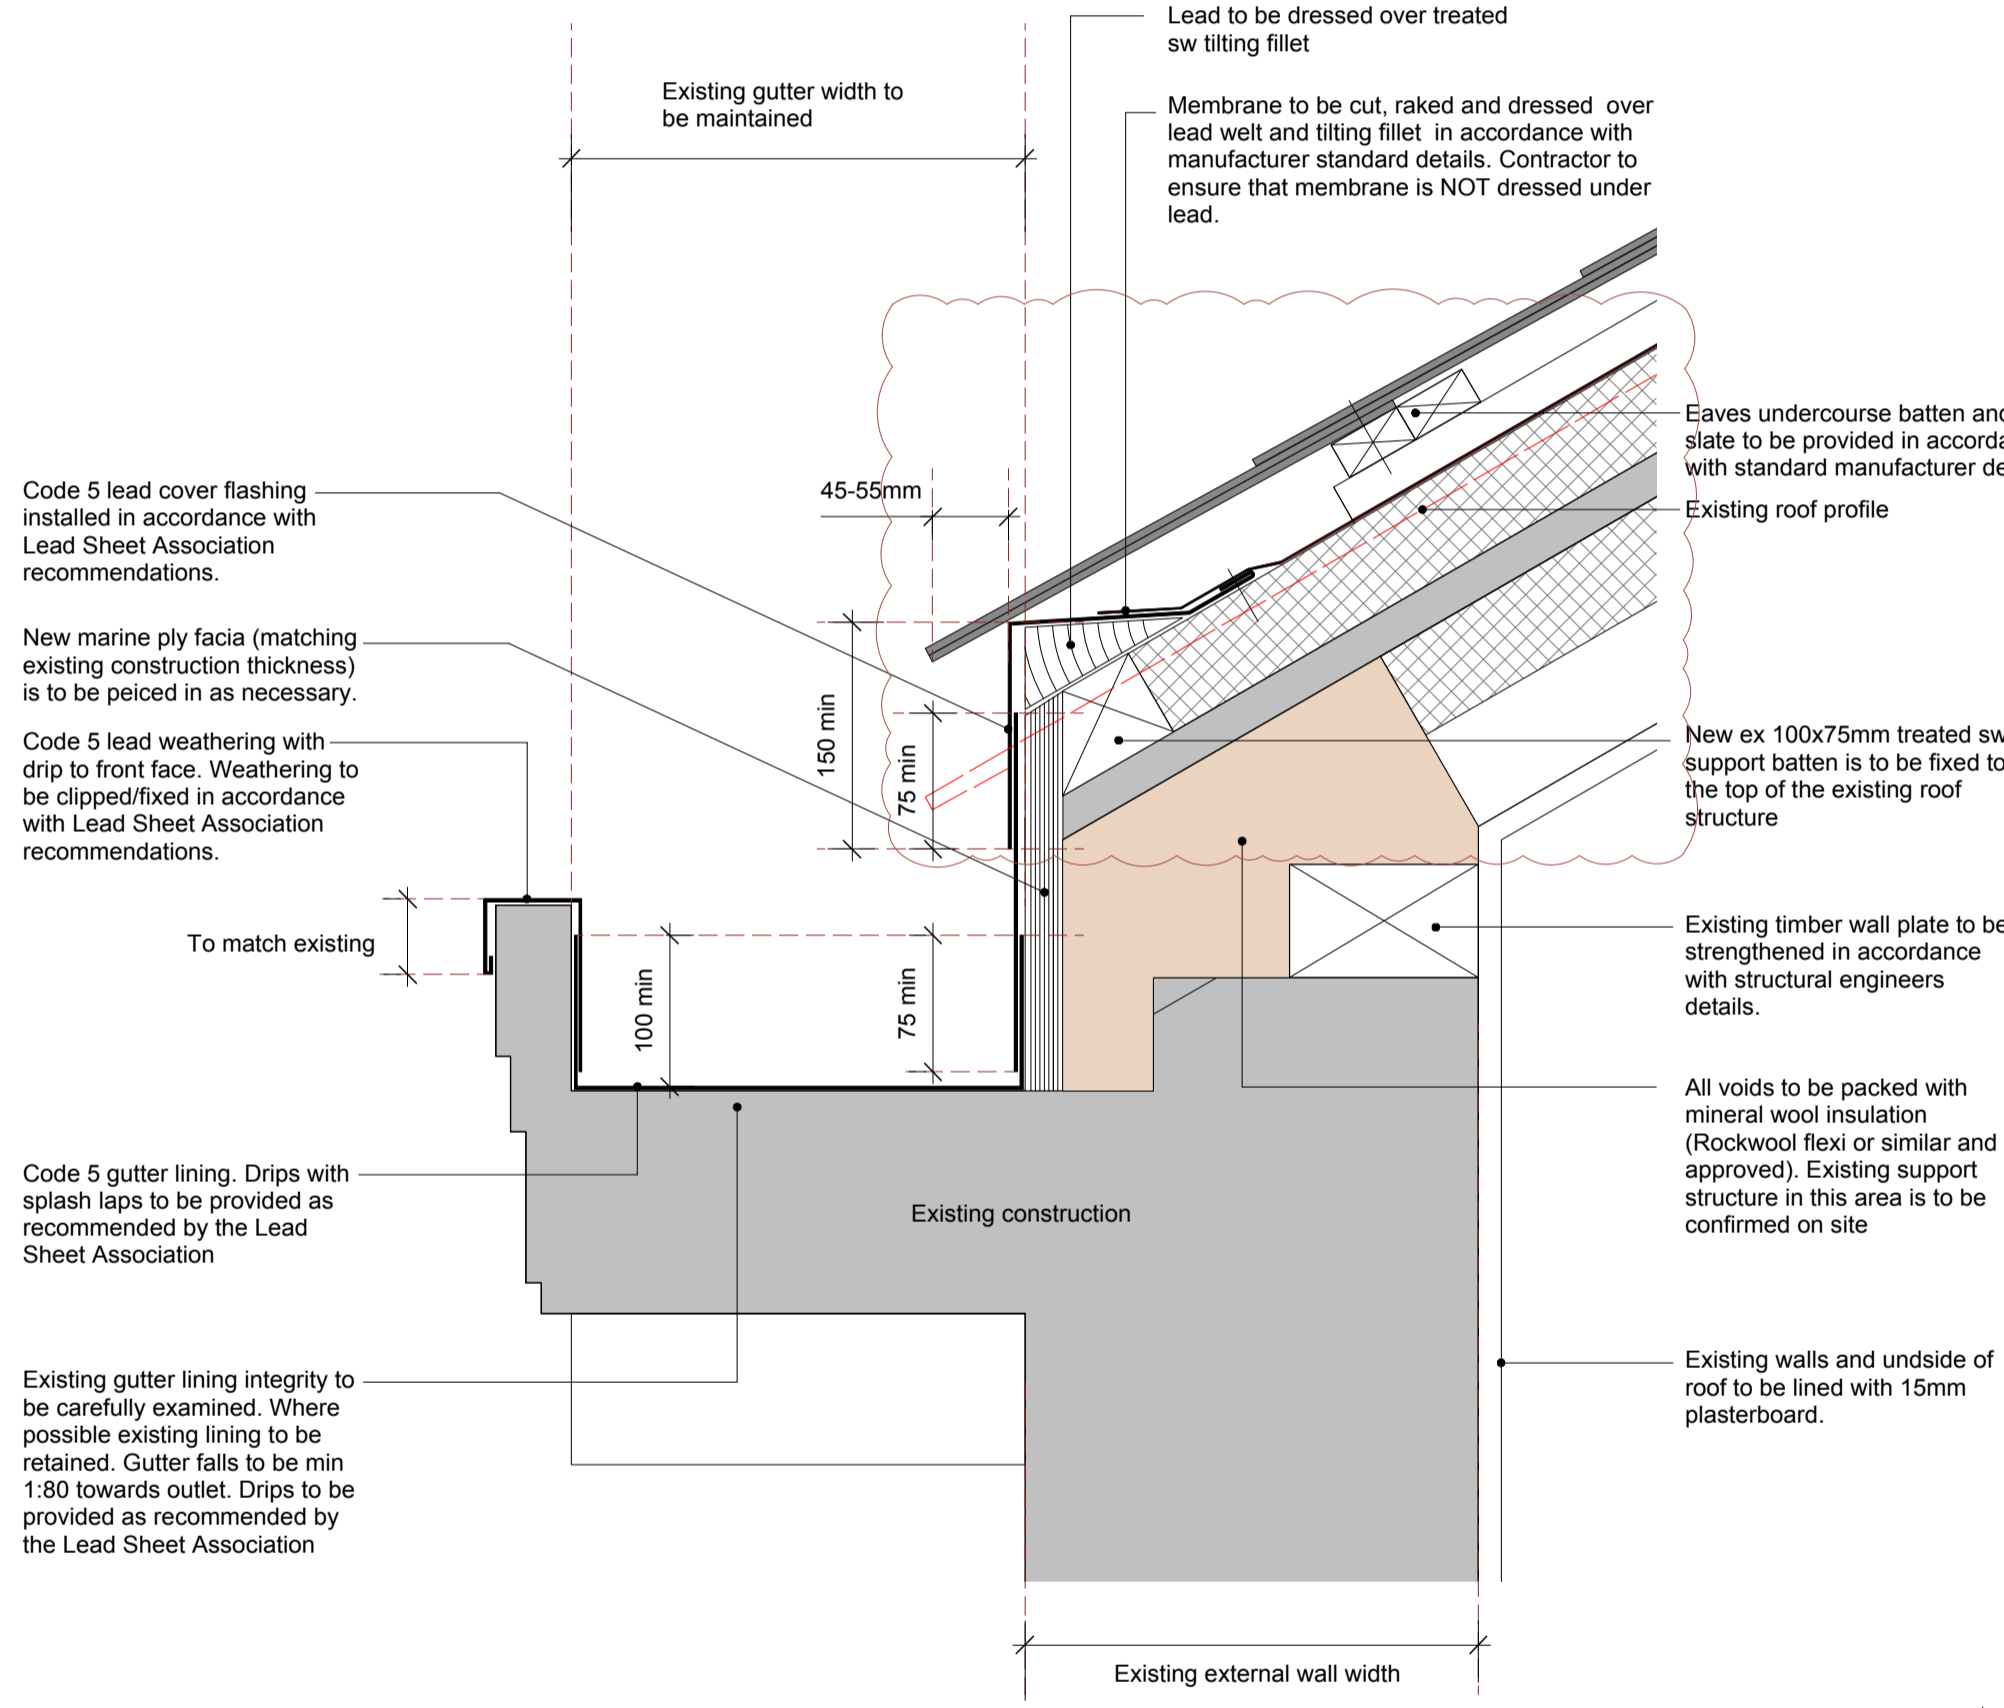
Detail 3: Typical Eaves Gutter Detail (1:5 @ A1)

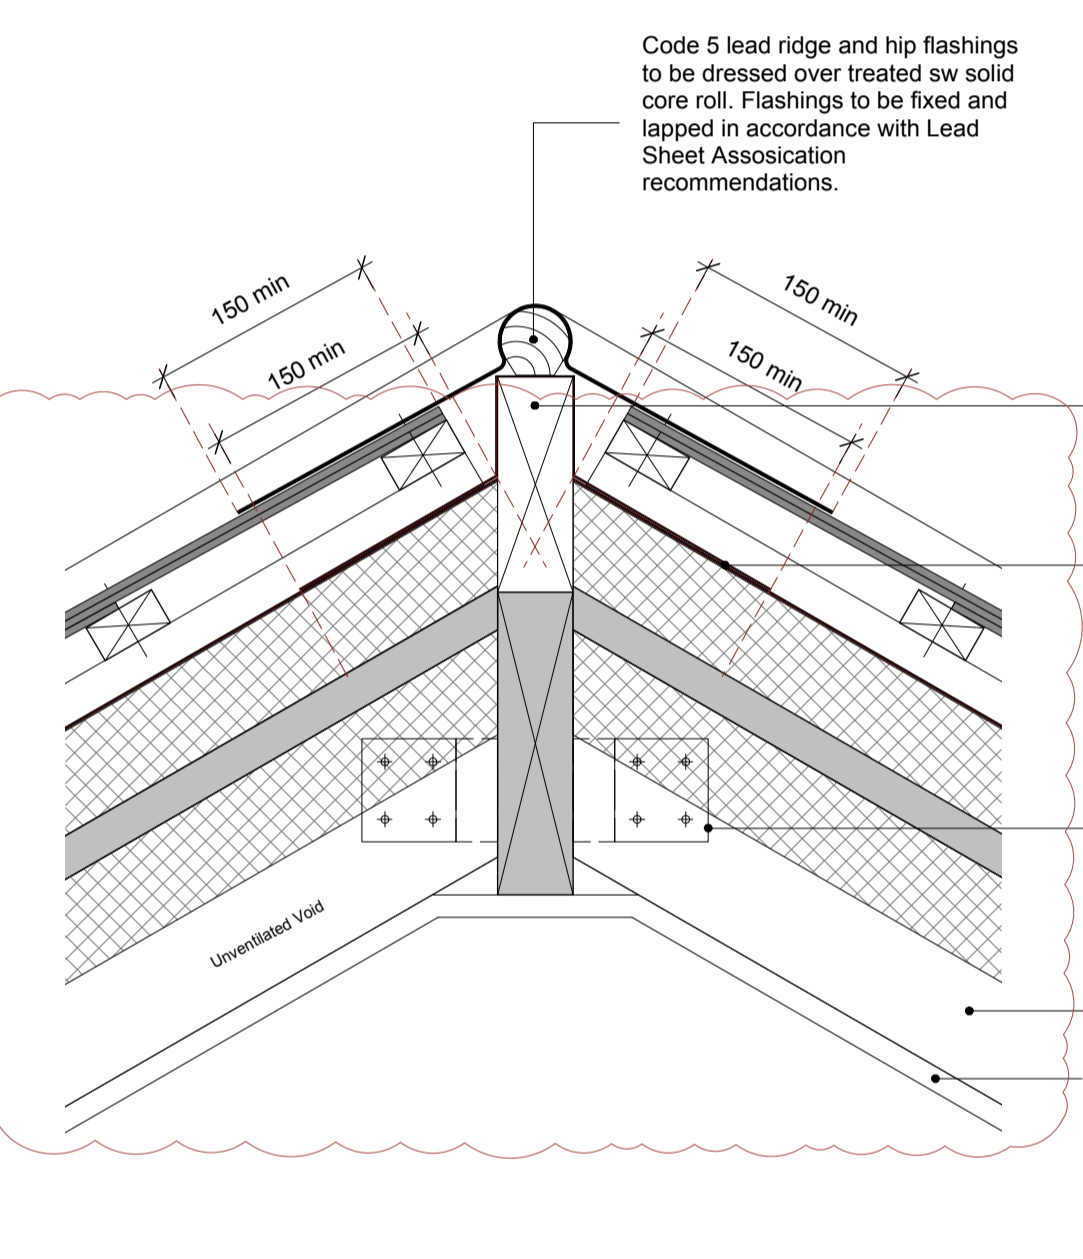
Detail 4: Typical Slate Ridge/Hip Detail (1:5 @ A1)

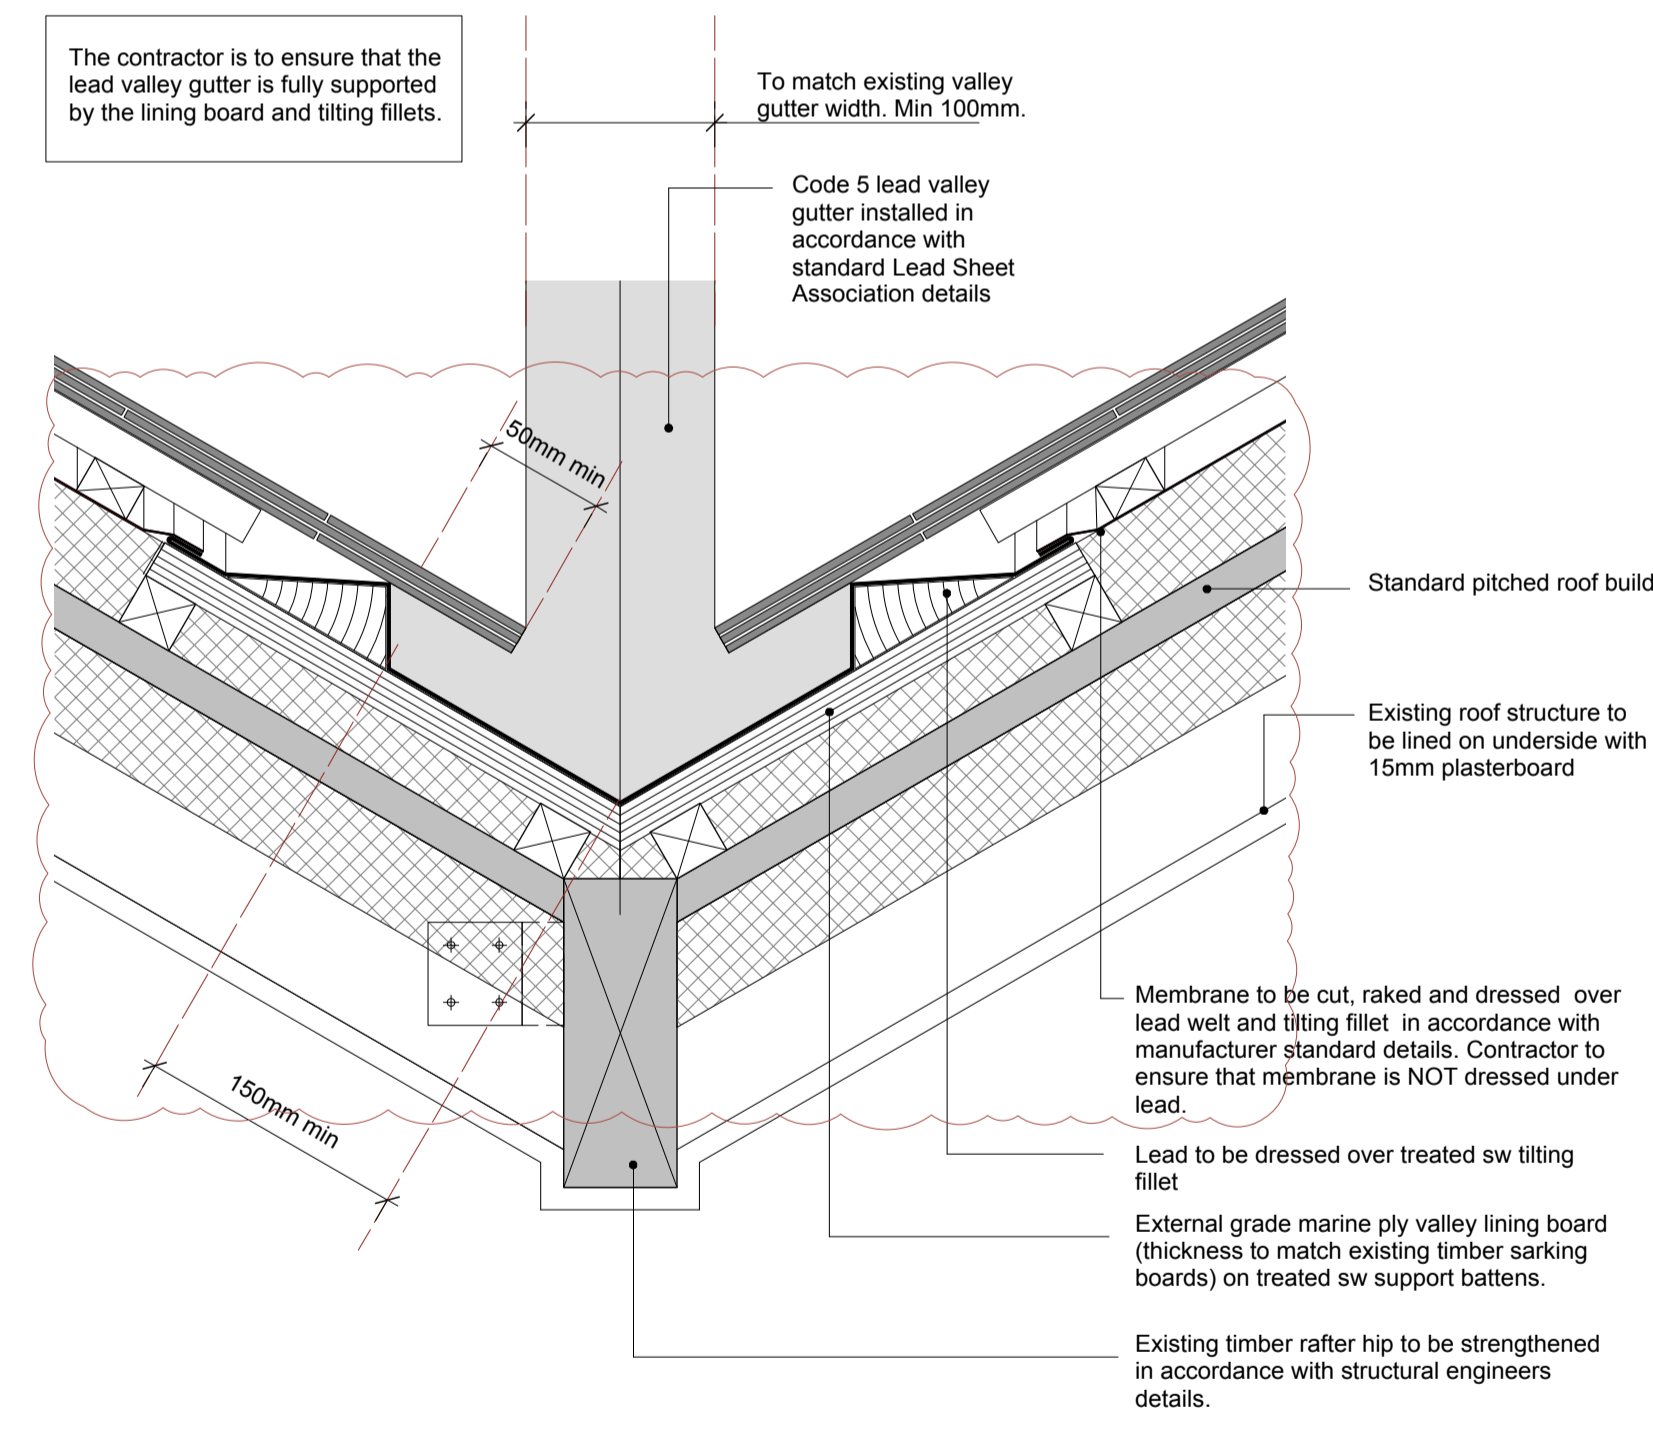
Detail 5: Typical Lead Lined Valley Detail (1:5 @ A1)
