## 2. Environmental Permits, Incidents and Registers Map

# 3. Landfill and Other Waste Sites Map

Report Reference: SCL-4072311

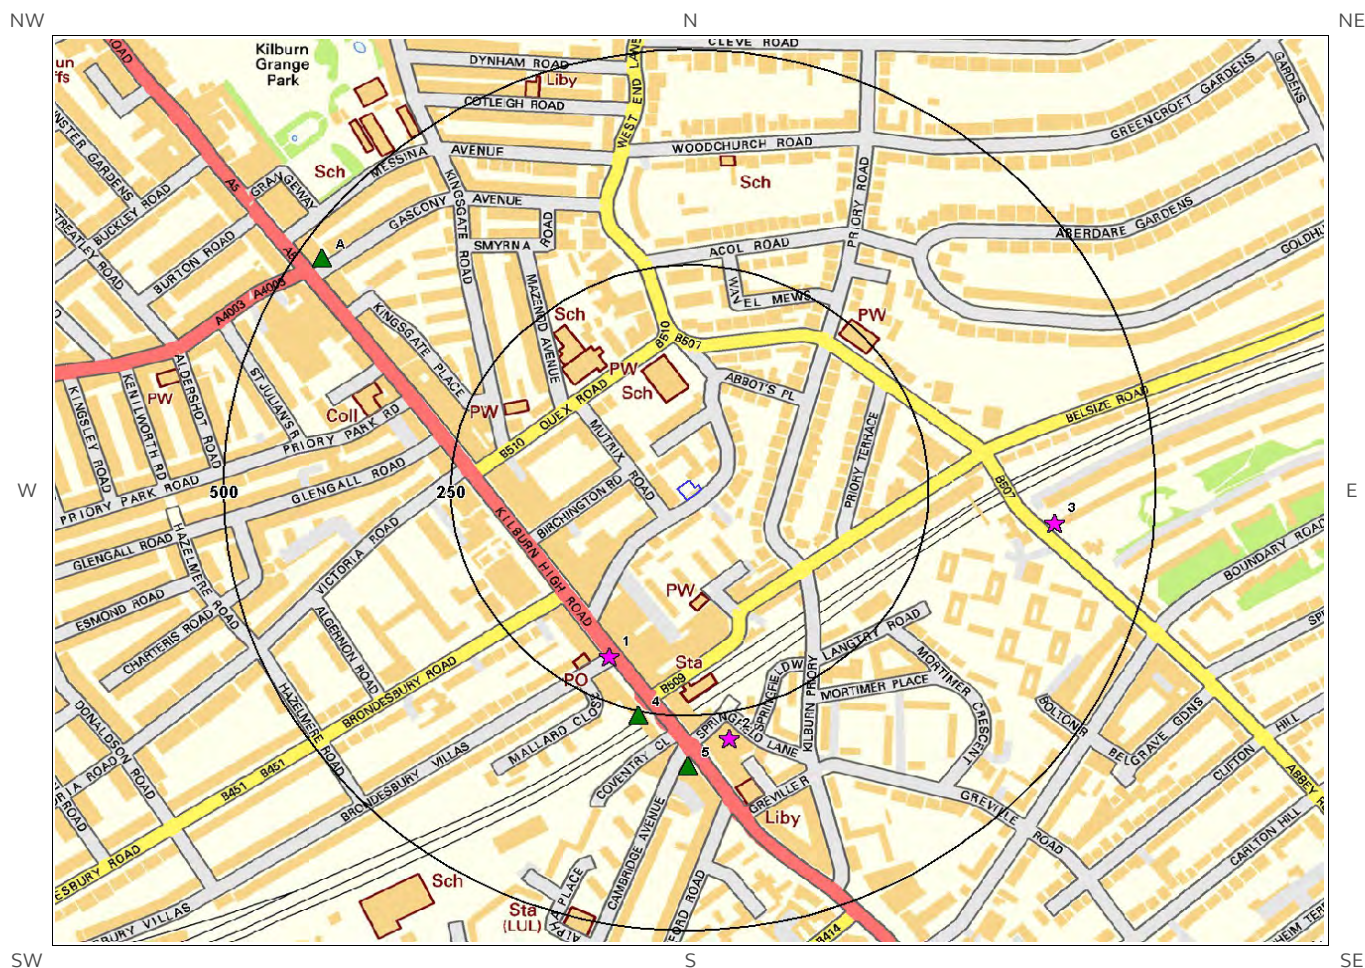
The following Part A(2) and Part B Activities are represented as points on the Environmental Permits, Incidents and Registers Map:

The following NIRS List 2 records are represented as points on the Environmental Permits, Incidents and Registers Map:

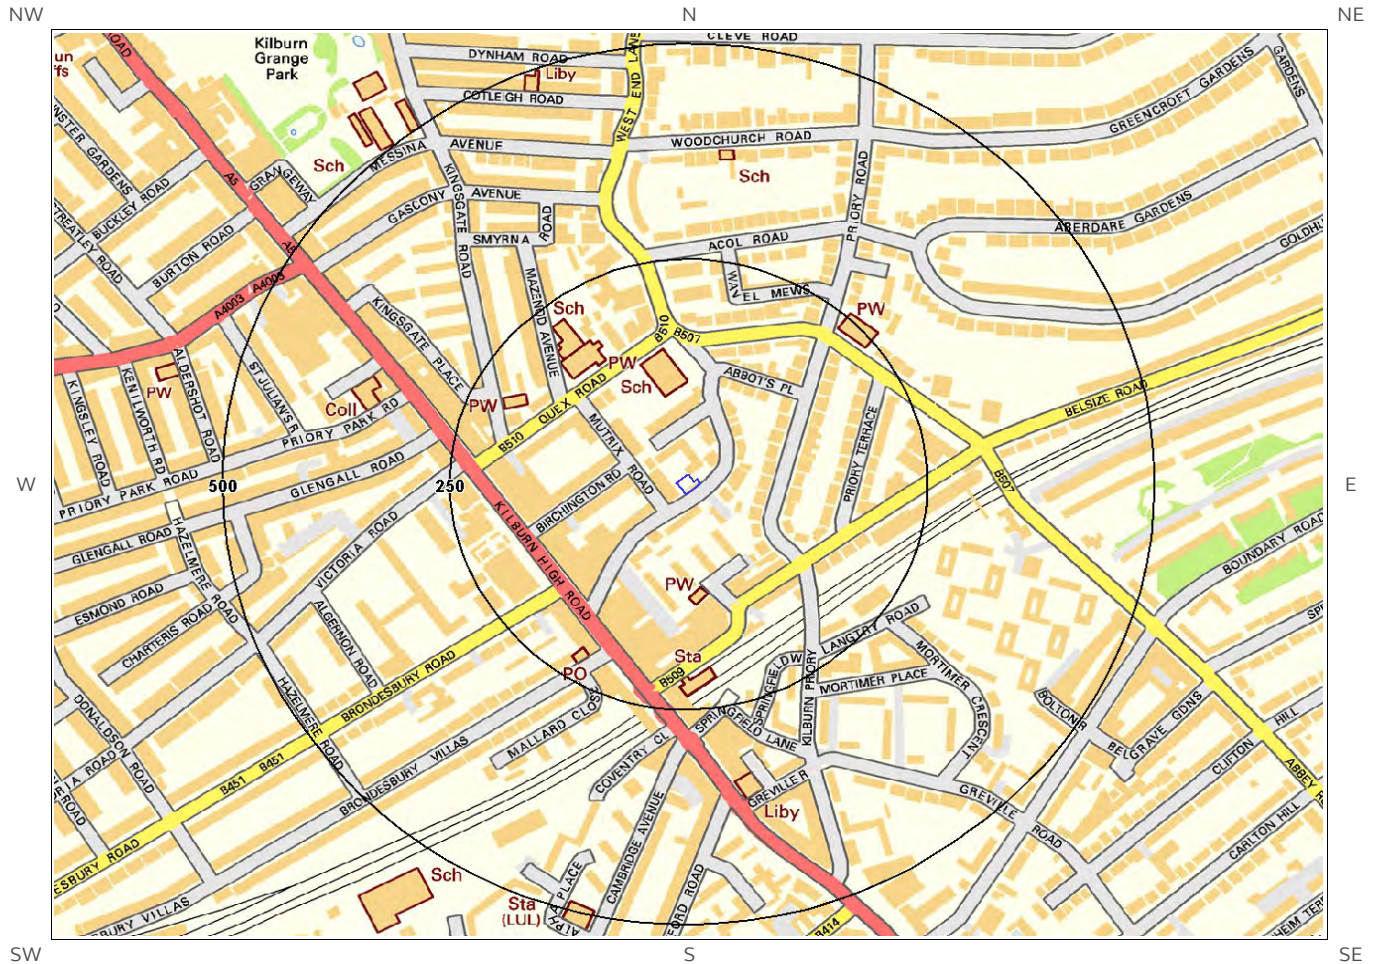
The following landfill records are represented as either points or polygons on the Landfill and Other Waste Sites map:

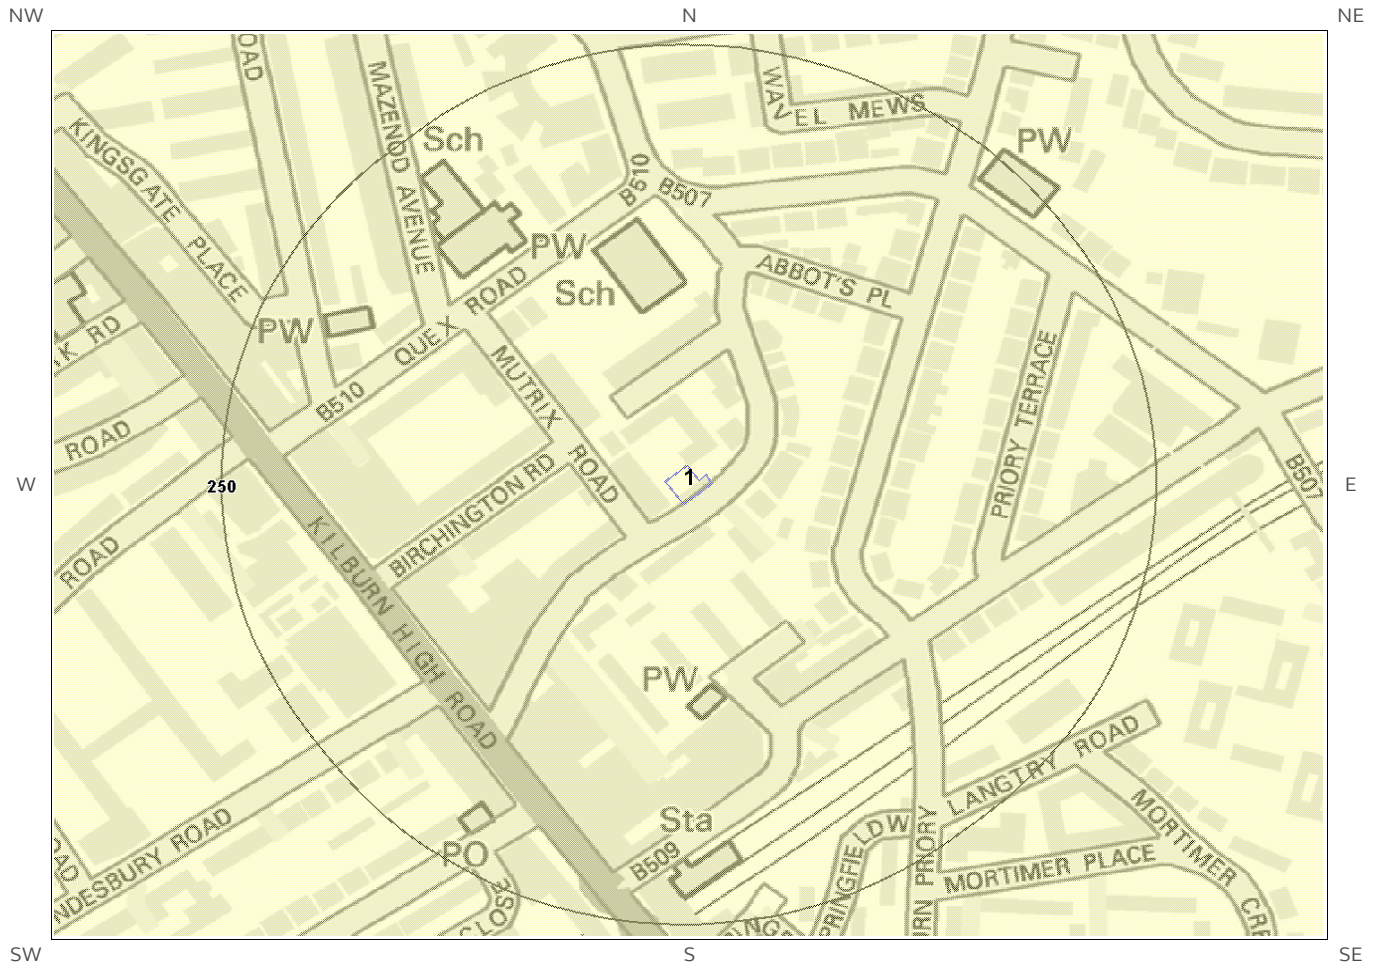
# 6.3 Ground Dissolution of Soluble Rocks Map

| ID | Distance (m) | Direction | Hazard Rating | Details |
|---|---|---|---|---|
| 1 | 0.0 | On Site | Negligible | Soluble rocks are present, but unlikely to cause problems except under exceptional conditions. No special actions required to avoid problems due to soluble rocks. No special ground investigation required, and increased construction costs or increased financial risks are unlikely due to potential problems with soluble rocks. |
