MASTER PLAN  
1:100

SECTION A-A  
1:100

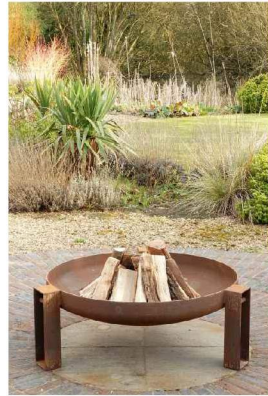
Outdoor Vulcano firepit Ø600

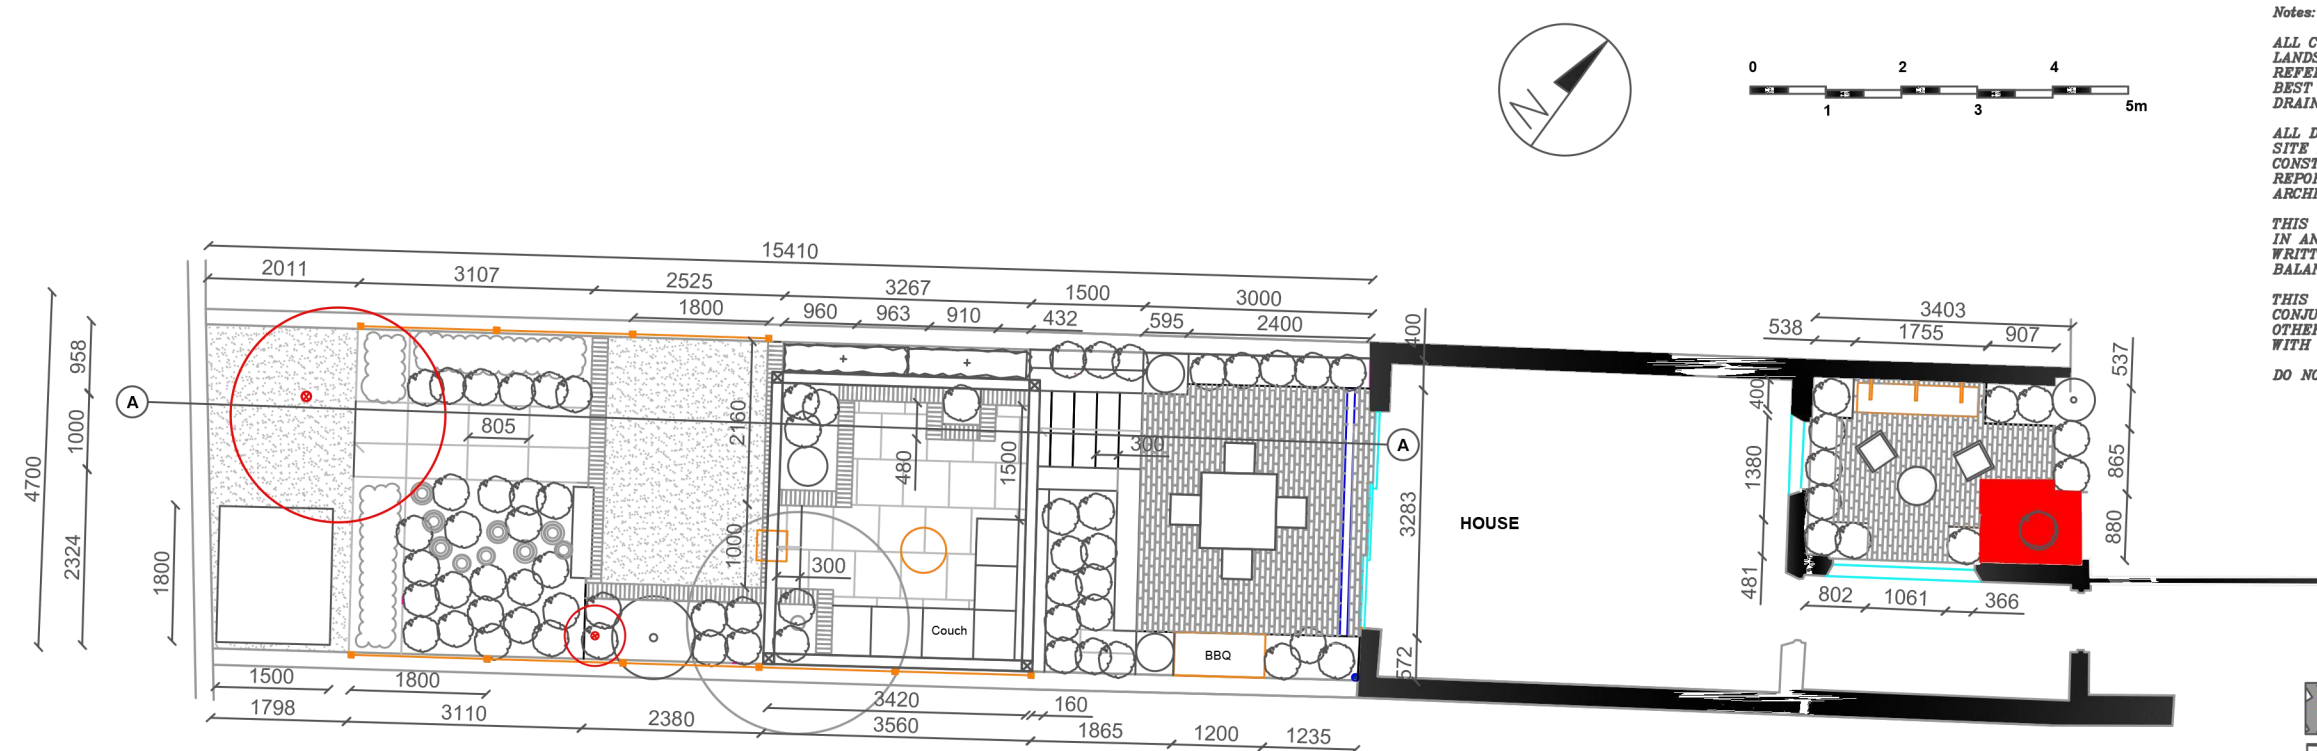
- Water feature in court yard
- Pots with plants
- Outdoor furniture
- Screening evergreen hedge
- Wooden stumps among planting
- Clay pavers running bond
- Galvanized grate to be installed over light well
- Slate stone paving
- Douglas Fir pergola 140mm2
- Pleached fruit trees
- Playground area with soft playing surface/ shade tolerant grass.
- Trellis on top of existing brick wall
- Clay pavers edging
- Wooden decking steps
- Aggregate
- New planting
- Fireplace
