Project	81 Gower Street London
---------	---------------------------

Title	Large Notch Repair
-------	--------------------

Drawing No	BB150 - 2017 - DT03
------------	---------------------

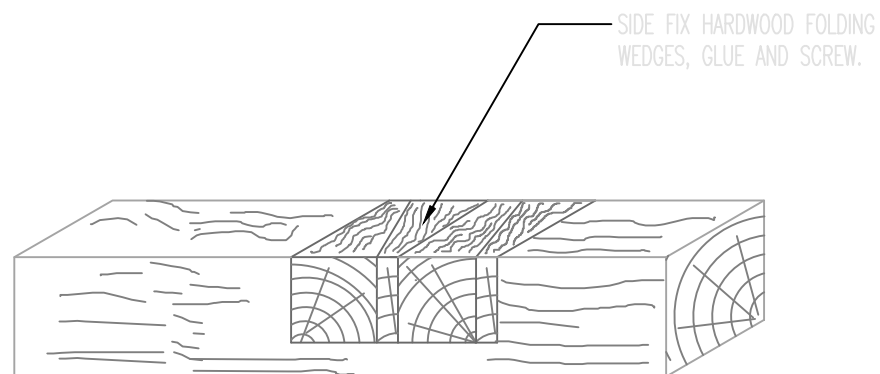
NOTCH REPAIR DETAIL FOR LONG NOTCH

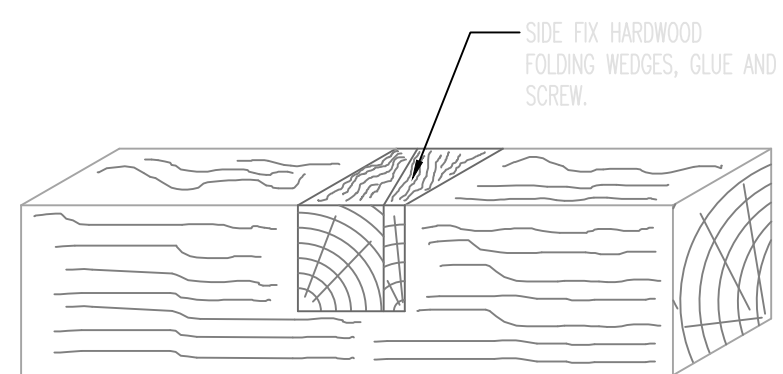
NOTCH REPAIR DETAIL 2
