BS 5837 Arboricultural Report

Impact Assessment & Method Statement

**26 Netherhall Gardens
Camden
London
NW3 5TL**

**Dated
21st July 2017**

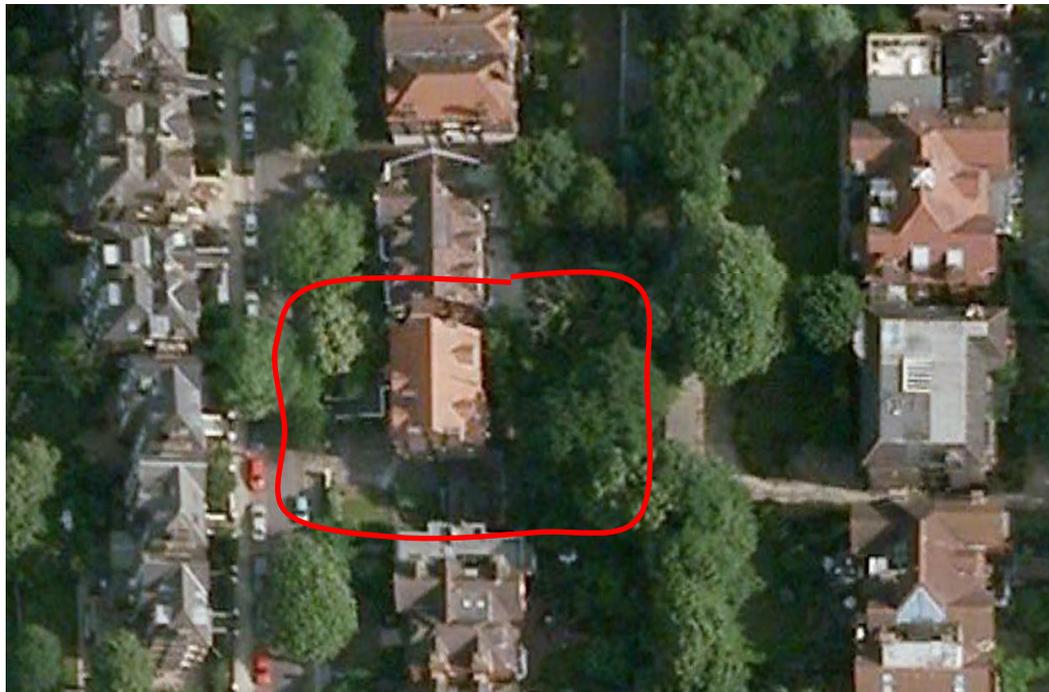
Figure 1 Extent of the survey (image is not current).

2.3.1. Our survey covered the area indicated in Figure 1.

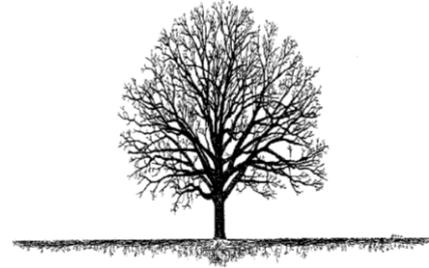
5.5.20. The majority of tree roots lie within the upper soil horizons. This is because the availability of oxygen decreases with depth and roots need to breathe to stay alive. In addition, nutrients are more readily available in the form of organic matter close to the soil surface.

5.5.21. Healthy soils contain about 25% air space between solid particles. Increased loading of the soils caused by construction activity causes air to be squeezed out as the soil becomes compacted preventing roots from breathing. Even an increase in pedestrian activity may cause some soil compaction.

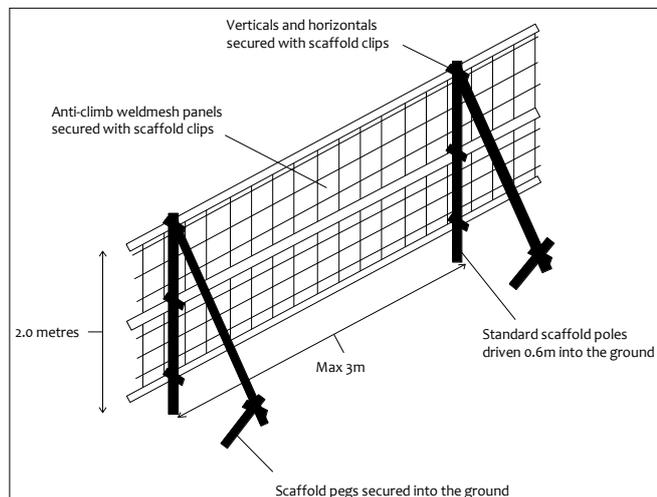
9.2.1. This system may be installed where indicated by a solid purple line on the Tree Protection Plan. It should be robust enough to withstand occasional knocks by plant machinery and, once installed, shall remain in place throughout the entire construction phase.

9.2.2. Vertical scaffold poles are driven into the ground, onto which are affixed horizontal scaffold poles and diagonal bracing struts. Weldmesh panels (or similar – e.g. Heras type fencing panels, or 18mm+ plywood boards) are secured to this scaffold framework using sturdy clips e.g. standard scaffold clips. The system is illustrated in the diagram to the right and is based on BS 5837 guidelines.

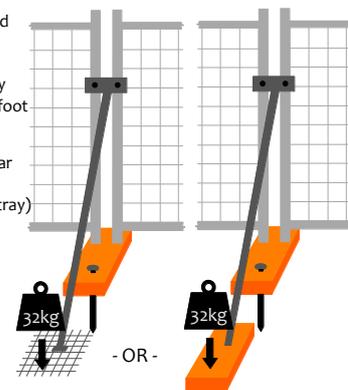
Each panel attached to a back stay which is founded in an additional foot or mesh tray as illustrated

Minimum 32kg ballast to retain rear foot or tray (including the weight of the foot/tray)

Front feet to be secured with ground pins or additional ballast

attached to a diagonal back stay connected to an additional foot or baseplate secured with ground pins or additional ballast. Where ground pins are not used, the total weight of the foot/plate plus ballast should total not less than 32kg.

9.3.1. This system may be installed where indicated by a solid or dashed purple line on the Tree Protection Plan. It is more practical over existing hard surfaces or where the fencing needs to be moved to enable permitted activities within a *Restricted Activity Zone*. This system should be able to withstand occasional knocks by machinery and should not be relocated except with the consent of the site manager and the approval of the local authority.

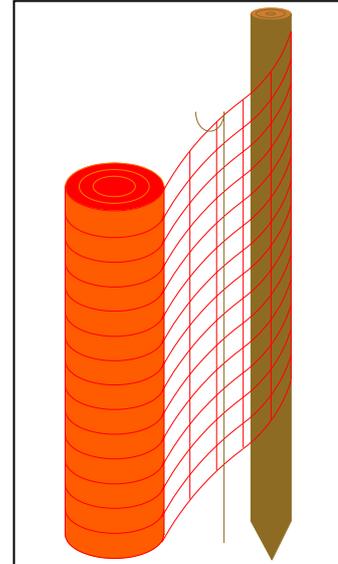
9.4.2. In this system, high visibility plastic safety fencing, 1m high, minimum grade 140g/m², is secured onto alternate wooden posts and fencing pins. Wooden posts to be located at 5m intervals, minimum dimensions 75mm.

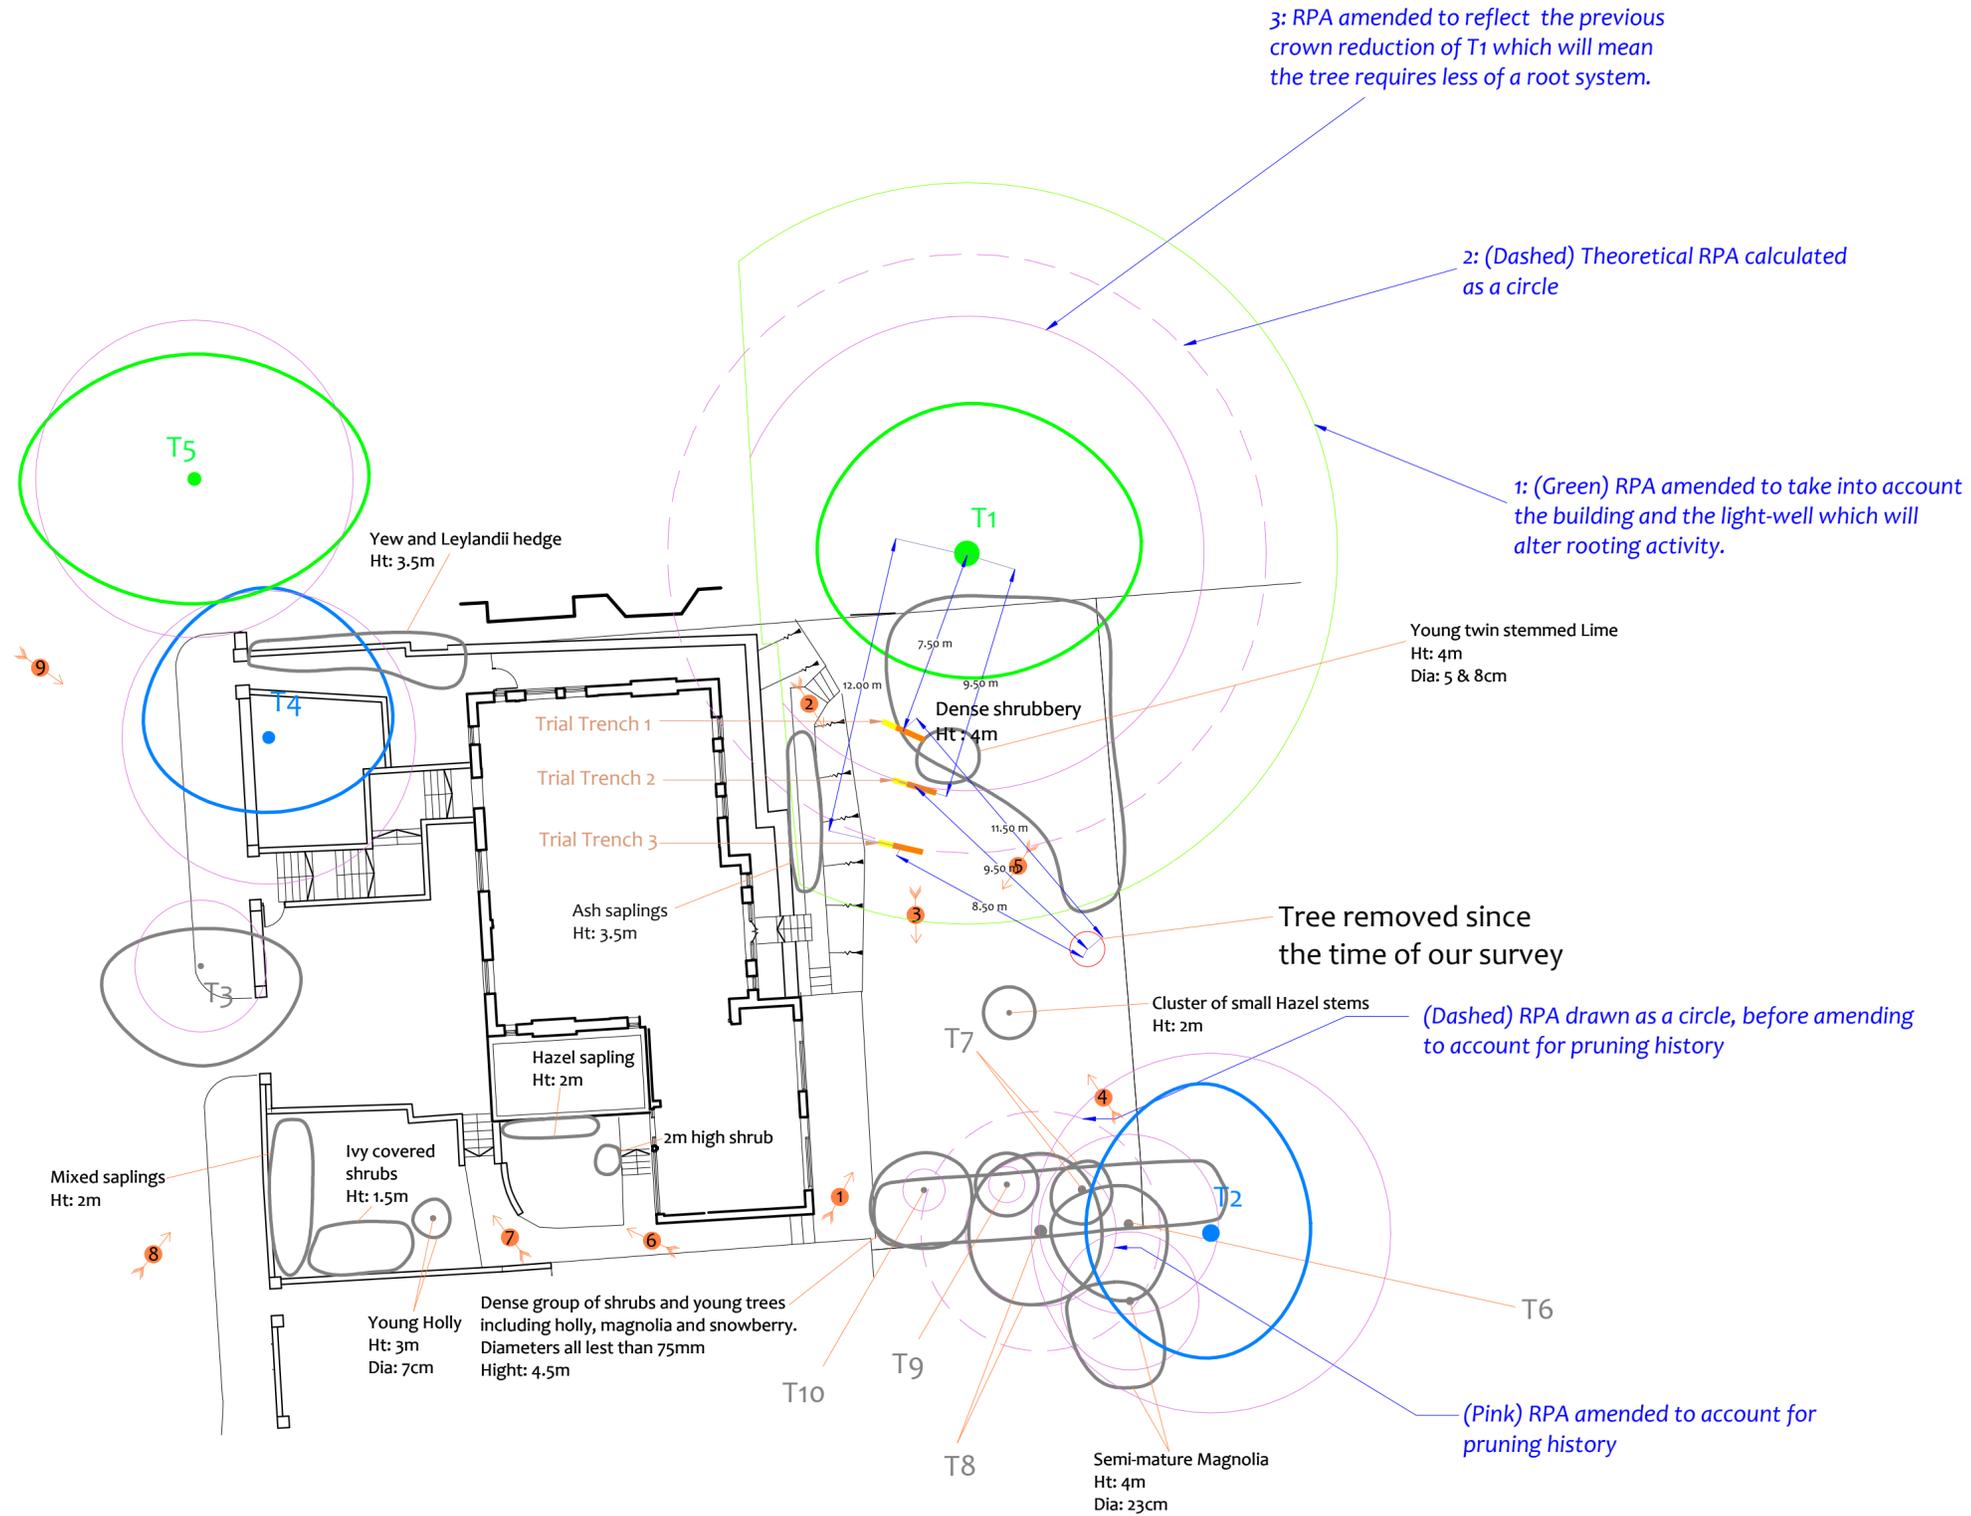
Drawing No: CCL 09552 / TCP Rev: 2
 Title: Tree Constraints Plan (Existing Layout)
 Site: 26 Netherhall Gardens Camden, NW3 5TL
 Scale: 1:200 Paper Size: A2

1.4.3. Where appropriate, the shapes of the RPAs have been amended to reflect actual site conditions or where trees have been heavily pruned. The 'original' RPAs are indicated as a dashed line whereas the amended RPAs are indicated as a solid line.

5.5.2. The Root Protection Areas on the Tree Constraints Plan are drawn as circles. However, for the lime tree, T4, the roots are more likely to be concentrated in the area of soft landscaping surrounding this tree which is enclosed on all sides by a retaining wall. This is because the wall and its foundations shall effectively act as a root barrier. What few roots grow beneath the foundations will find relatively inhospitable rooting conditions so are unlikely to proliferate.

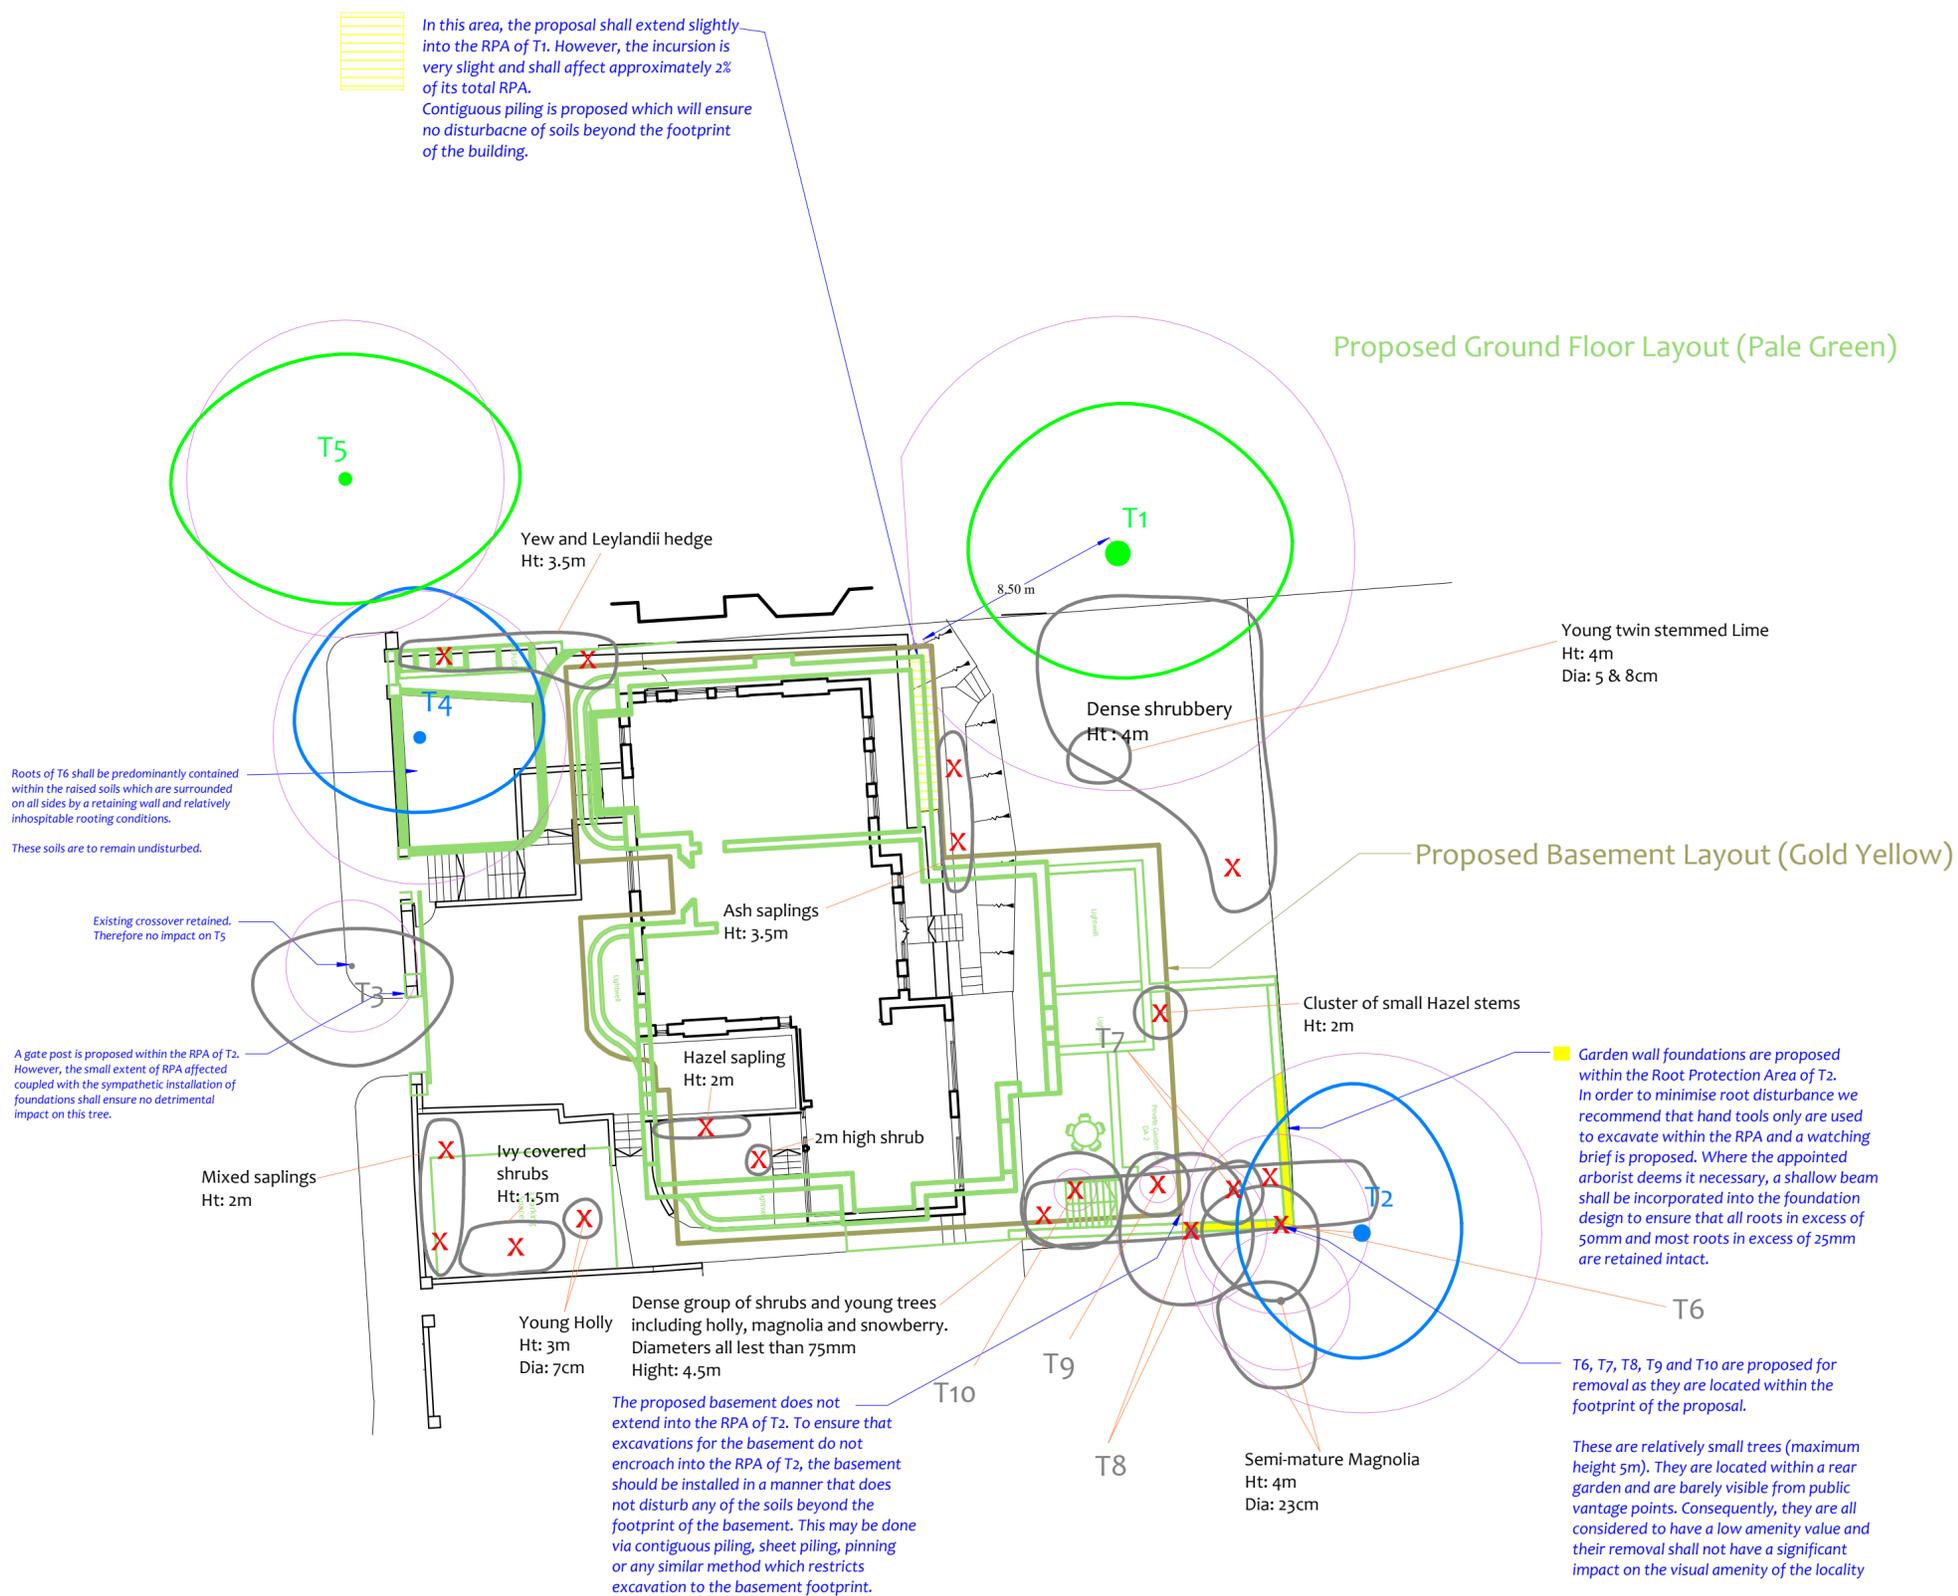
(Existing Layout with Proposals Overlaid)

Drawing No: CCL 09552 / IAP Rev: 2
 Title: Impact Assessment Plan (Existing Layout with Proposals Overlaid)
 Site: 26 Netherhall Gardens Camden, NW3 5TL
 Scale: 1:200 Paper Size: A2

1.4.4. The *Impact Assessment Plan* indicates the tree constraints with the proposals overlaid. Where applicable, this plan shows where works are proposed in Root Protection Areas and which trees are to be pruned or removed. This plan accompanies the Impact Assessment which is to be found in Section 5.

5.5.6. The impact Assessment plan shows where excavation is proposed for foundations / basement within the rear garden. The vast majority of excavation for the basement shall be in excess of 12.5m from T1 and shall have no detrimental impact. A small area is shaded yellow on the accompanying impact assessment Plan. This indicates where excavation is proposed into the embankment where roots may be growing. However, this area equates to approximately 2% of the Root Protection Area of this tree.

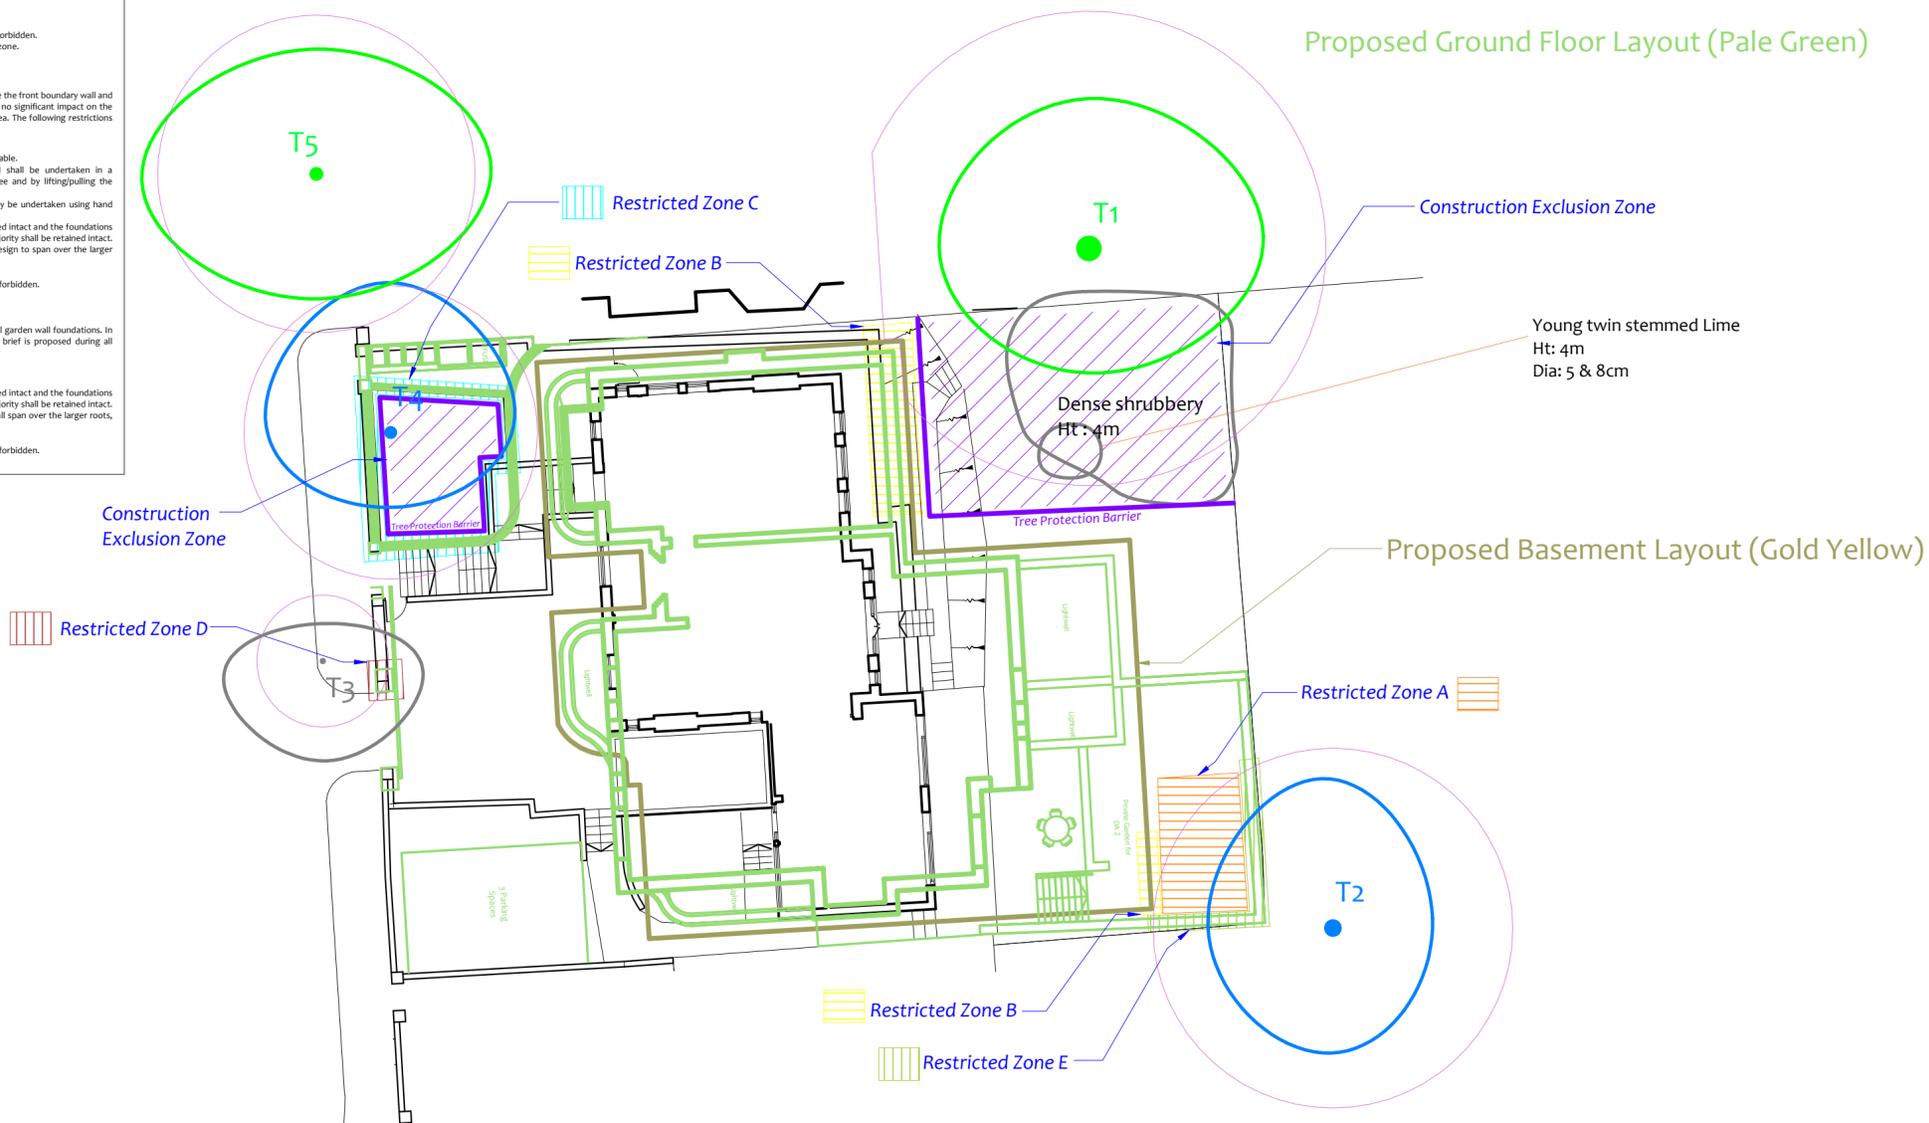
Tree Protection Plan

Tree Protection Barriers:

Fixed protective barrier: The 'In-Ground System' or the 'Backstay System'. To remain in place for all construction activity		Construction Exclusion Zone Stem protected to a height of 2.5m with thick cloth & wire Tree Protection Boxing 1.2 x 1.2 x 2.4m high 25mm plywood
	Moveable protective barrier: The 'Backstay System'. To remain in place except when approved works are being undertaken in the Restricted Zone		Orange Barrier Mesh Fencing. Ht 1m, on steel fencing pins and wooden posts To remain in place throughout all construction activity

1.4.5. The *Tree Protection Plan* shows the protection measures that are to be installed during the construction phase. This plan accompanies the Method Statement which is to be found in Section 6.

6.10.1. Within this zone (indicated on the Tree Protection Plan) it is proposed to replace the front boundary wall and to install new pillars which may require larger foundations. In order to ensure no significant impact on the root system of T3 a watching brief is proposed during all excavation in this area. The following restrictions shall apply:

6.11.1. Within this zone (indicated on the Tree Protection Plan) it is proposed to install garden wall foundations. In order to ensure no significant impact on the root systems of T2 a watching brief is proposed during all excavation in this area. The following restrictions shall apply:
