55 Gower Street London

Large Notch Repair

BB137 - 2017 - DT03

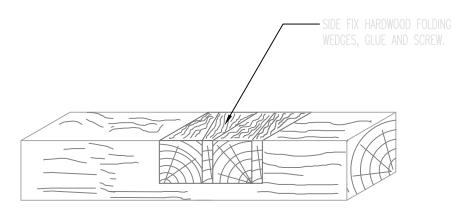
NOTCH REPAIR DETAIL 2

NOTCH REPAIR DETAIL FOR LONG NOTCH

FOR NOTCHES GREATER THAN 25mm DEEP.
