**PROPOSED REAR ELEVATION**

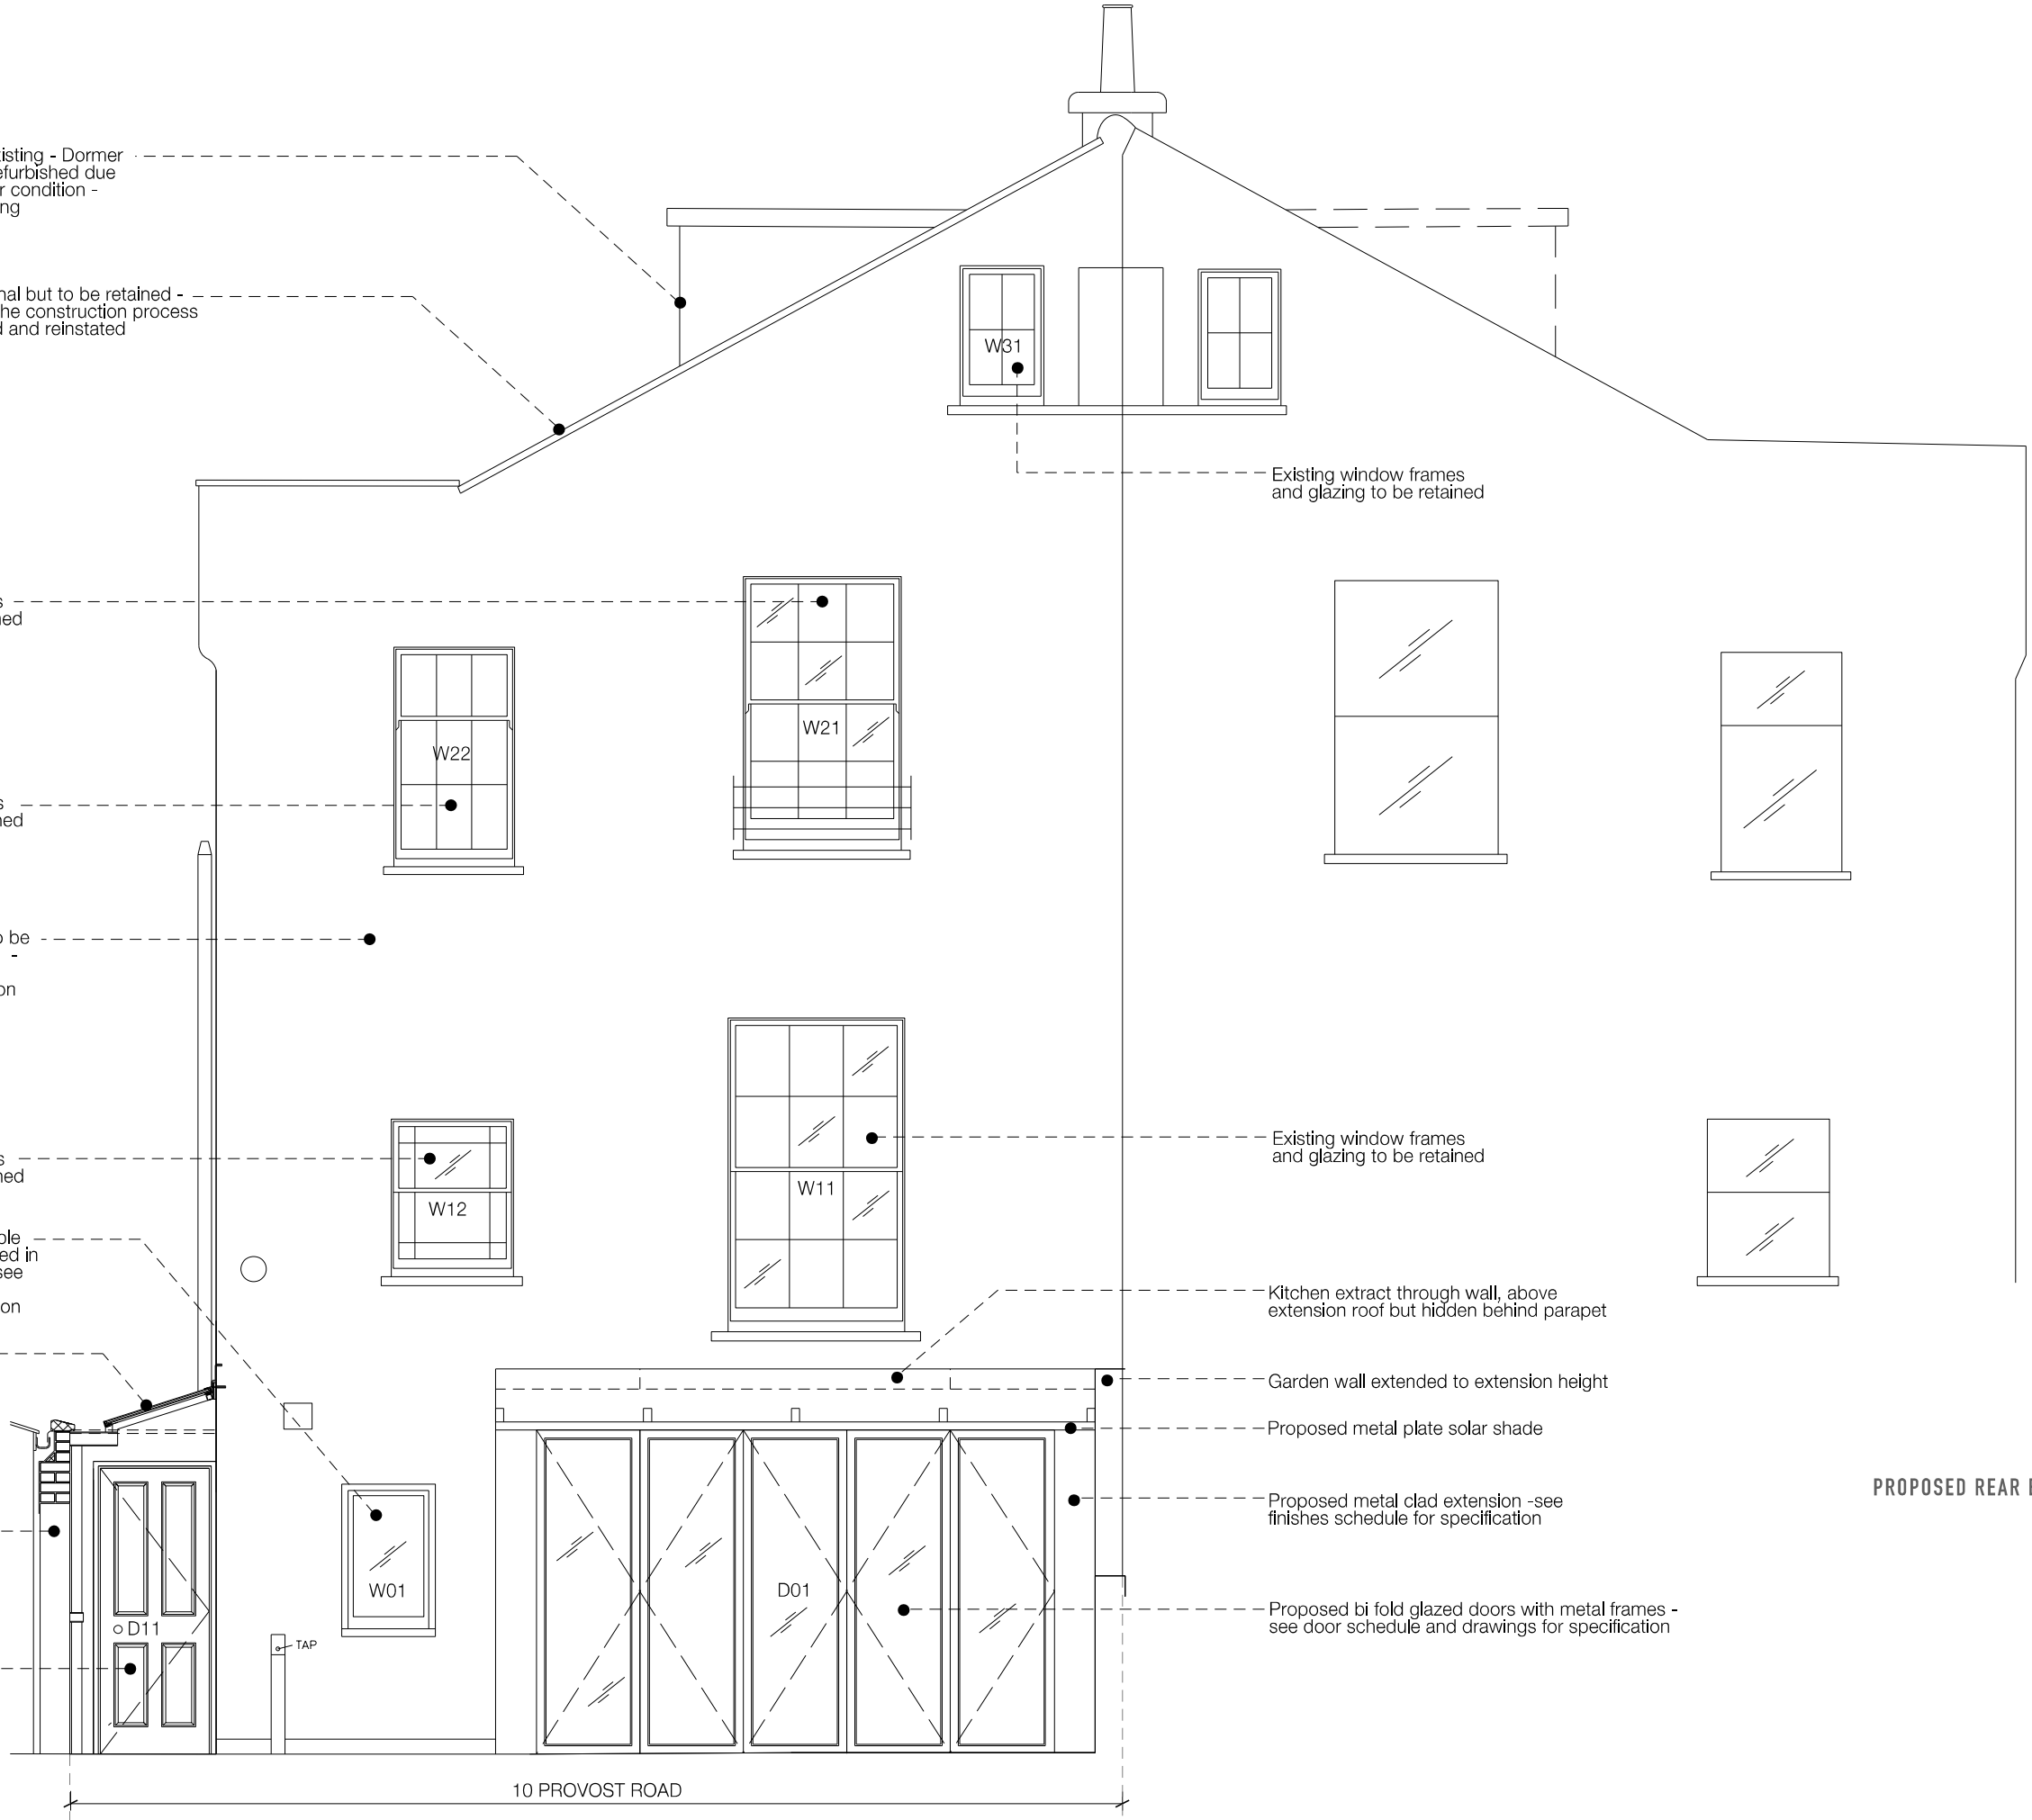
Dormer to remain as existing - Dormer roof and side finishes refurbished due to existing being in poor condition - Finishes to match existing

Existing slates not original but to be retained - those removed during the construction process will be carefully handled and reinstated

Existing window frames and glazing to be retained

Rear elevation render to be repaired and re-painted - see door schedule and drawings for specification

New timber frame double glazed window proposed in same sized opening - see window schedule and drawings for specification

Existing corrugated roof over side passageway to be replaced with fixed glazed panels within a lightweight timber structure to shelter passageway

Party wall - connection detail as per detail drawings 74.711 and 74.712

Traditional door to replace existing door along side passageway - see door schedule and drawings for specification

Kitchen extract through wall, above extension roof but hidden behind parapet

Garden wall extended to extension height

Proposed metal plate solar shade

Proposed metal clad extension - see finishes schedule for specification

Proposed bi fold glazed doors with metal frames - see door schedule and drawings for specification
