UCL NEW STUDENT CENTRE

HEAD DETAIL
DOOR ED17

031-51-3202-DR-X-00628-ZZ

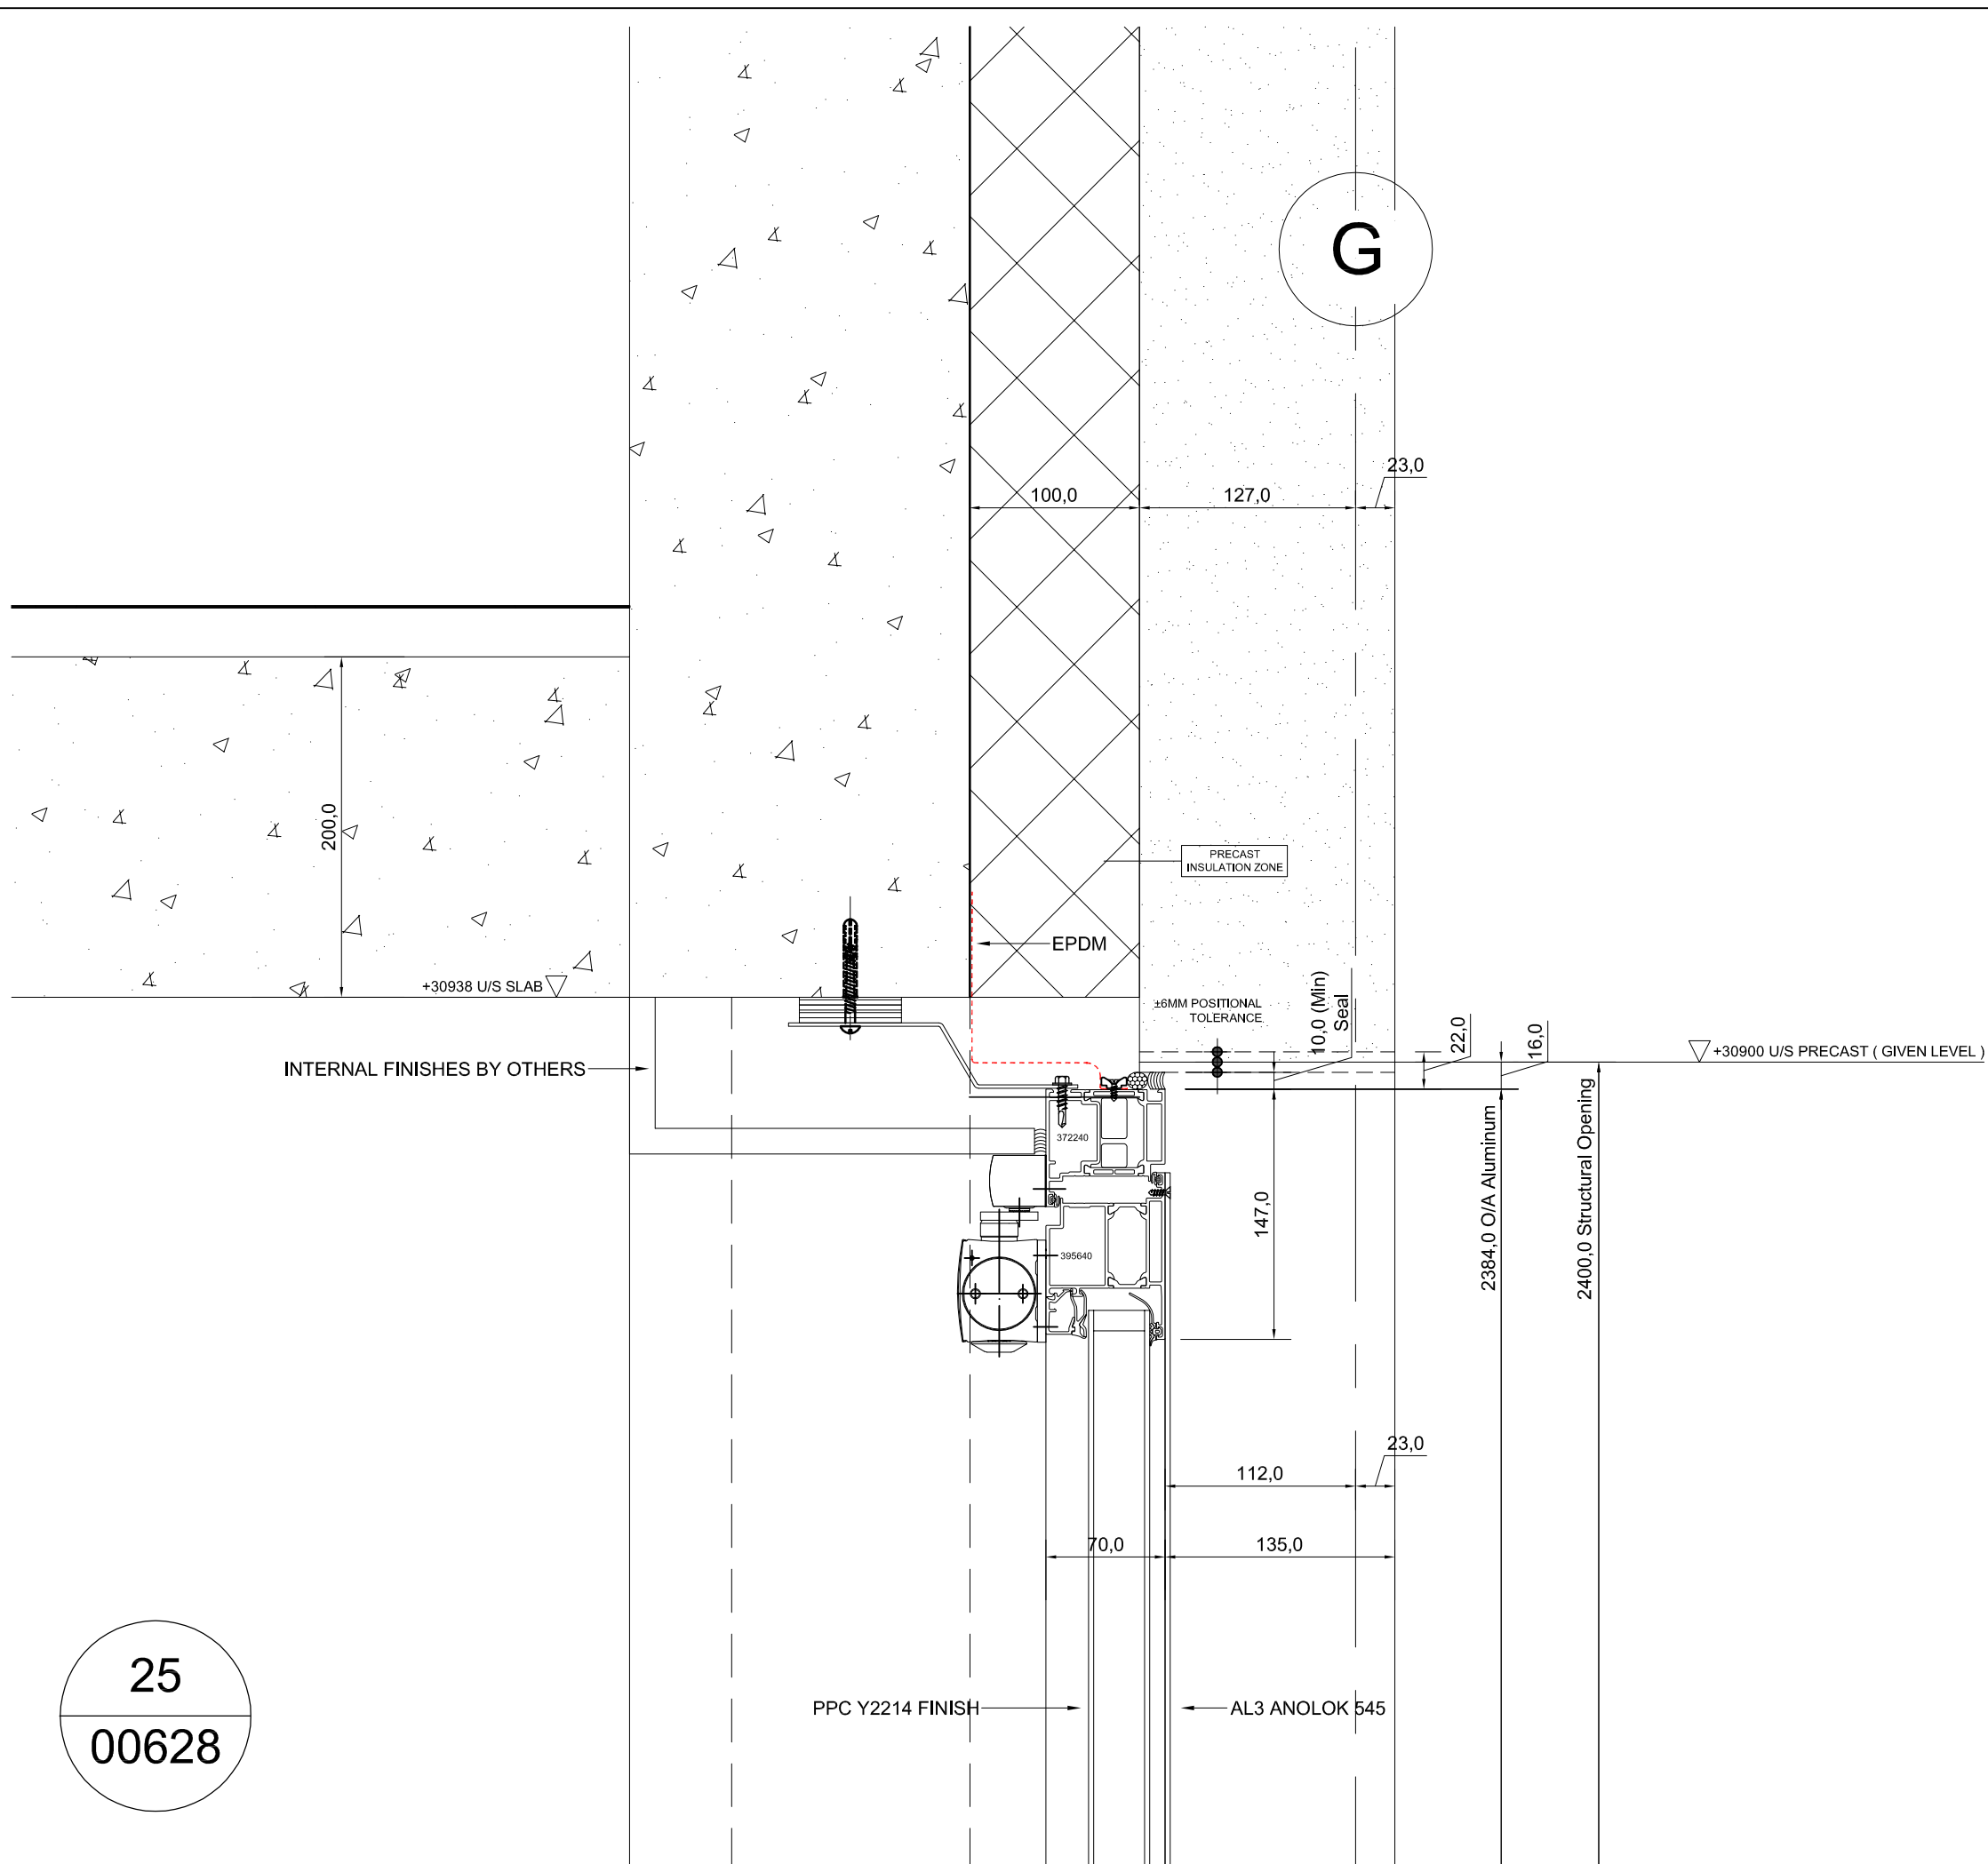
- Membrane by Glassolutions
