Project: **CBCD Toddler Laboratory**

Key: **32 Torrington Square
Bloomsbury
London
WC1E7HX
Birkbeck University of London**

Information Title: **Proposed - First Floor Plan**

Project No.	Originator	Zone	Level	Type	Role	Number	Suitability	Revision
BB029	BA	Z0	01	DR	A	1203	S0	P3

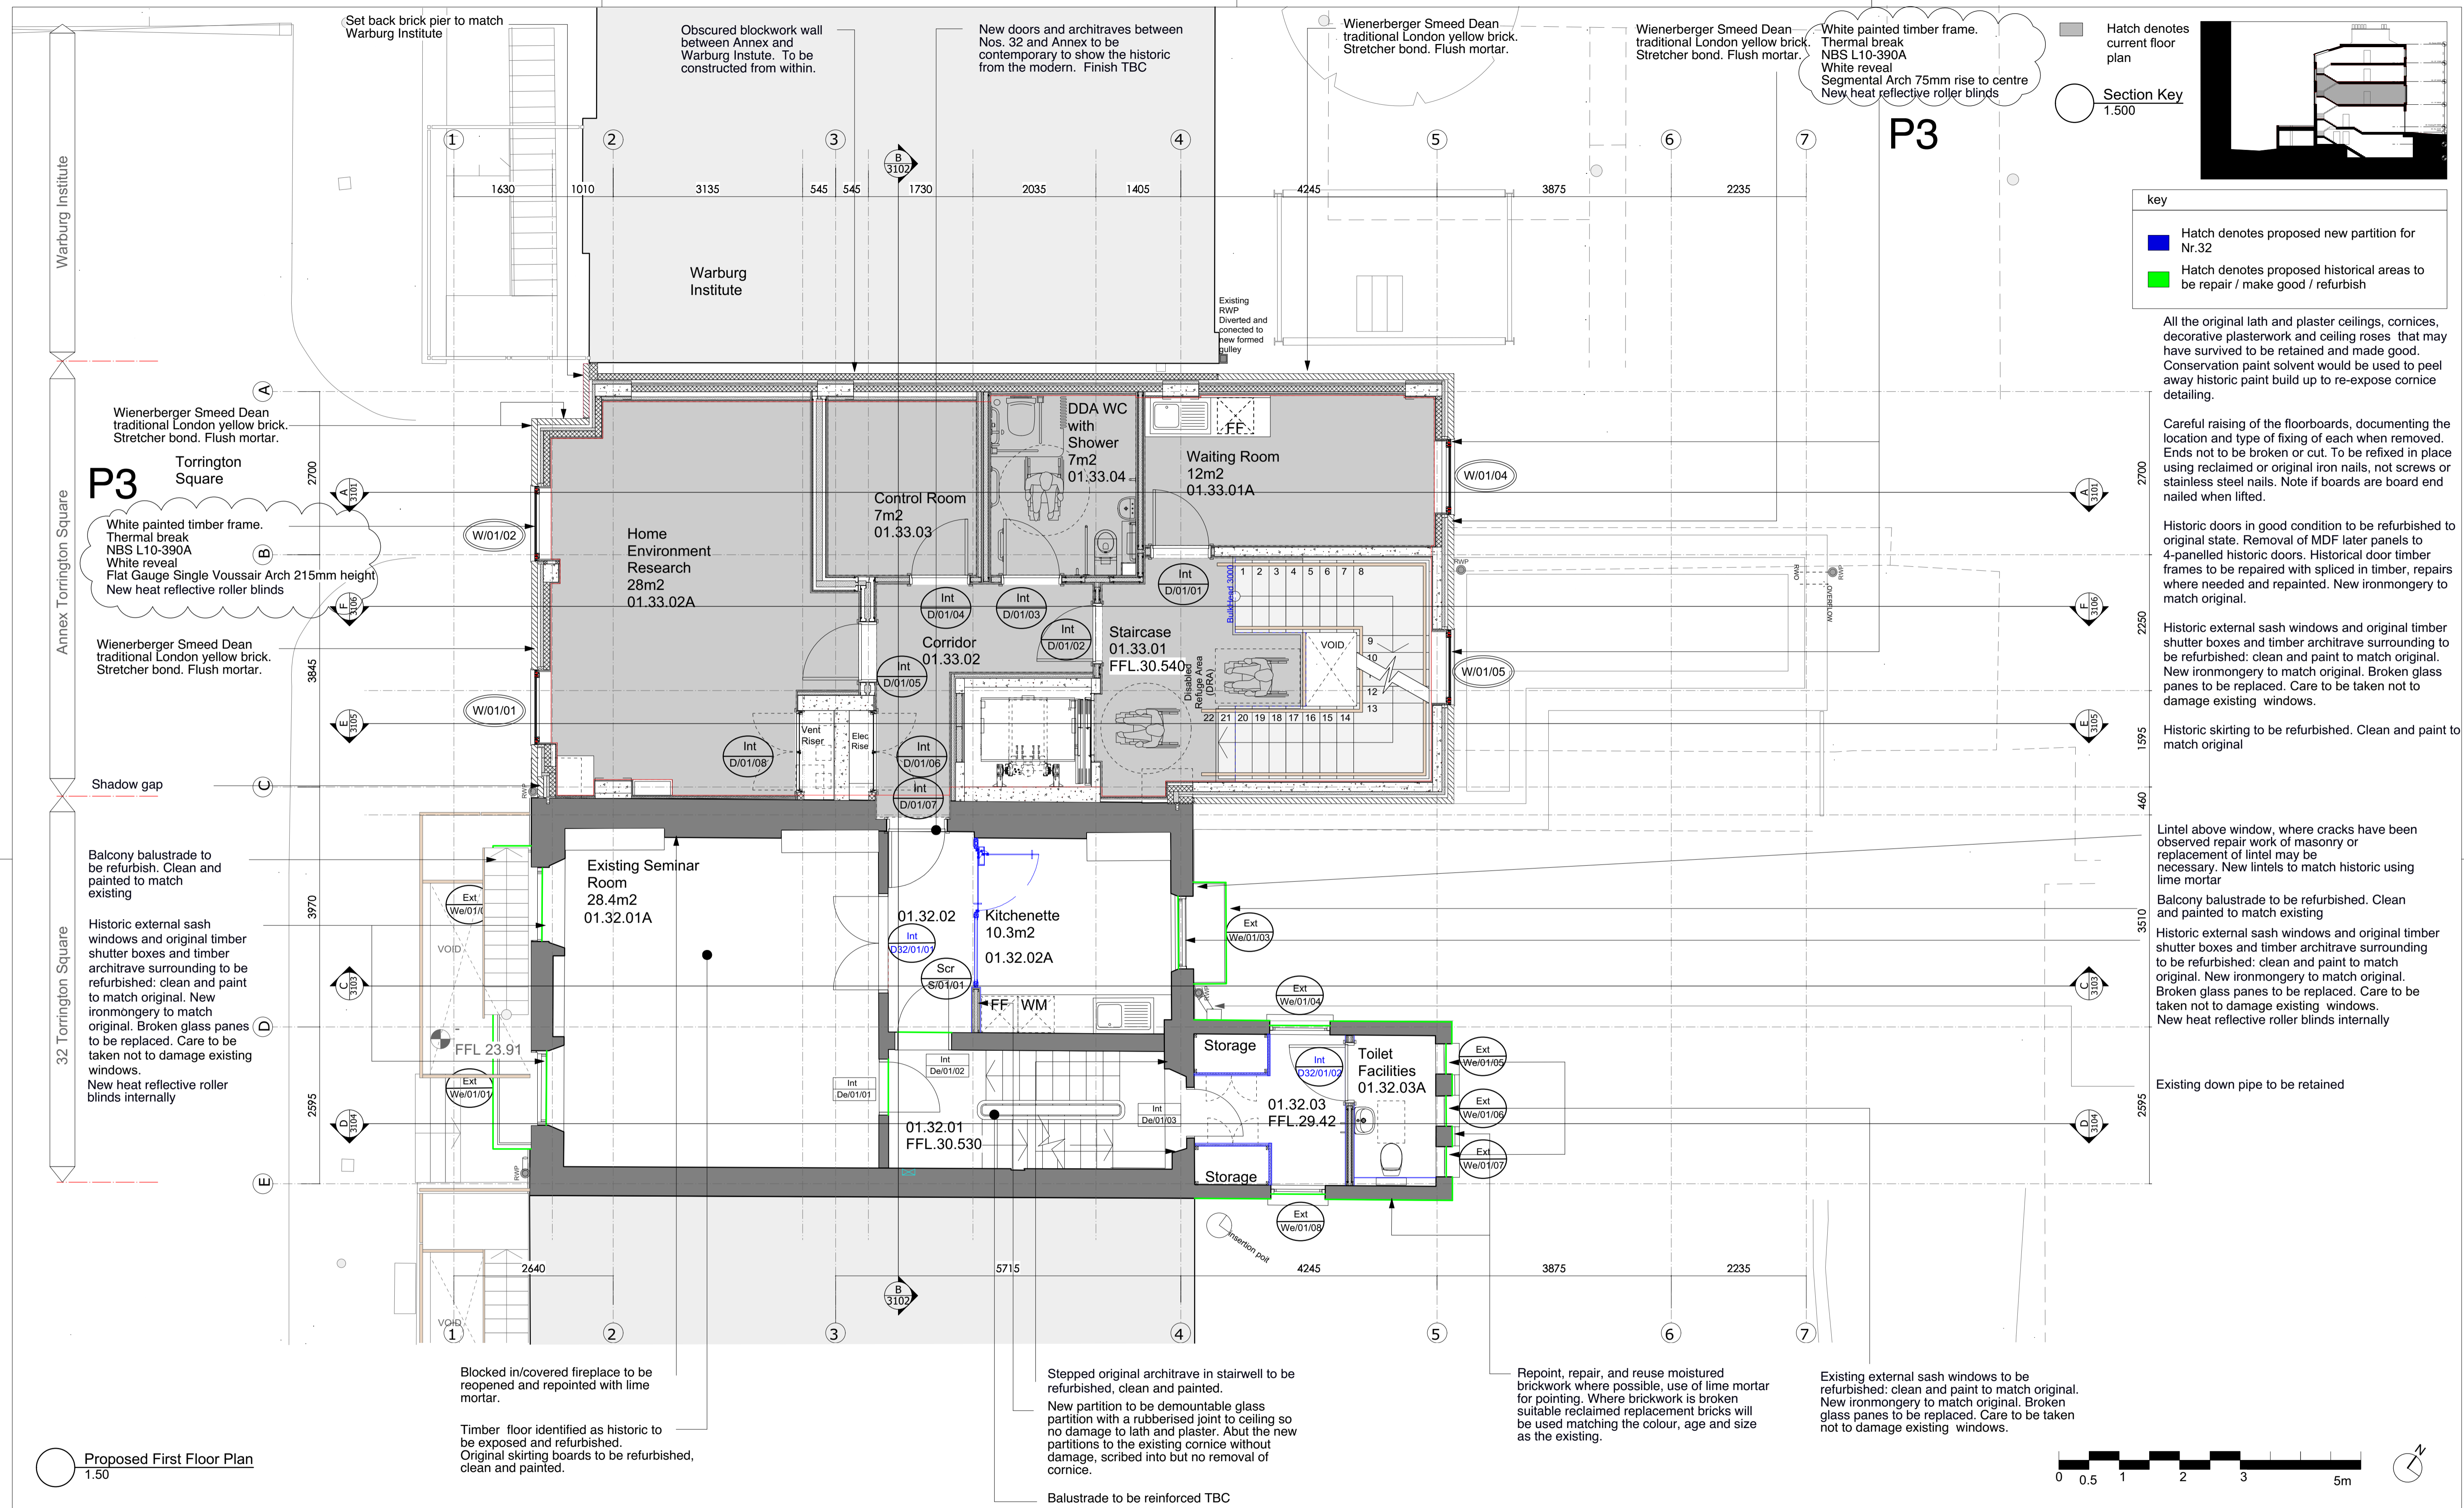
- key**
- Hatch denotes proposed new partition for Nr.32
 - Hatch denotes proposed historical areas to be repair / make good / refurbish

All the original lath and plaster ceilings, cornices, decorative plasterwork and ceiling roses that may have survived to be retained and made good. Conservation paint solvent would be used to peel away historic paint build up to re-expose cornice detailing.

Careful raising of the floorboards, documenting the location and type of fixing of each when removed. Ends not to be broken or cut. To be refixed in place using reclaimed or original iron nails, not screws or stainless steel nails. Note if boards are board end nailed when lifted.

Historic doors in good condition to be refurbished to original state. Removal of MDF later panels to 4-panelled historic doors. Historical door timber frames to be repaired with spliced in timber, repairs where needed and repainted. New ironmongery to match original.

Historic external sash windows and original timber shutter boxes and timber architrave surrounding to be refurbished: clean and paint to match original. New ironmongery to match original. Broken glass panes to be replaced. Care to be taken not to damage existing windows.

Historic skirting to be refurbished. Clean and paint to match original

Lintel above window, where cracks have been observed repair work of masonry or replacement of lintel may be necessary. New lintels to match historic using lime mortar

Balcony balustrade to be refurbished. Clean and painted to match existing

Historic external sash windows and original timber shutter boxes and timber architrave surrounding to be refurbished: clean and paint to match original. New ironmongery to match original. Broken glass panes to be replaced. Care to be taken not to damage existing windows. New heat reflective roller blinds internally

Existing down pipe to be retained
