# THE GARDEN HOUSE

*Outbuilding Restoration*

## DESIGN AND ACCESS STATEMENT

The Garden House, Vale of Health, NW3 1AN

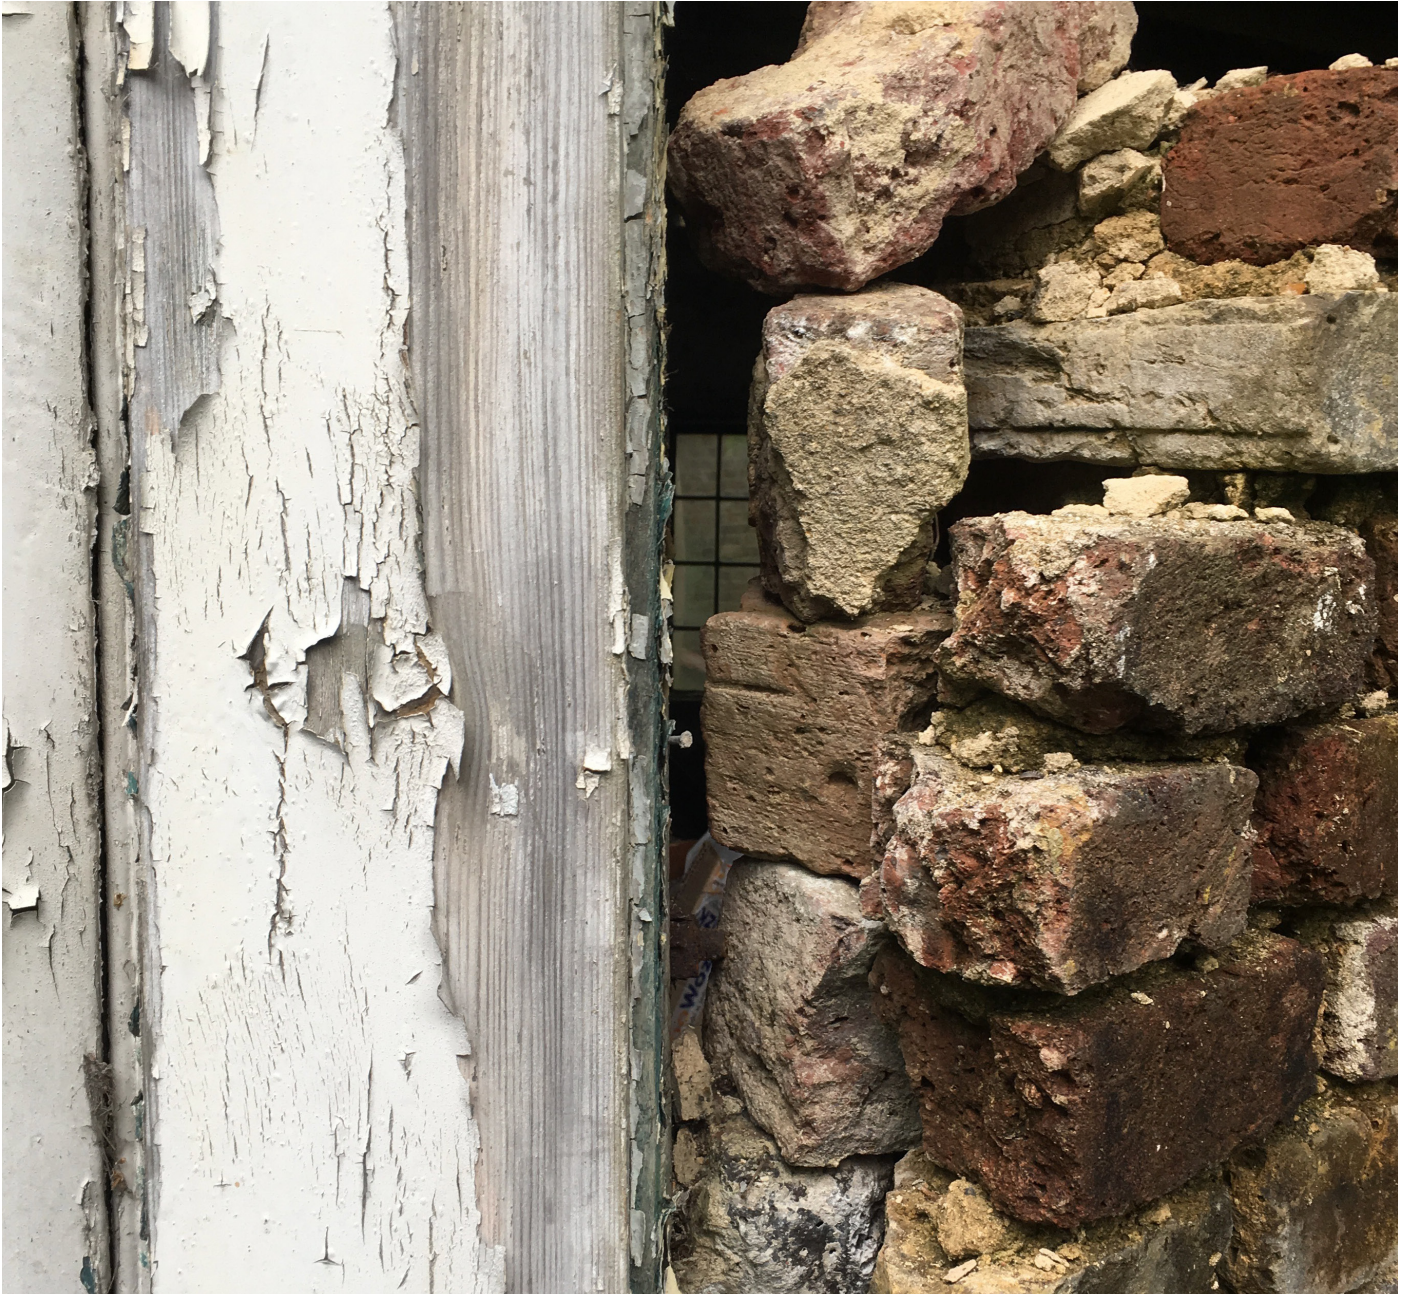
EXISTING OUTBUILDING WALL CONDITION

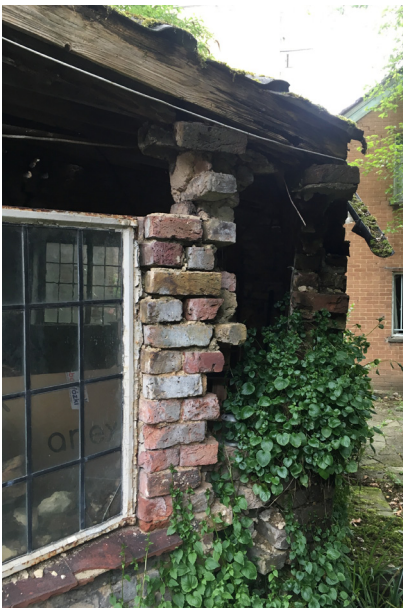
South-east view of existing external wall, showing large areas of missing bricks, cracks and bowing.

The external walls and roof are therefore in an unsafe condition. Due to the extent of the above defects we recommend that the existing walls and roof will need to be rebuilt. Given the historic movement of the walls we propose to install new foundations to support the new external walls and therefore the building will essentially be replaced entirely on the same footprint.

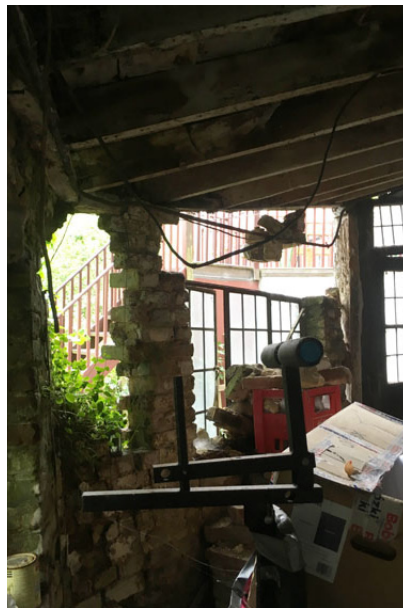
Internal view looking south, the existing roof supported by an insecure brick pier.

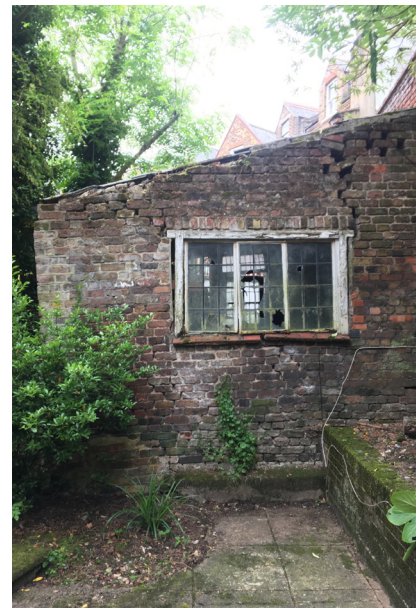
View to north-facing external wall- showing severe cracking and damage.

The external walls are visibly bowing outwards and comprise significant cracking, approximately 30mm wide in places, indicative of inadequate footings and ongoing movement.

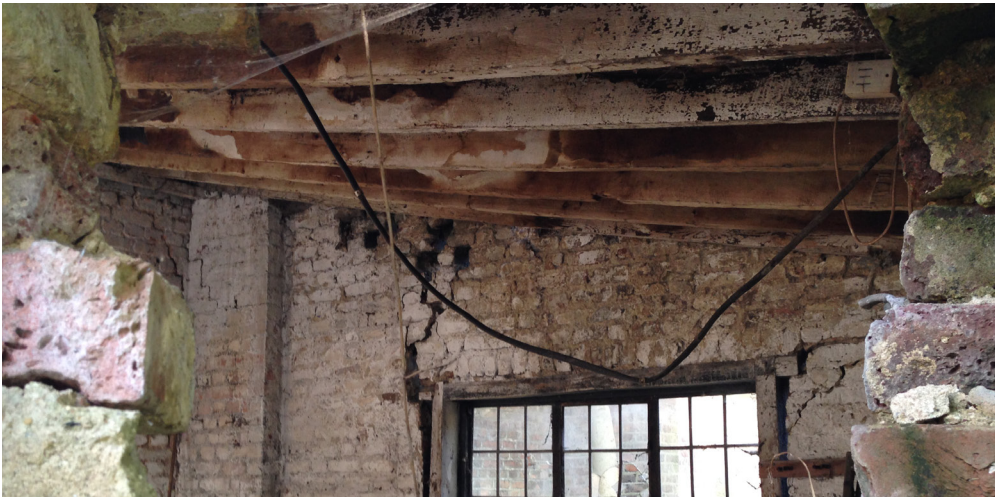
The structure comprises clay tiles on cross batons and timber rafters onto 215 wide brickwork walls on spread foundations with a ground bearing floor slab. From a visual inspection at the site, the roof timbers have decayed due to extensive water ingress and the three external walls comprise a multitude of structural defects.

Decaying roof timbers, likely caused by water ingress.
