Design & Access Statement

26 Rosecroft Avenue, London, NW3 7QB

City Planning Limited

January 2018

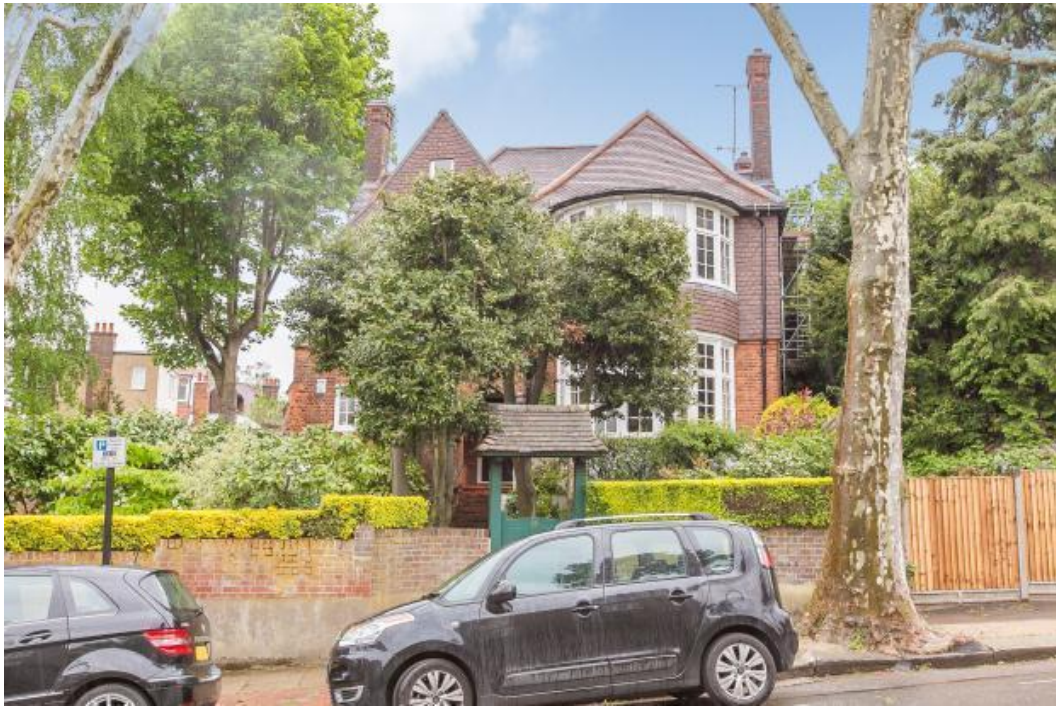
Figure 2. The street elevation of 26 Rosecroft Avenue.

- 1.4 The property is a detached three storey with basement Edwardian villa (Fig.2.). It is configured as two maisonette flats. Each flat has a separate entrance. The ground and basement floor maisonette is accessed via the front of the property at ground floor level. The first and second floor maisonette is accessed via an entrance at the side of the property. There is an existing vehicle crossover, which provides access to a driveway at the street level (Fig.3.).

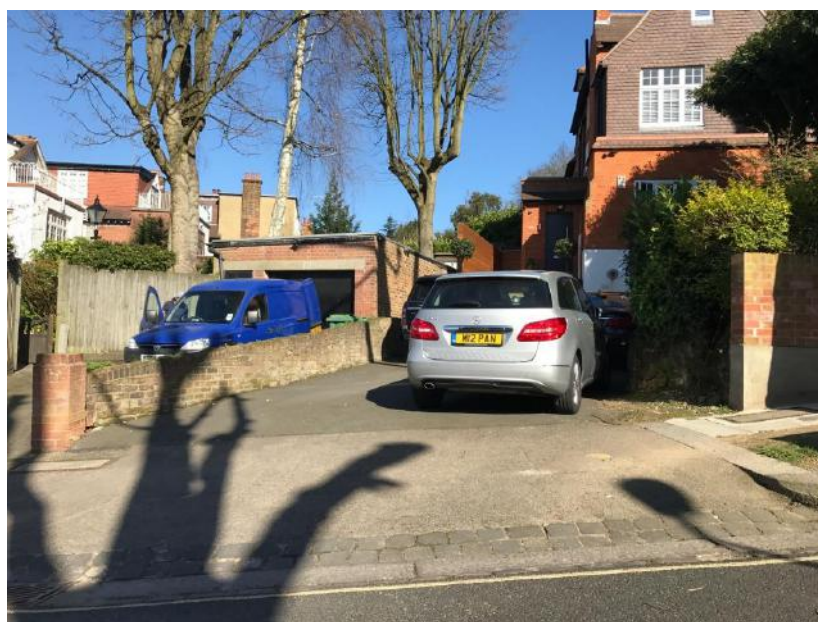
Figure 3. Driveway and hardstanding of 26 Rosecroft Avenue with the entrance to the upper floor's maisonette at the rear.

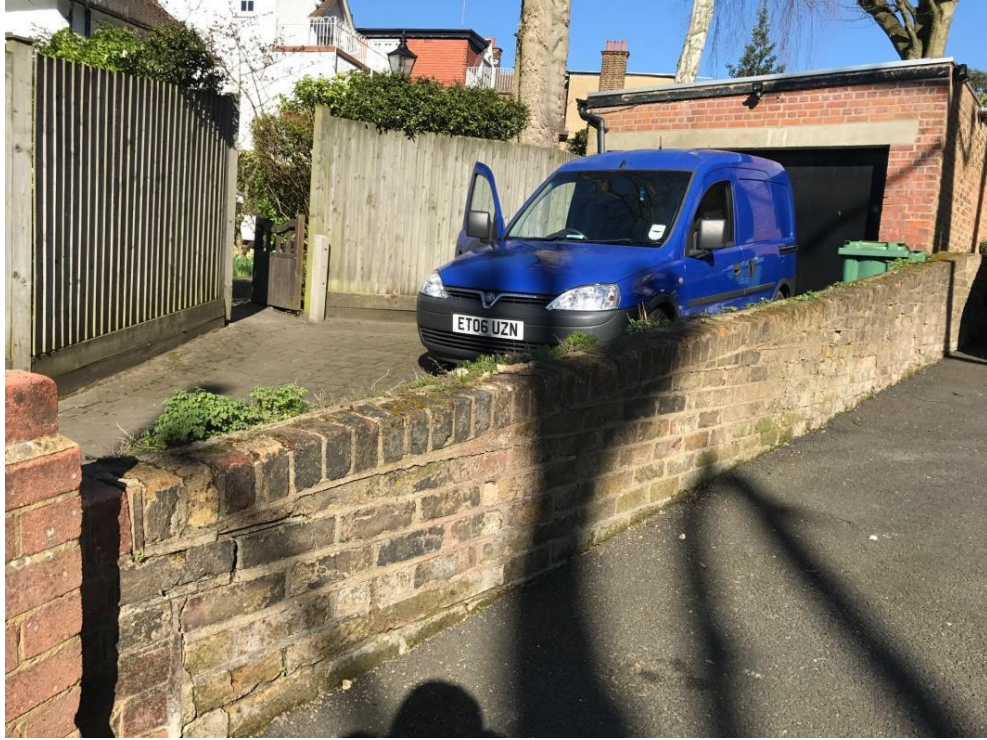
Figure 4. The existing 0.6m brick wall between Nos. 26 and 28 Rosecroft Avenue.

- 1.5 A 0.6m brick wall separates the hardstanding of the site, from the driveway of the No.28 Rosecroft Avenue (Fig.4 & 5.) There is a brick pier at the end of the wall, fronting Rosecroft Avenue.

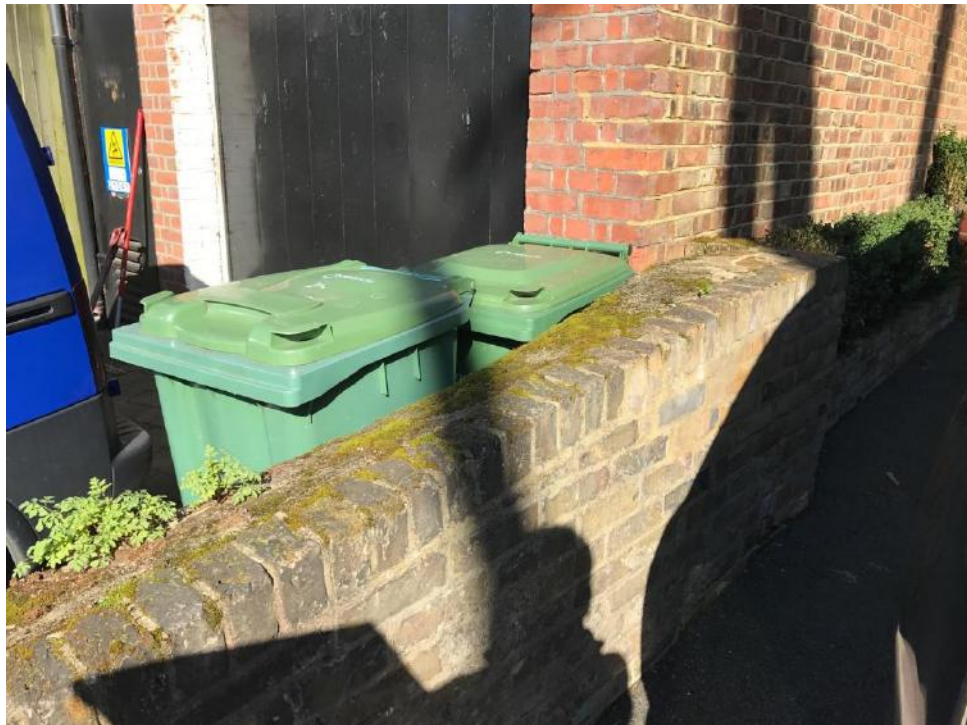
Figure 5. Brick wall on the boundary with the garage and bin store of No.28 Rosecroft Avenue.

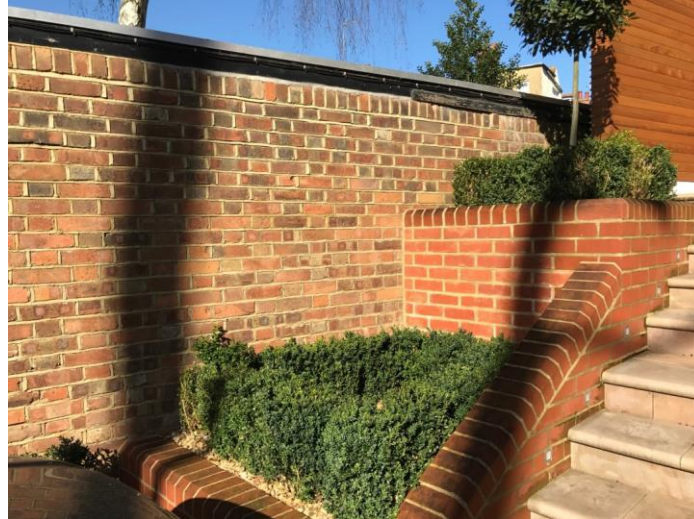
Figure 6. Soft landscaping at the rear of the driveway.

- 1.6 At the rear of the hardstanding, there are stairs leading to the entrance of the upper floor's maisonette. The stairs are flanked by soft landscaping in brick enclosures (Fig.6.).

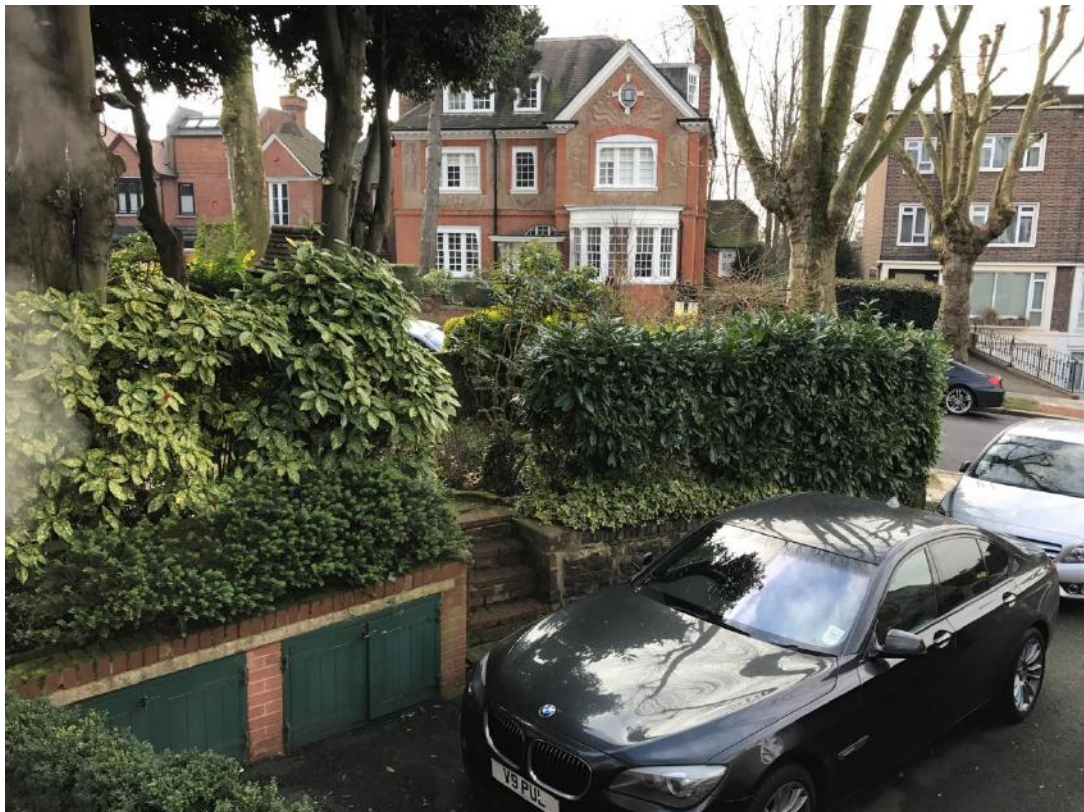
Figure 7. Existing refuse store and stair to the front landscaped area.

- 1.7 Also, at the rear, there is an existing fully enclosed refuse and recycling store measuring 0.885m x 2.716m x 0.950m (Fig. 7&8). Next to the store, there are stairs leading up to the soft landscaped area (Fig.7.).

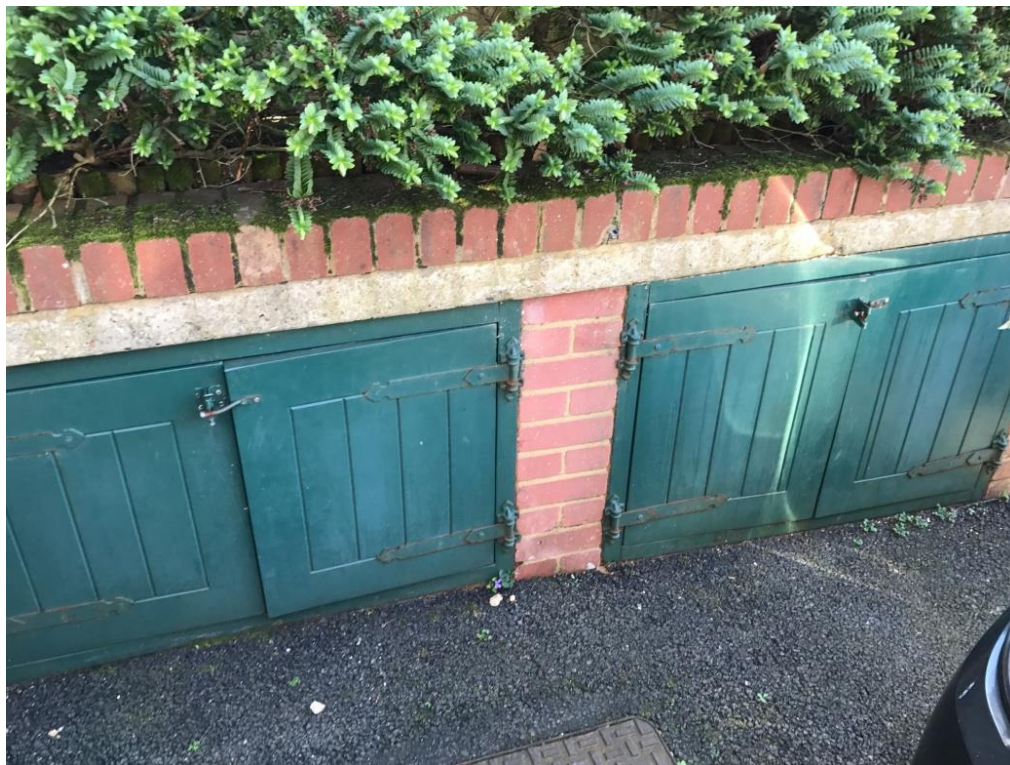
Figure 8. Close up of the existing refuse and recycling store that is no longer able to accommodate the new wheelie bins.

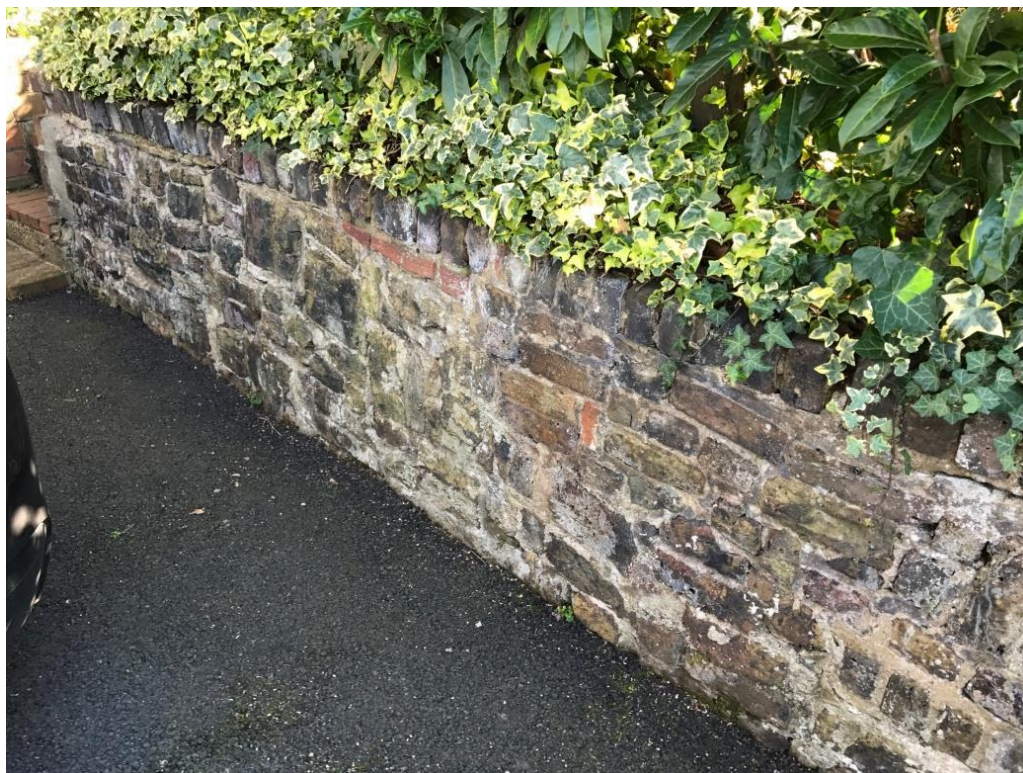
Figure 9. Close up of the brick wall separating hardstanding and garden area.

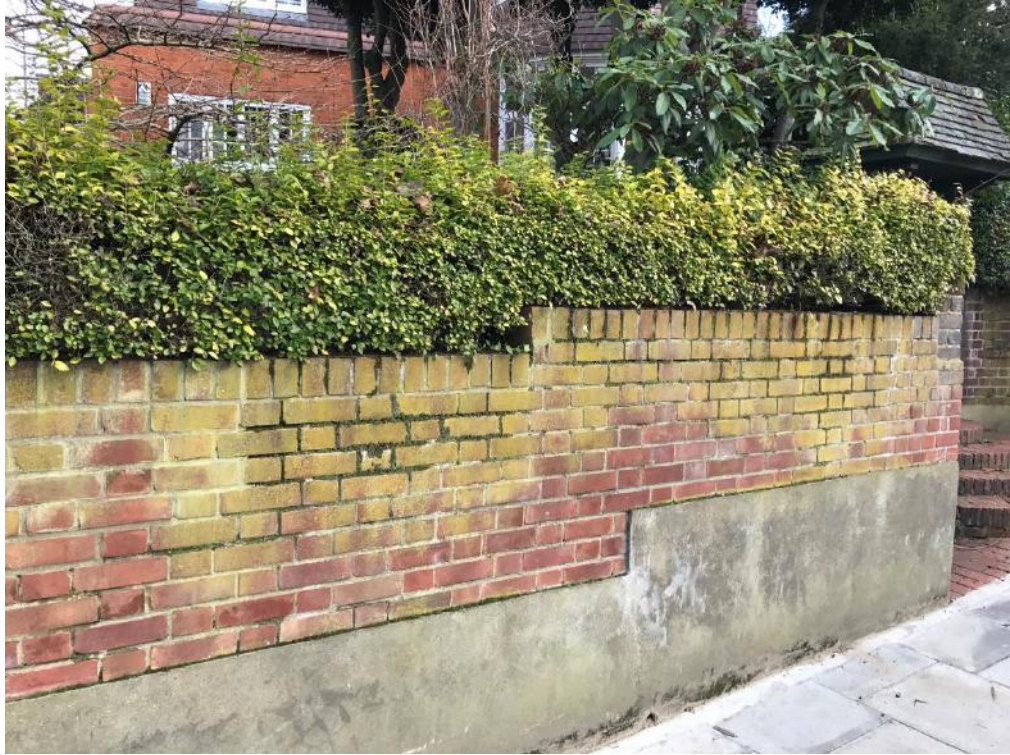
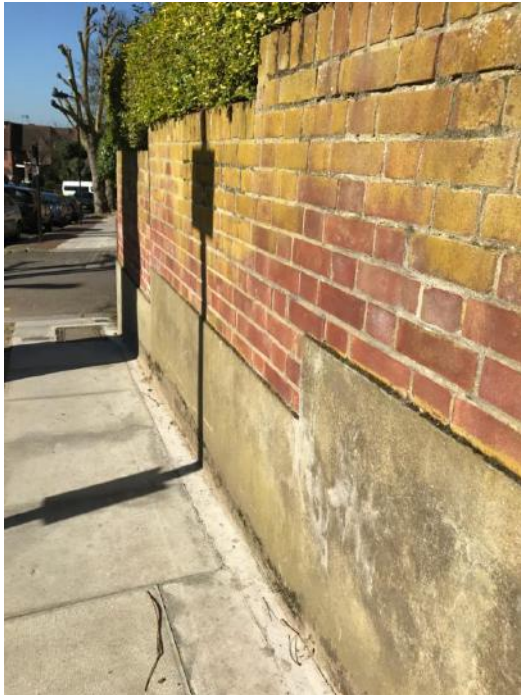
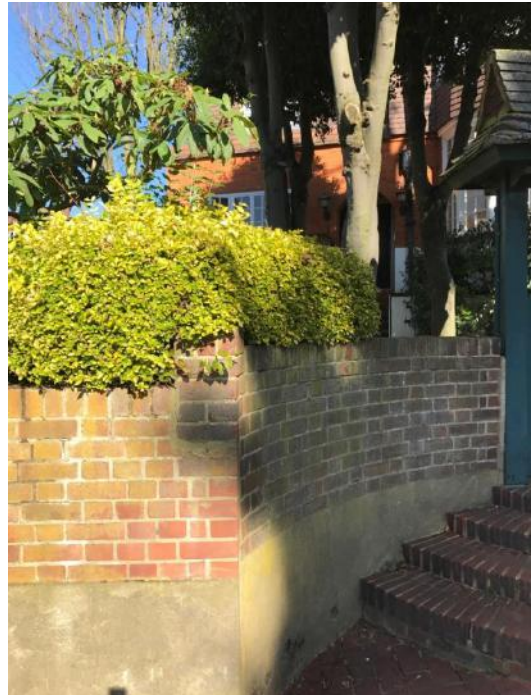
Figure 10. Existing front boundary wall and Lynch gate.

- 1.8 The front boundary wall is 1.6m high 1970s brick wall with concrete render at the footing (Fig.10). In the middle, a set of semi-circular steps lead to a Lynch gate, which provides pedestrian access to the property.

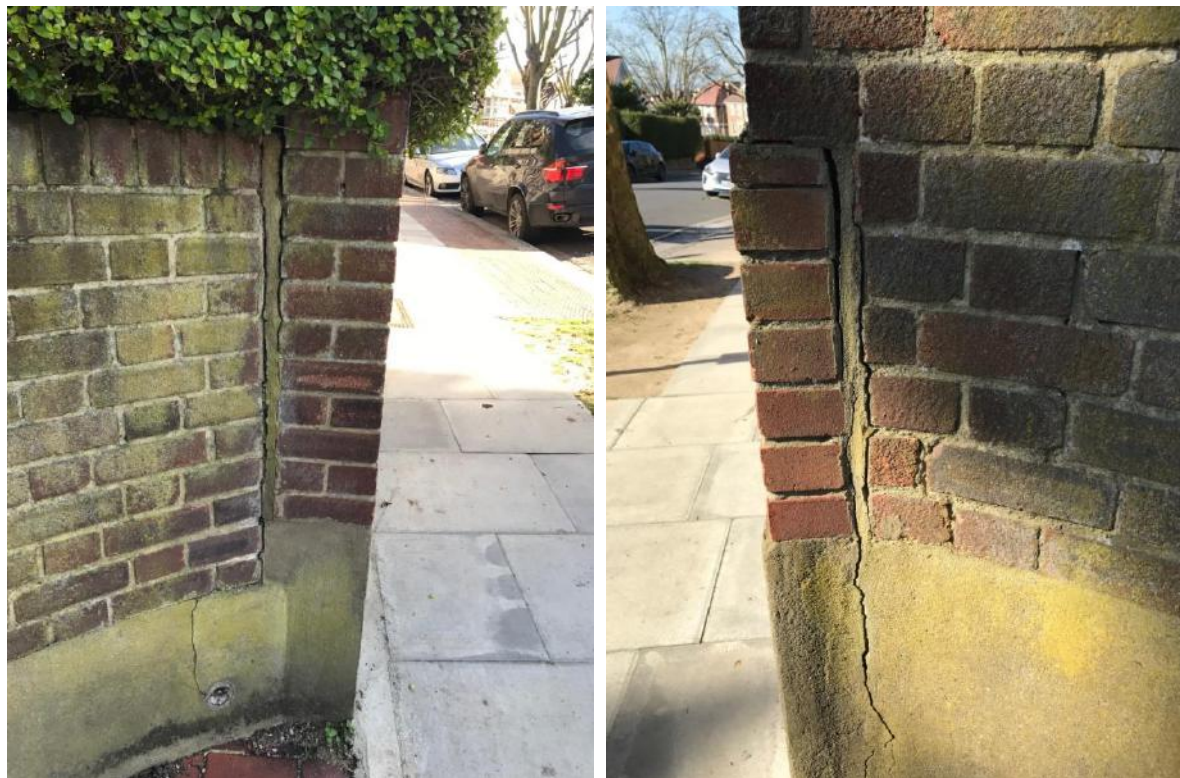
Figure 11. Damage to the existing front boundary wall.

- 1.9 The wall has been damaged and is leaning out towards the main footway on Rosecroft Avenue, therefore improvement works are necessary (Fig.11.).

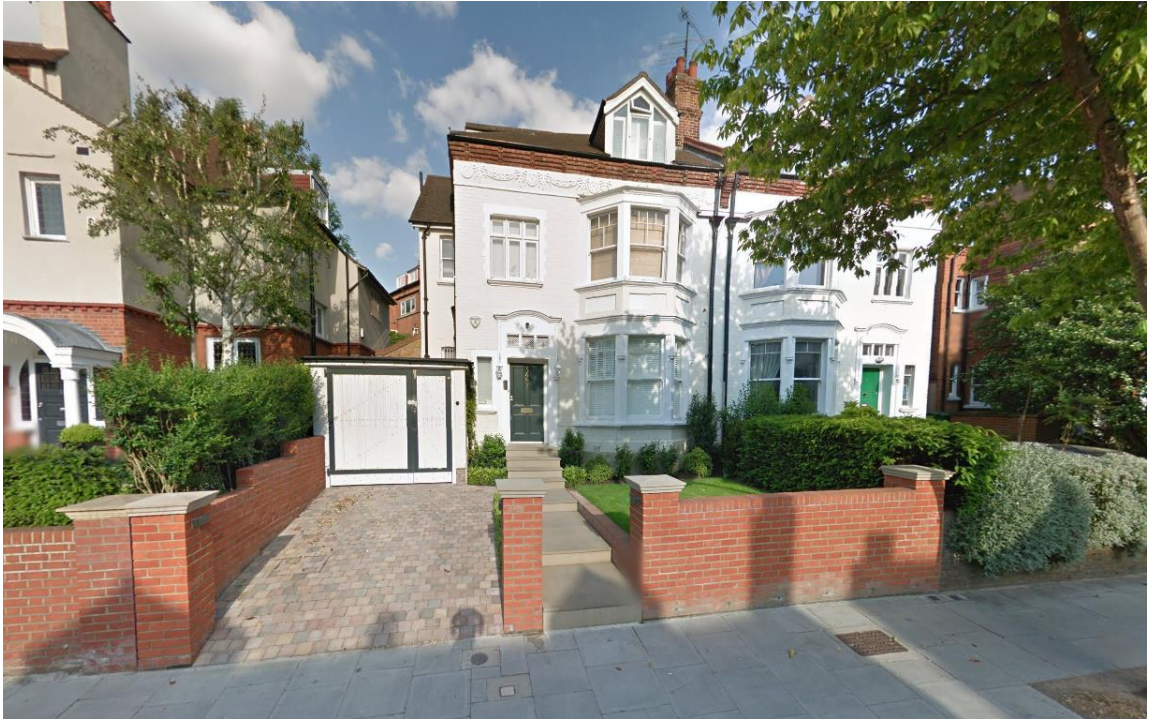
Figure 12. The brick front boundary with piers and coping stone finish at 32 Platt's Lane.

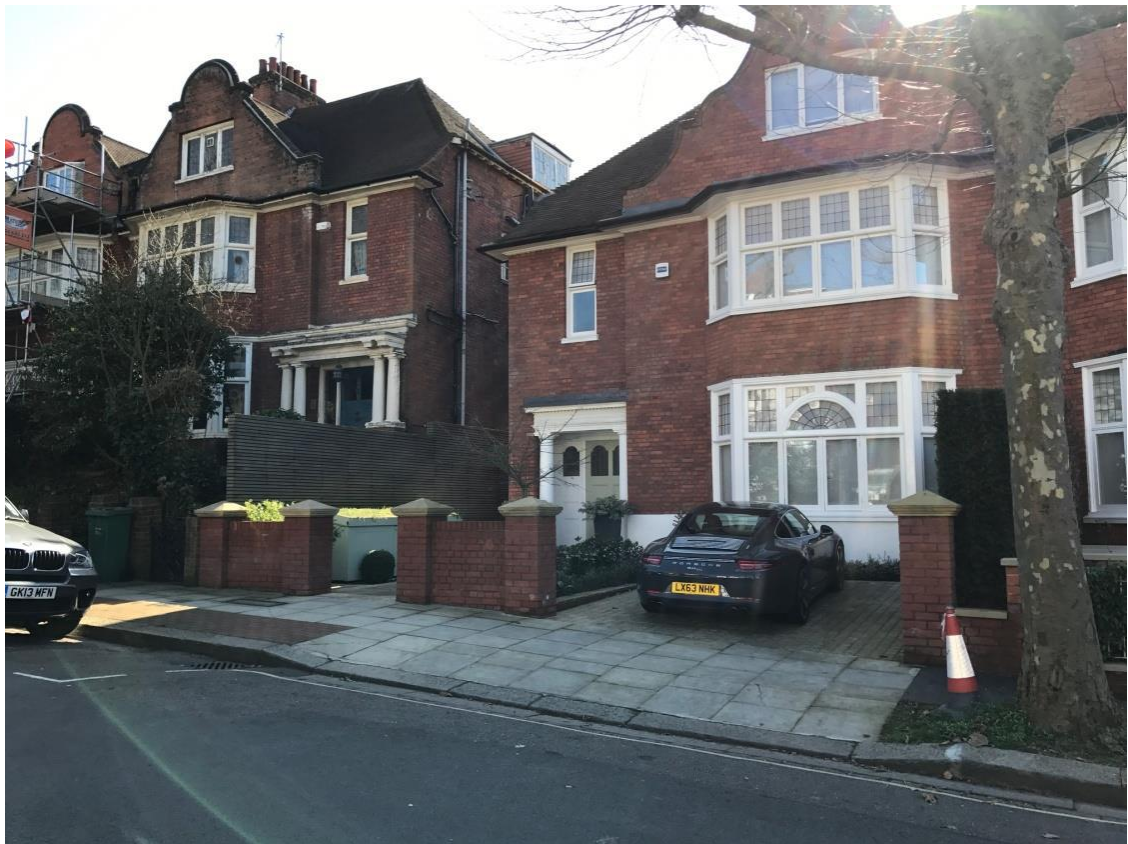
Figure 13. New brick wall with piers and coping stone finish at 30 Hollycroft Avenue.

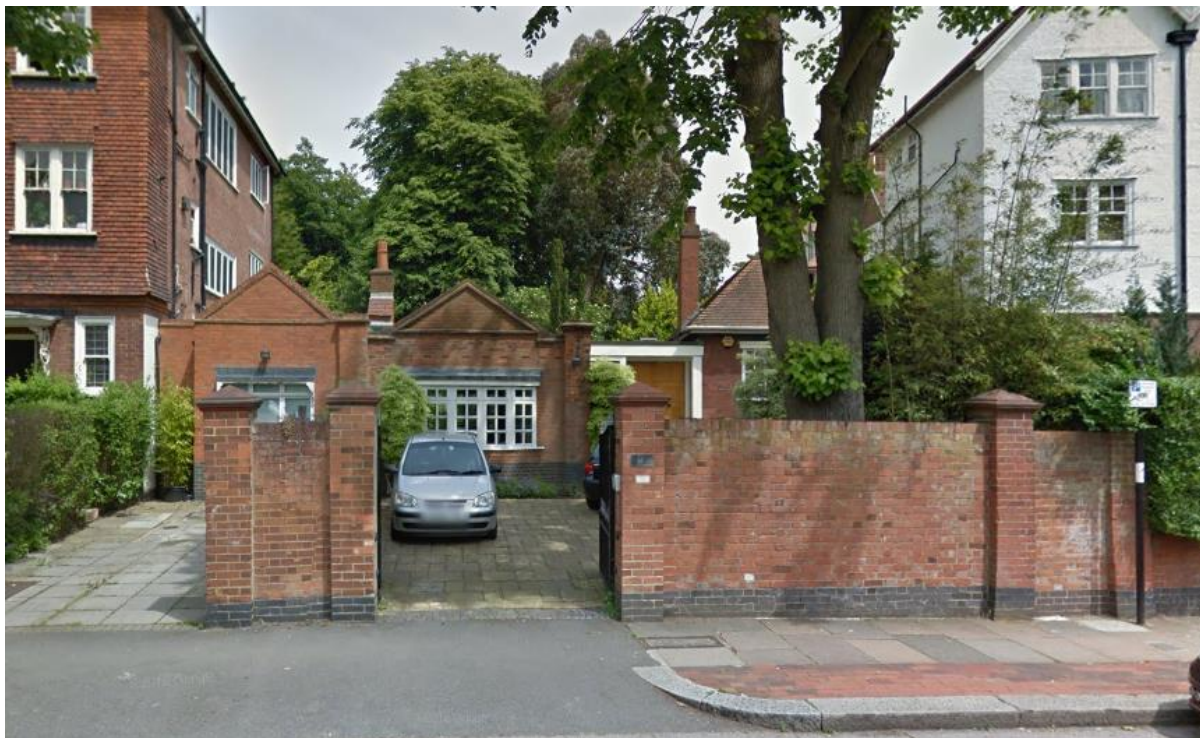
Figure 14. Example of more historic brick front boundary wall with piers and coping stone finish at 16A Fencroft Avenue.

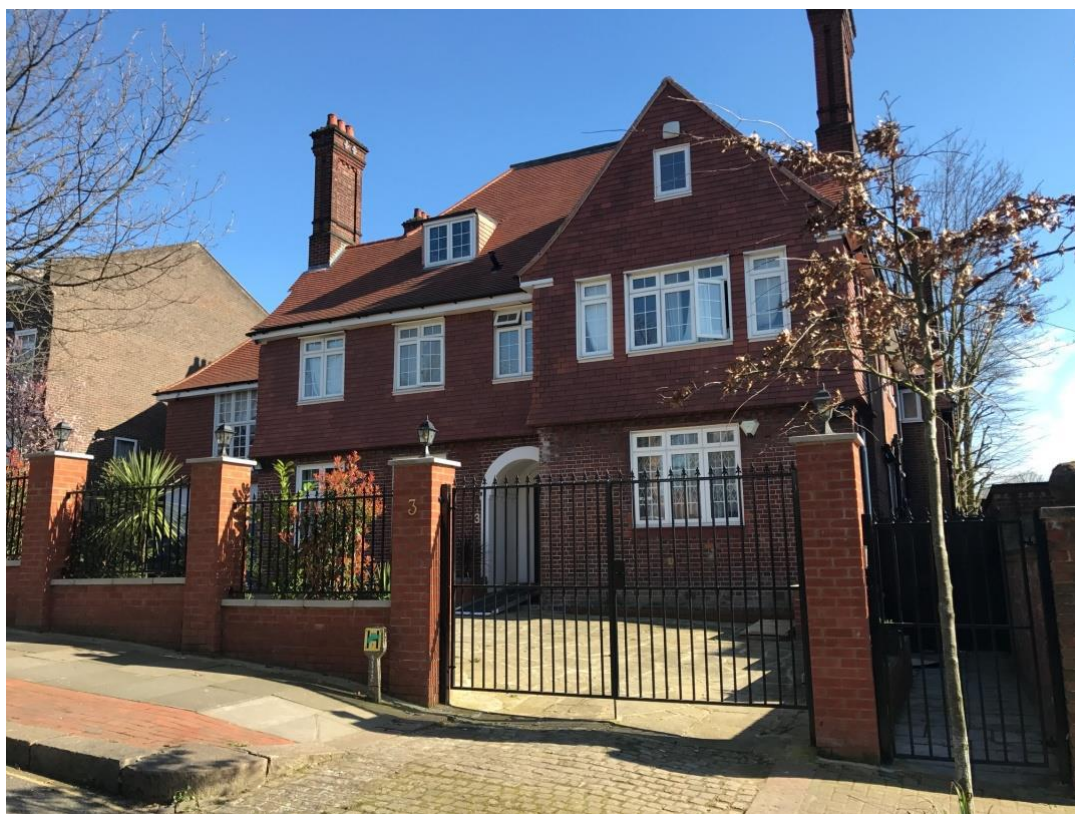
Figure 15. Brick front boundary wall with black metal railings and piers with a coping stone finish at 3 Oakhill Avenue.
