## Venoru Ltd.

49 Marchmont Street, WC1N 1AP

SURVEY OF SIGNIFICANCE third floor plan

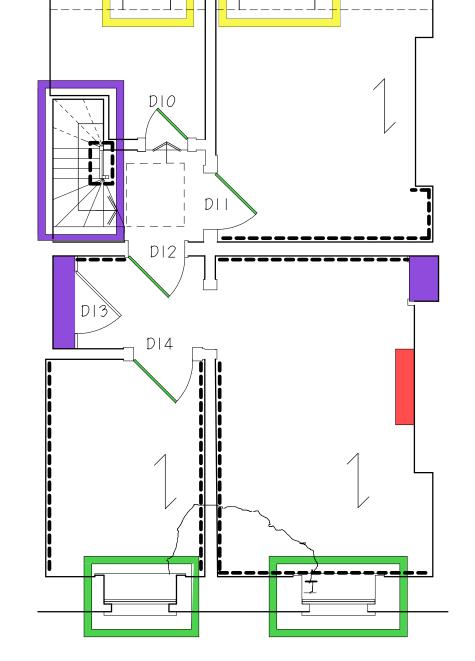
SURVEY OF SIGNIFICANCE THIRD (top) FLOOR PLAN

SURVIVING SKIRTINGS

CUPBOARD AND SHELVES ORIGINAL

DOORS ORIGINAL BUT COMPROMISED

REAR WINDOWS - NOT ORIGINAL

FRONT WINDOWS ORIGINAL BUT IN POOR CONDITION

MID 20TH CENTURY FIREPLACE IN FRONT OF ORIGINAL FIREPLACE

STAIRCASE ORIGINAL - MISSING SPINDLES

ARCHED WINDOW AT FOOT OF STAIRS - FRAGMENT

NO SURVIVING FIREPLACES OR ELEMENTS

MODERN CEILING LININGS

SOME SKIRTINGS SURVIVE

OVERALL CONDITION POOR
