NO. 3 ETON VILLAS • LONDON • NW3 4SX

PROPOSED SIDE ELEVATION (SHOWING NEW DRAINAGE)

406/208

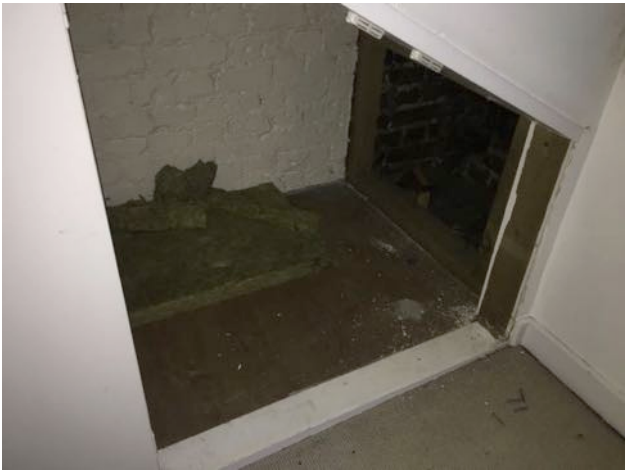
Existing cupboard uncovered to reveal service void below existing roofline and above ceiling void of bathroom below

\*SITE INVESTIGATIONS AND UNCOVERING WORKS HAVE CONFIRMED THAT NO EXISTING JOISTS OR RAFTERS ARE REQUIRED TO BE ALTERED TO ACHIEVE THIS (SEE PICTURES PROVIDED ABOVE)

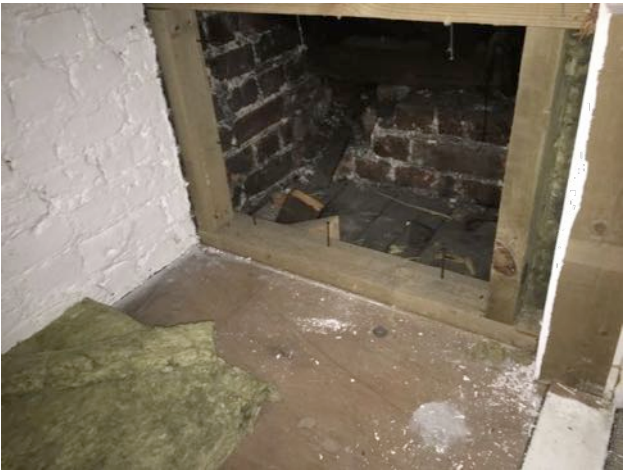
Existing cupboard uncovered to reveal service void below existing roofline and above ceiling void of bathroom below

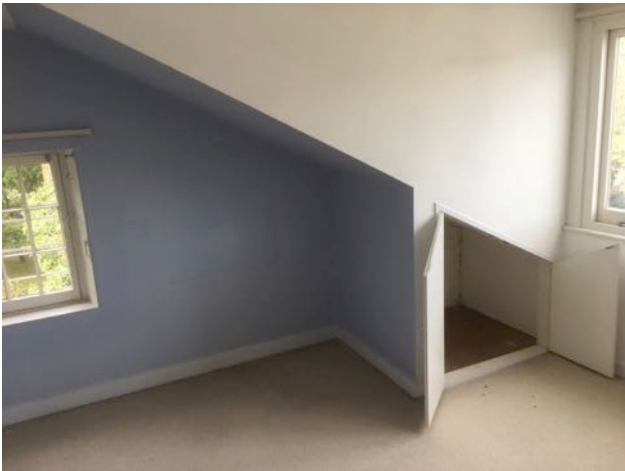
Photographic record of existing cupboard in "bedroom 1" to the rear of the loft floor plan of No. 3 Eton Villas (CUPBOARD A)

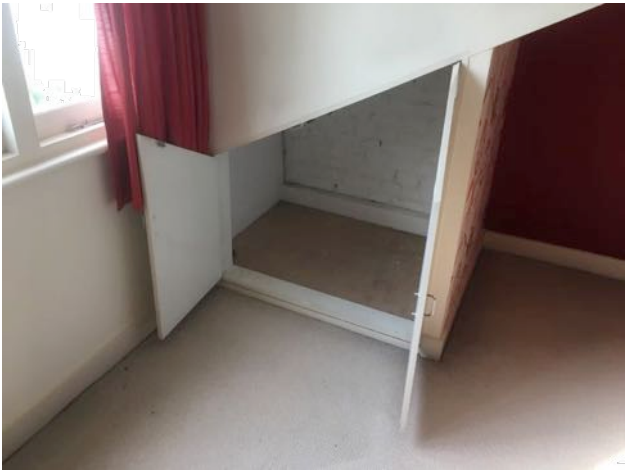
Photographic record of existing cupboard in "bedroom 2" to the front of the loft floor plan of No. 3 Eton Villas (CUPBOARD B)

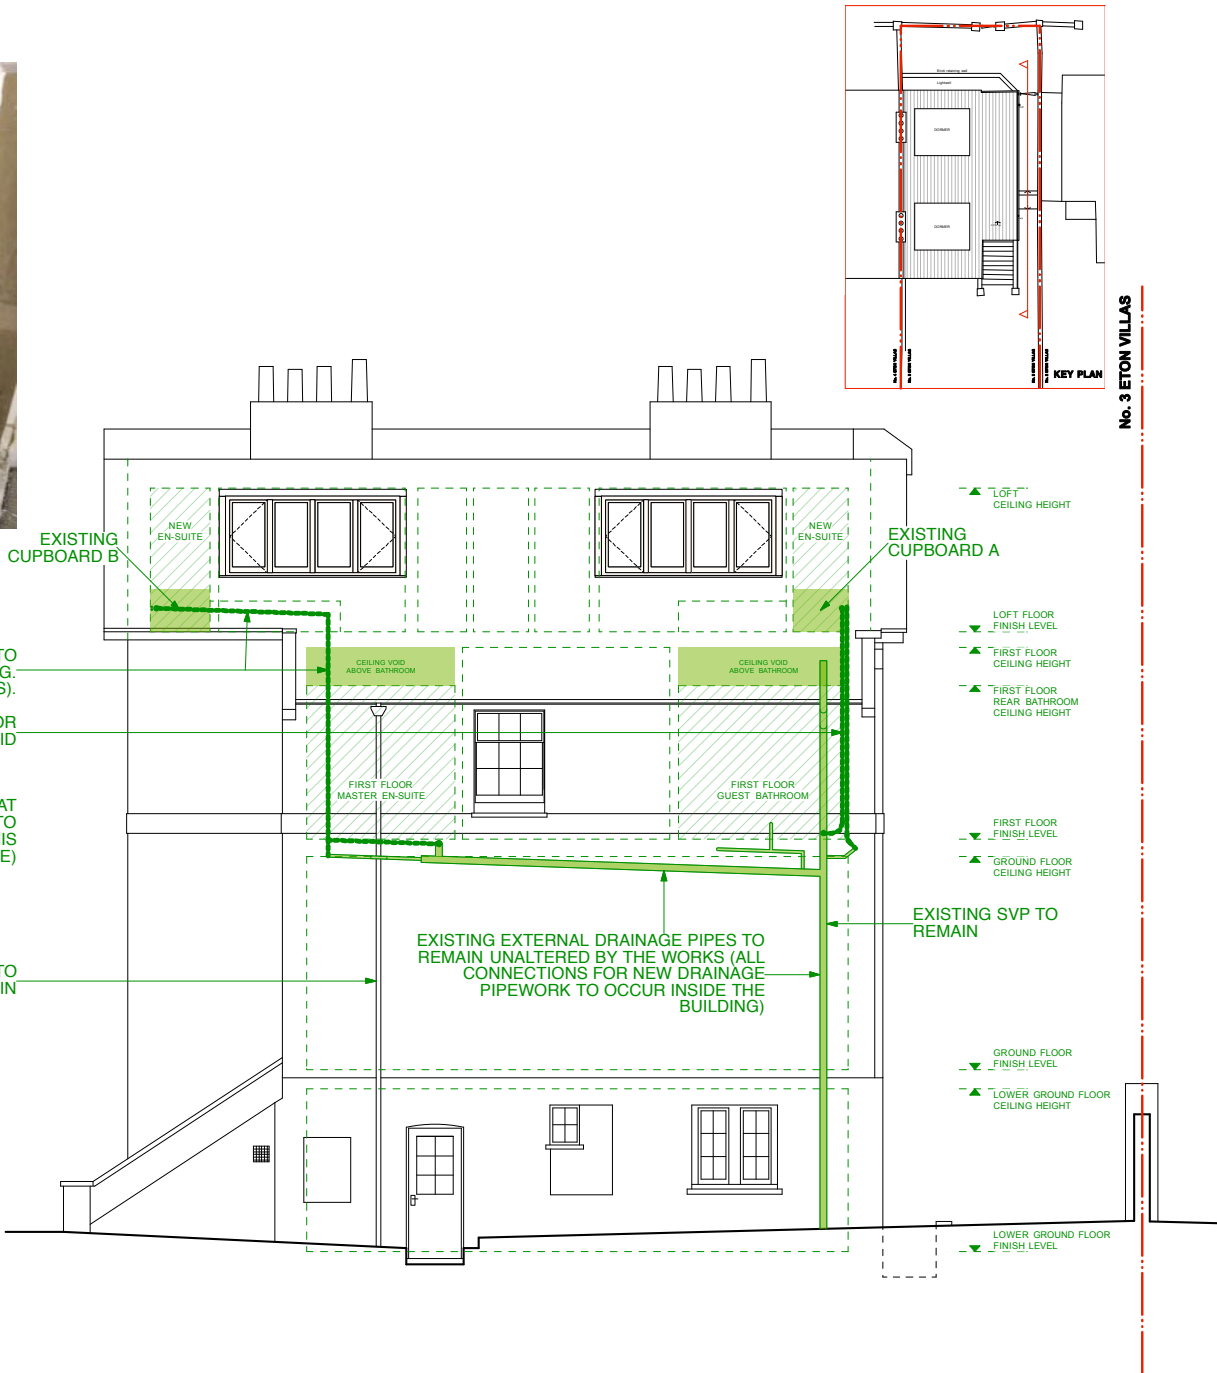
SIDE ELEVATION PROPOSED

ALL NEW DRAINAGE FROM LOFT-LEVEL EN-SUITES TO CONNECT TO EXISTING SVP AND VERTICAL DRAINAGE PIPES INSIDE THE BUILDING. (NO EXTERNAL ALTERATIONS ARE REQUIRED TO ACHIEVE THIS).

ALL PIPEWORK WILL BE RUN WITHIN TILED / PLASTERBOARDED INTERIOR LINED 'WET-WALLS' AND WITHIN EXISTING ROOF / CEILING VOID

(DETAILS OF DRAINAGE SHOWN AS SUPERIMPOSED SECTION INFORMATION)

NO ALTERATIONS TO EXTERNAL DRAINAGE RUNS OR PIPEWORK ARE REQUIRED
