L. B. CAMDEN

20 Leighton Crescent
Kentish Town, London, NW5 2QY

REPLACEMENT WINDOWS

Drg.no: 40-SK(0)008

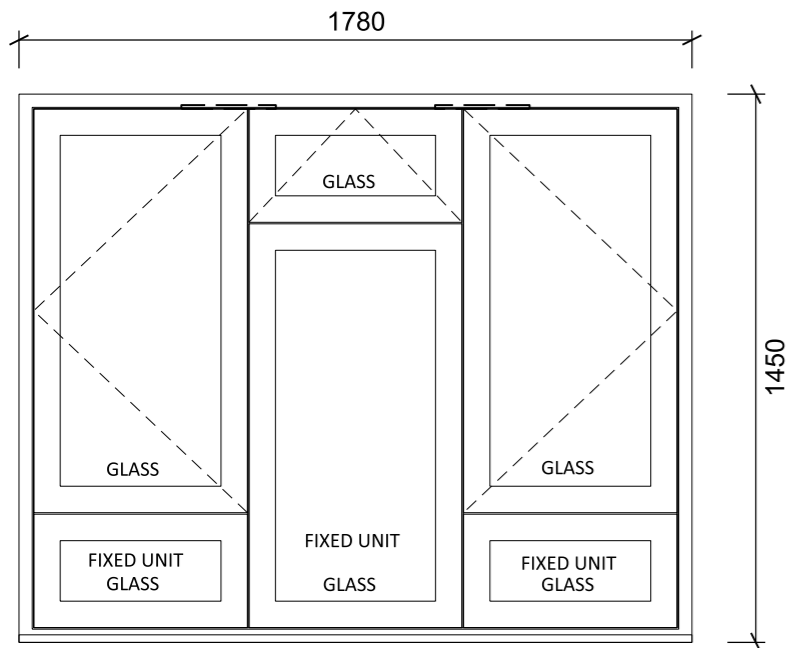
WINDOW 1
DOUBLE GLAZED TIMBER WINDOW

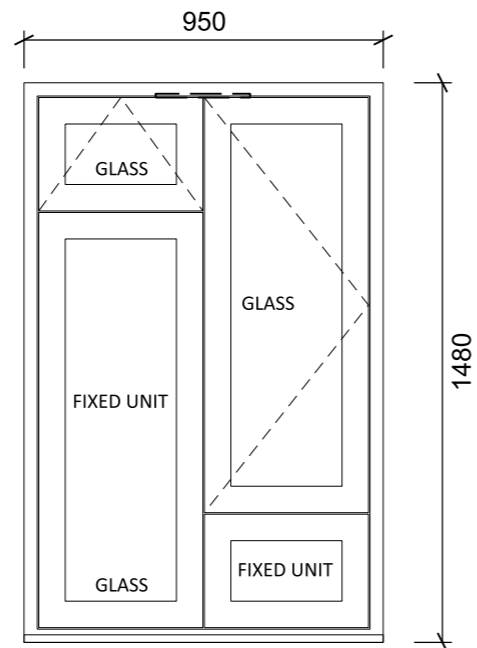
WINDOW 2
DOUBLE GLAZED TIMBER WINDOW
OBSCURE GLAZING (BATHROOM)

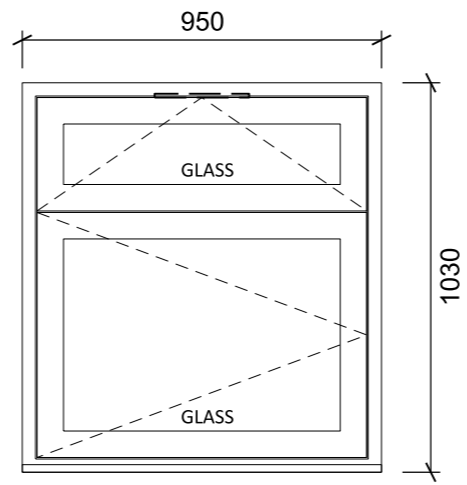
WINDOW 3
DOUBLE GLAZED, OBSCURE GLASS
TIMBER WINDOW, NEW FENESTRATION
PATTERN TO REPLACE WC WINDOW

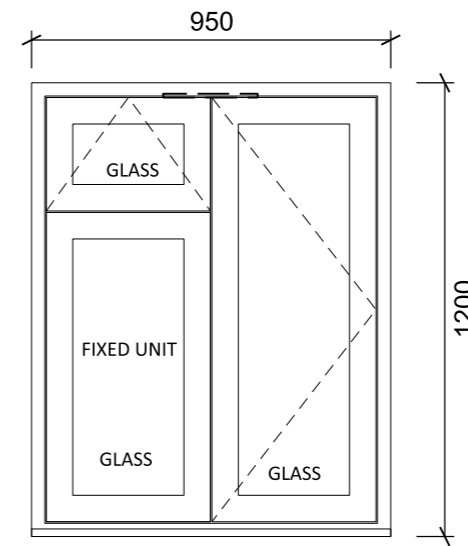
WINDOW 4
DOUBLE GLAZED TIMBER WINDOW
OBSCURE GLAZING (BATHROOM)

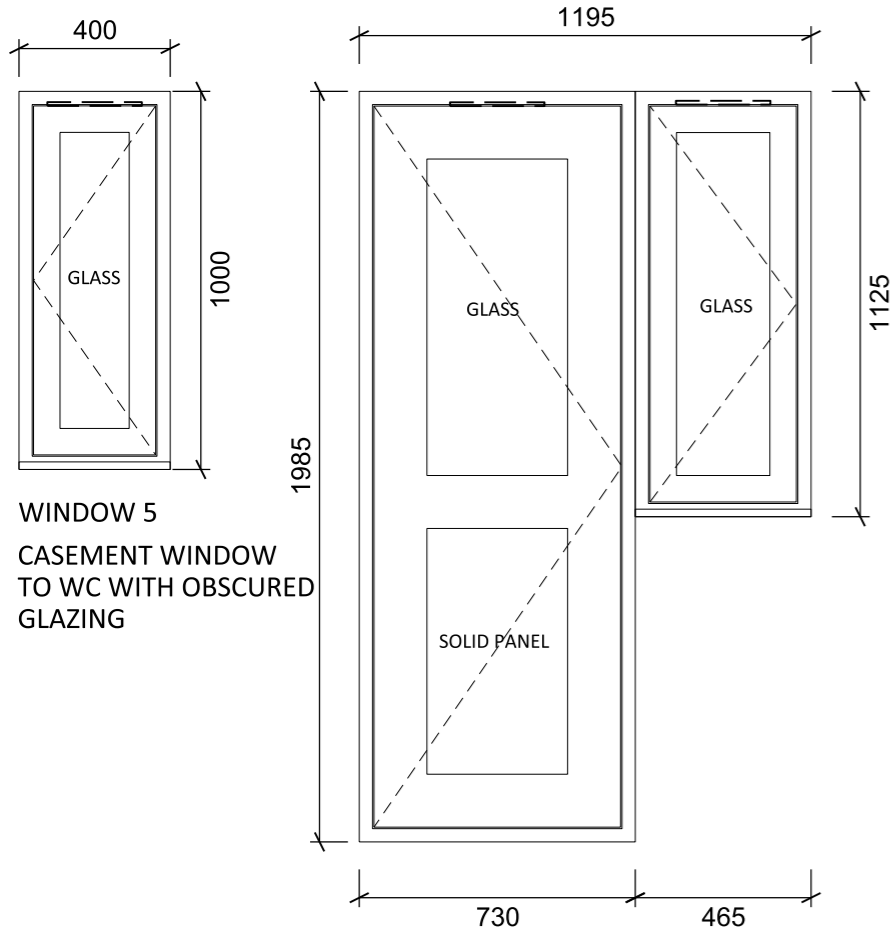
WINDOW 5
CASEMENT WINDOW
TO WC WITH OBSCURED
GLAZING

**WINDOW 6
& DOOR**
REPLACEMENT DOOR AND
VESTIBULE WINDOW FOR
LOWER GROUND FLOOR
SIDE ELEVATION OF BACK
ADDITION DOUBLE GLAZED,
LAMINATED GLASS, (CLEAR
OR OBSCURED TO TENANTS
CHOICE.) TIMBER FRAME.

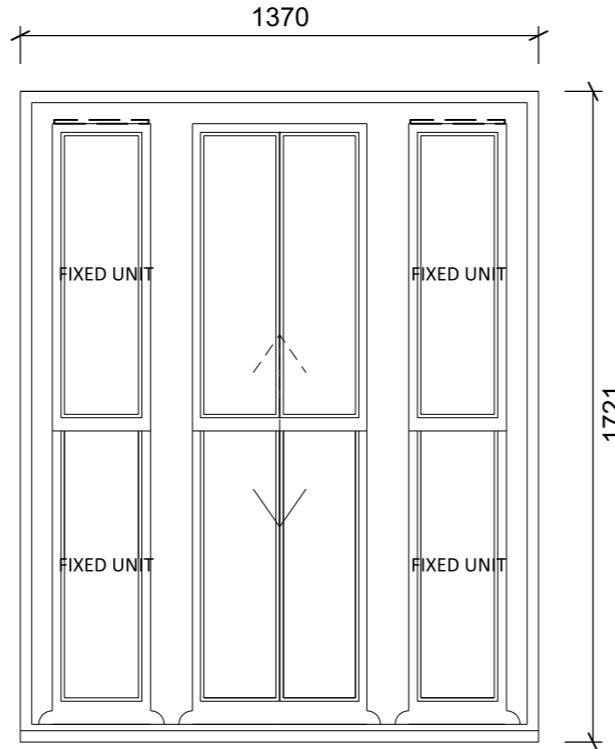
WINDOW 7
REPLACEMENT TIMBER SLIDING
SASH WINDOWS, SAME PATTERN
AS EXISTING WINDOW.
NEW TO HAVE DOUBLE GLAZED UNITS

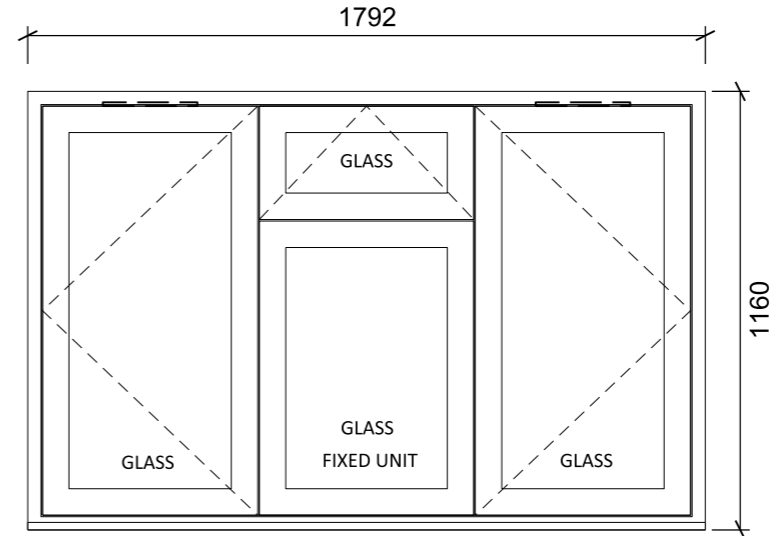
WINDOW 8
REPLACEMENT OF STEEL WINDOW
TO BEDROOM. REPLACE WITH
NEW TIMBER WINDOW WITH
SIMILAR PATTERN. NEW WINDOW TO
HAVE DOUBLE GLAZED UNITS
