HISTORIC BUILDING IMPACT ASSESSMENT

**THE PROVISION OF NEW YORKSTONE STEPS TO THE FRONT
OF**

**9 ST GEORGES TERRACE,
LONDON
NW1 8XH**

**DATE PREPARED:
MARCH 2018**

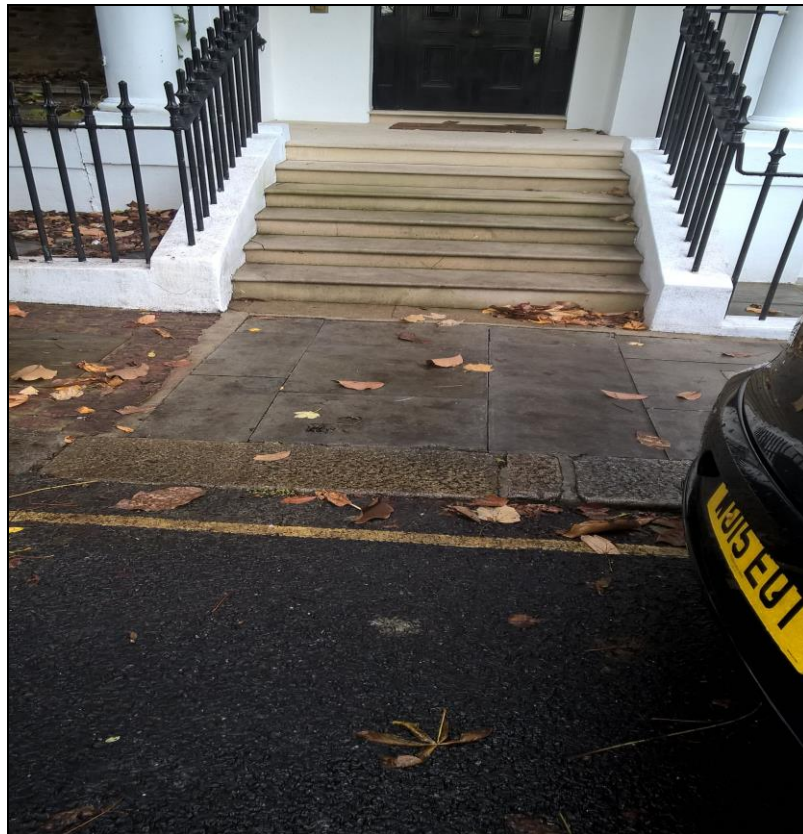
Photograph 3 below shows Yorkstone steps to the front of a different property in St George's Terrace; Similar material is proposed for House 9, St George's Terrace.

- 3.1 The visual appearance of the steps will be altered but, the materials and new appearance will be more in keeping with those that existed when the property was built. See Photograph 1 and Photograph 3.
- 3.2 The works are external, will not conflict with the building and there will be no impact on the original features.

- 4.1 A new base will be constructed supported on pre-stressed concrete lintels. A water-proof membrane will be applied chased into the balustrade walls and finished with matching render. The disturbed decorations to the adjacent surfaces will be painted to match the existing. The steps will be finished with yellow Yorkstone which would have been used in the original construction. See Photograph 3.
- 4.2 Where the water-proof membrane is applied to the walls a render coat will be applied over and it will be painted white to match the adjacent masonry.
- 4.3 NB: The proposals can be seen in the photographs 2, 3 and 4 below

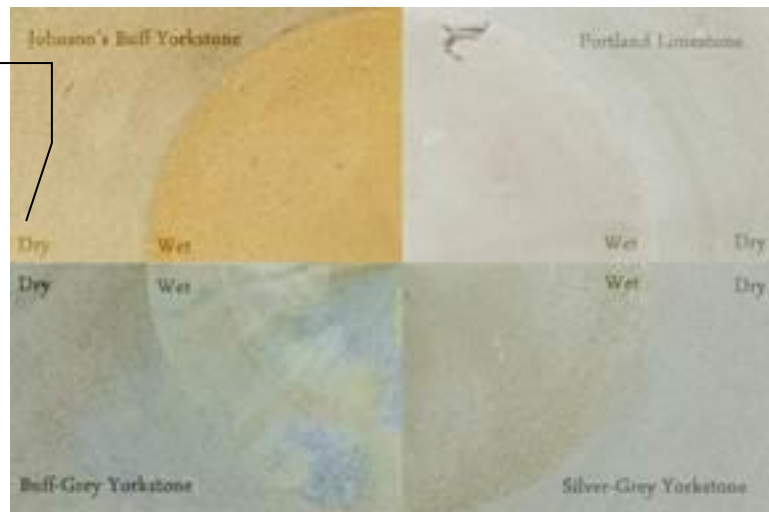
Photograph 4

Proposed colour for new stone steps.
