Ground and basement, 51-53 Shelton Street, London WC2H 9JU

## SITE HISTORY

## OUR PROPOSAL

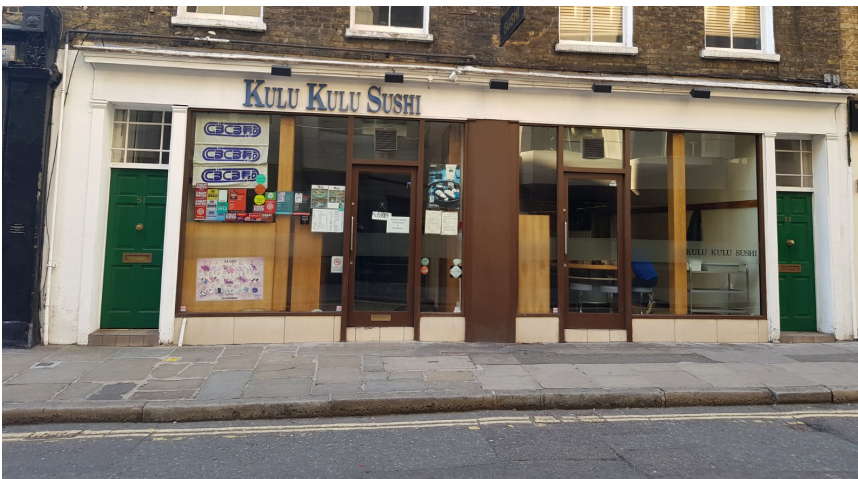
Existing ground floor facade

The existing shopfront is formed of a non-period timber frame glazed front set within the original pilasters and fascia.

We propose to replace the existing shop front with a fully-glazed front (no timber frame); paint the original pilasters and fascia; replace the existing externally illuminated fascia sign and a light internal refurbishment involving the removal of partition walls and the installation of a new kitchen on the ground floor.
