British Museum Perimeter Properties Refurbishment	
P2007246	
DRAWING TITLE 1-1A Montague Street Proposed Front Elevation	SCALE 1:50@A1
PLANNING AND LBC APPLICATION	DATE April '17
(15)AE001	REVISION D

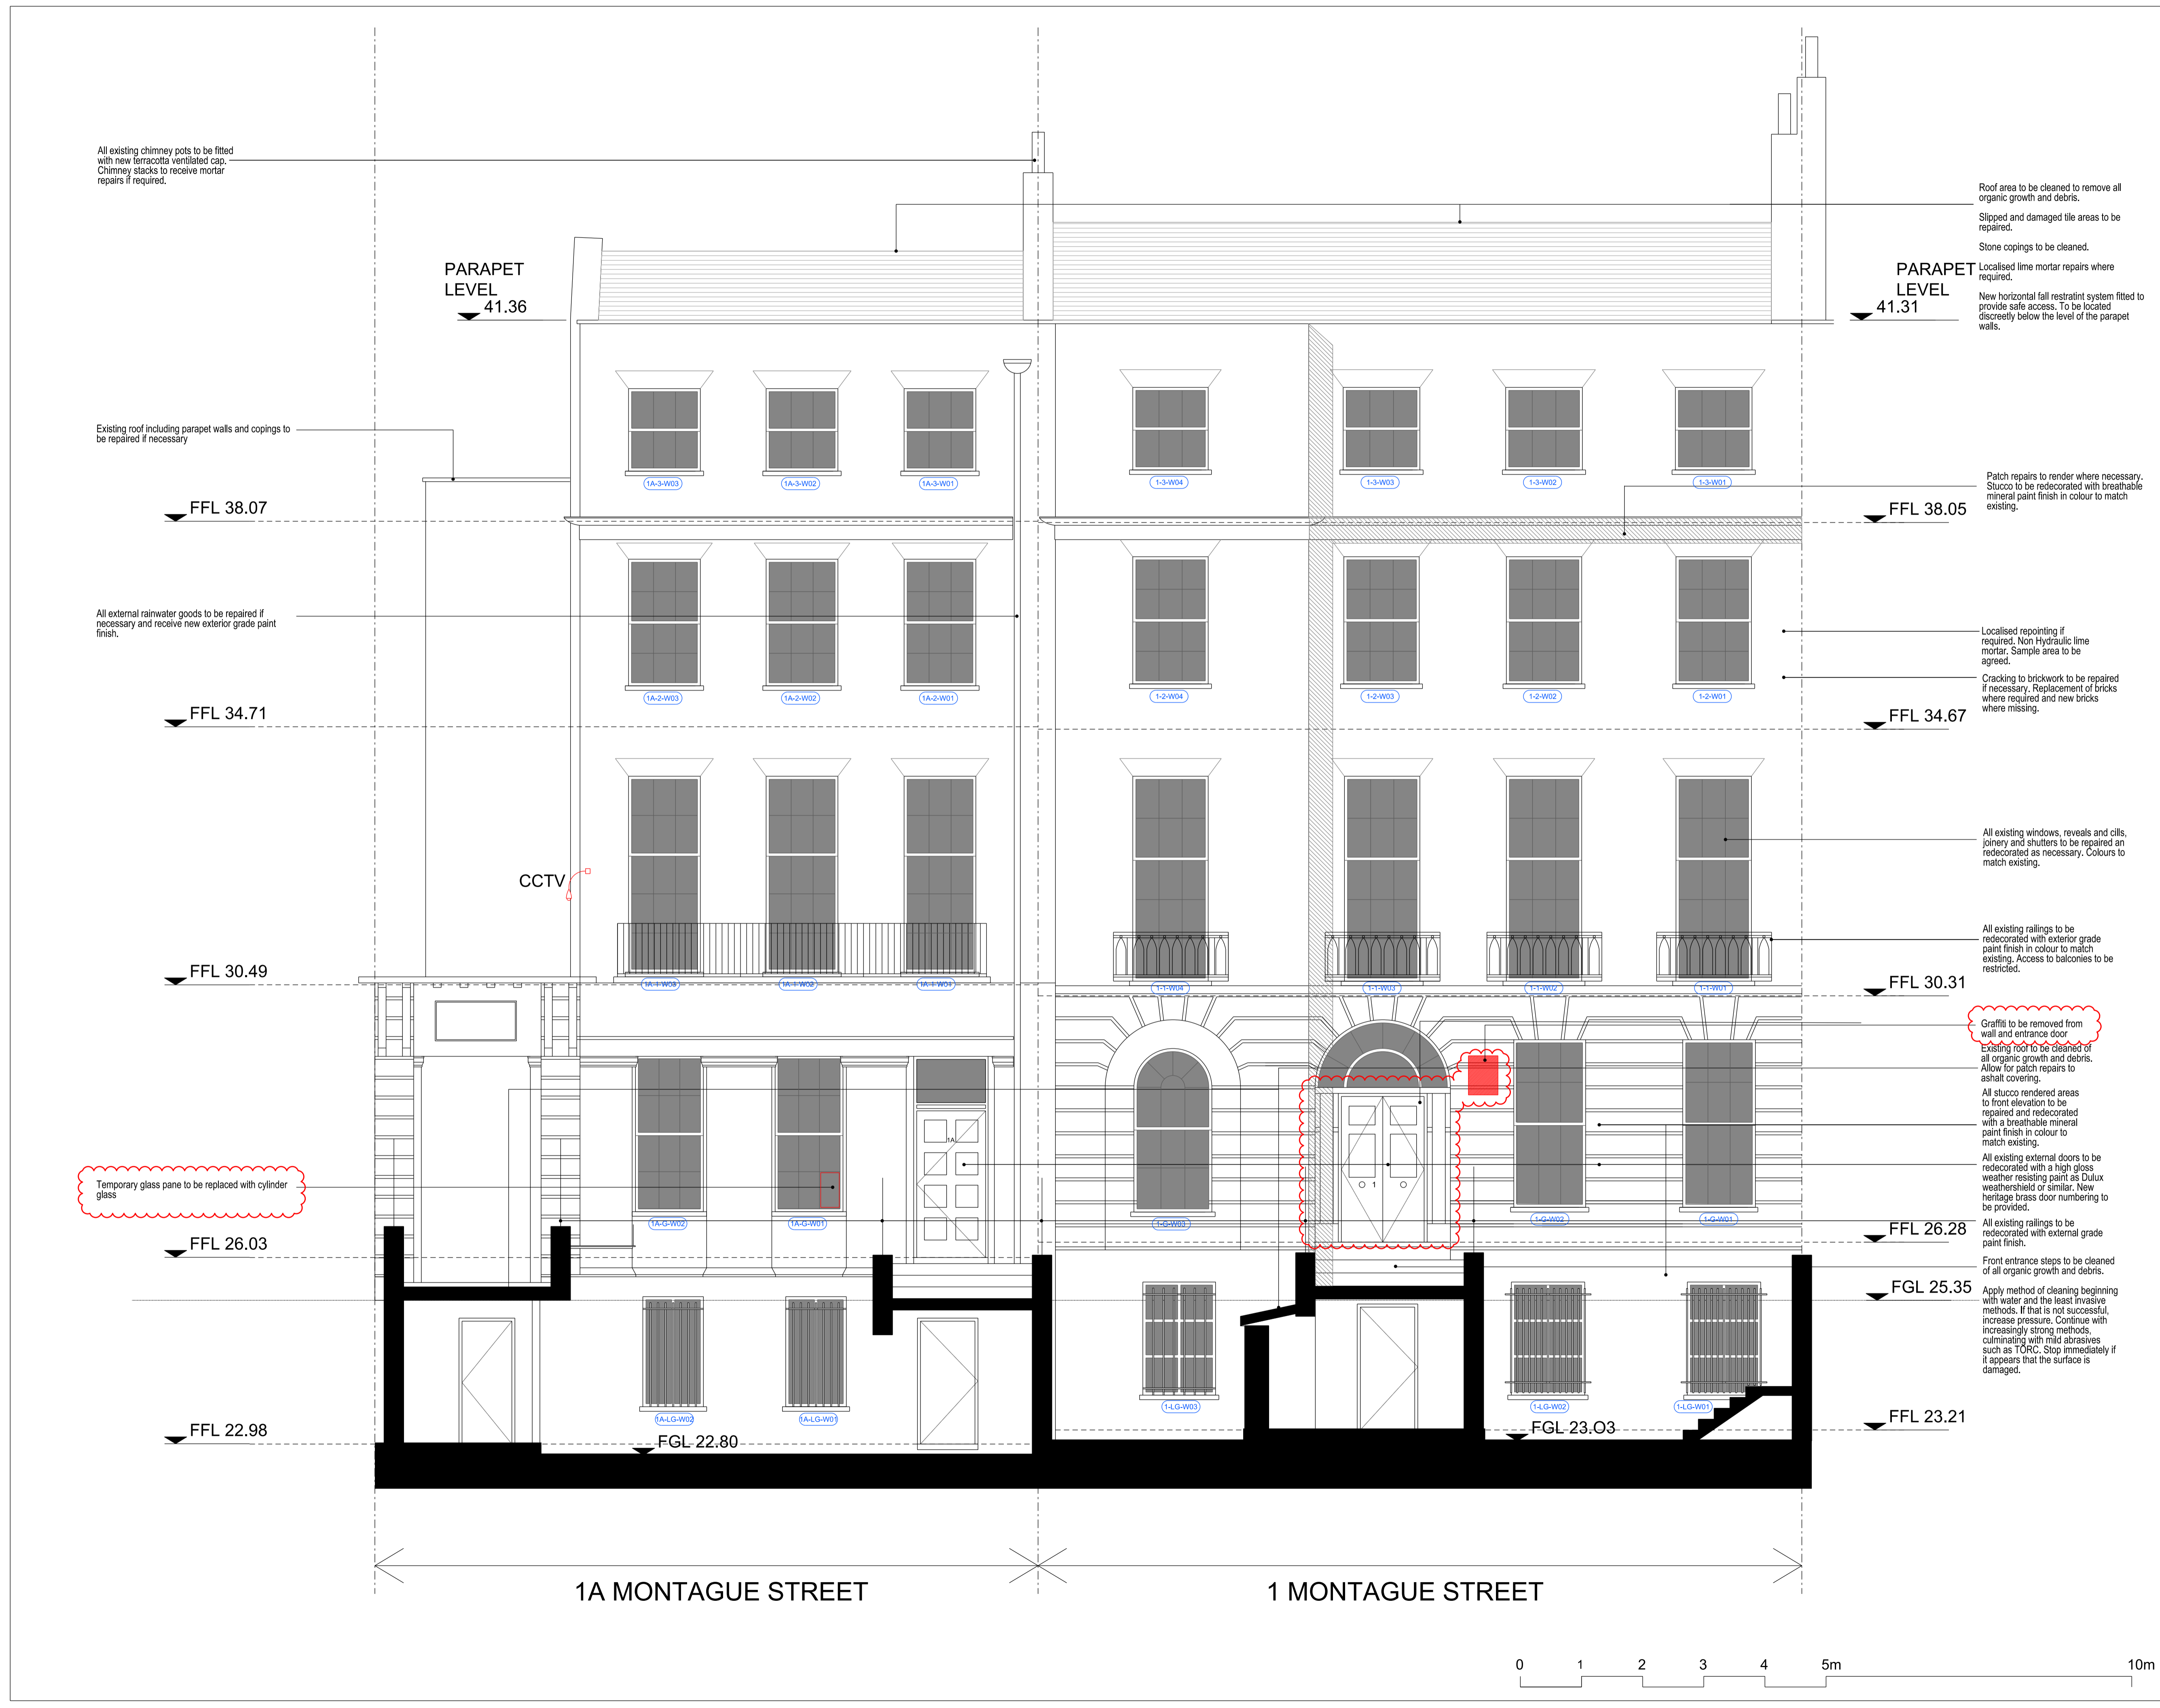
All existing chimney pots to be fitted with new terracotta ventilated cap. Chimney stacks to receive mortar repairs if required.

Roof area to be cleaned to remove all organic growth and debris.  
 Slipped and damaged tile areas to be repaired.  
 Stone copings to be cleaned.  
 Localised lime mortar repairs where required.  
 New horizontal fall restraint system fitted to provide safe access. To be located discreetly below the level of the parapet walls.

Existing roof including parapet walls and copings to be repaired if necessary

Patch repairs to render where necessary. Stucco to be redecorated with breathable mineral paint finish in colour to match existing.

All external rainwater goods to be repaired if necessary and receive new exterior grade paint finish.

Localised repointing if required. Non Hydraulic lime mortar. Sample area to be agreed.  
 Cracking to brickwork to be repaired if necessary. Replacement of bricks where required and new bricks where missing.

All existing windows, reveals and cills, joinery and shutters to be repaired and redecorated as necessary. Colours to match existing.

All existing railings to be redecorated with exterior grade paint finish in colour to match existing. Access to balconies to be restricted.

Graffiti to be removed from wall and entrance door.  
 Existing roof to be cleaned of all organic growth and debris. Allow for patch repairs to asphalt covering.  
 All stucco rendered areas to front elevation to be repaired and redecorated with a breathable mineral paint finish in colour to match existing.

All existing external doors to be redecorated with a high gloss weather resisting paint as Dulux weathershield or similar. New heritage brass door numbering to be provided.

All existing railings to be redecorated with external grade paint finish.

Front entrance steps to be cleaned of all organic growth and debris.  
 Apply method of cleaning beginning with water and the least invasive methods. If that is not successful, increase pressure. Continue with increasingly strong methods, culminating with mild abrasives such as TORC. Stop immediately if it appears that the surface is damaged.
